# Blakes Lock Welfare Facility

## Ecological Advice Note

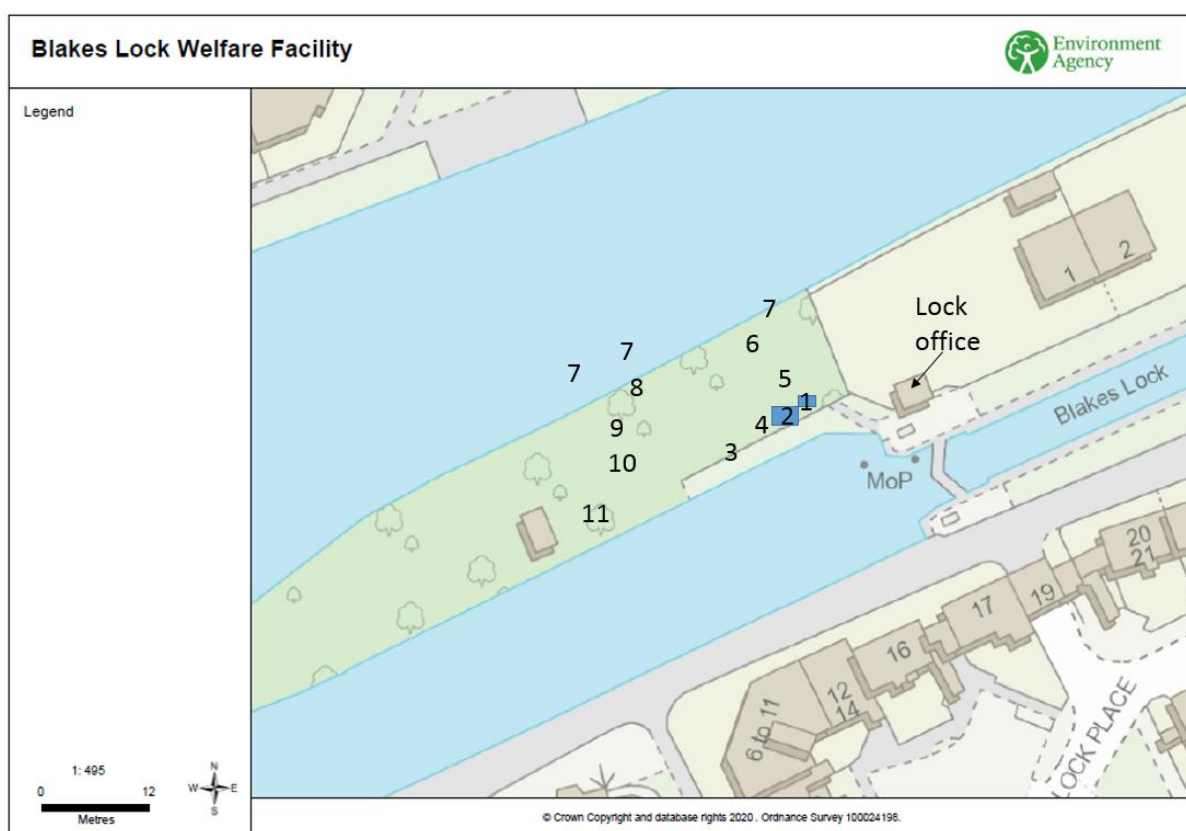
**Figure 3. Map illustrating the existing structures and features on the development site**

1. Metal unit containing existing toilet – see photograph 1.
2. Existing wooden shed used for storage – see photographs 2 and 4.
3. Rhododendron (*Rhododendron* sp.) hedge.
4. Pile of recently cut, large pieces of timber.
5. Pile of brash with old fence panels and pallets – see photograph 4.
6. Pile of brash – see photograph 3.
7. Crack willow trees at the bottom of the river bank and within the channel.
8. Cherry tree (*Prunus* sp.) on top of river bank.
9. Ivy covered tree, species unknown – see photograph 4.
10. Mature coppiced tree, species unknown – see photograph 4.
11. Cherry tree (*Prunus* sp.).

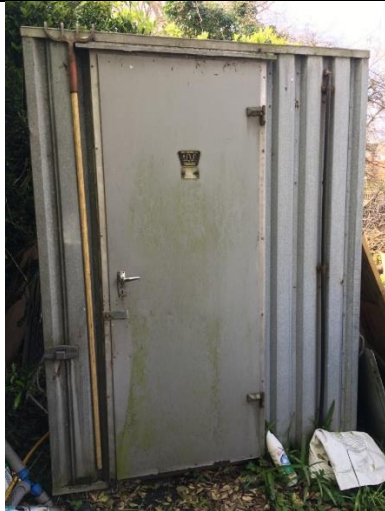
Photograph 1: Metal unit containing toilet.

The existing metal unit had no gaps where bats could enter, and being made of metal the temperatures are likely to fluctuate making it less suitable for bats. Therefore this had negligible potential to support roosting or hibernating bats. The existing wooden shed had no gaps where bats could enter and no signs such as bat droppings were observed. Therefore this had negligible potential to support roosting or hibernating bats. The only tree with bat potential was the ivy-covered tree (target note 8 and photograph 4) as bats could roost within crevices behind the ivy, although it was not possible to see the trunk. This tree has low potential for bats.

As neither the metal unit nor the timber shed have any bat potential, they can both be removed without the need for a bat survey. The footprint of the proposed welfare unit is not in the vicinity of the ivy-covered tree with low bat potential. A bat survey would only be required if the tree needed to be removed or pruned, e.g. to enable access for the materials to be craned in. Enhancements could include the installation of bat boxes on the island.

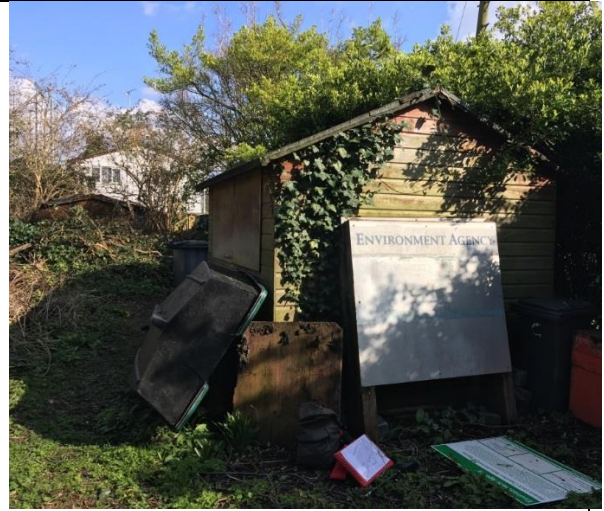
Photograph 2: Wooden shed.

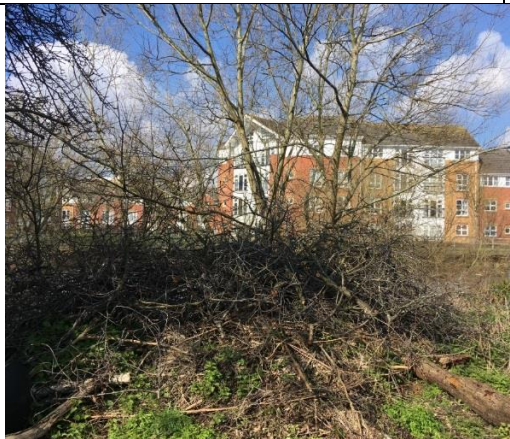
Photograph 3: Brash pile next to the river, looking north.

The three timber piles could potentially be used by reptiles for cover. The most likely species would be grass snake that could swim across to the island. But given the lack of good foraging habitat it is considered unlikely that grass snakes inhabit the island.

While it is unlikely that any reptiles are present on the island, the timber piles should be removed by hand and checked for reptiles while this takes place.

While it is unlikely that any amphibians are present on the island, the timber piles should be removed by hand and checked for amphibians while this takes place.

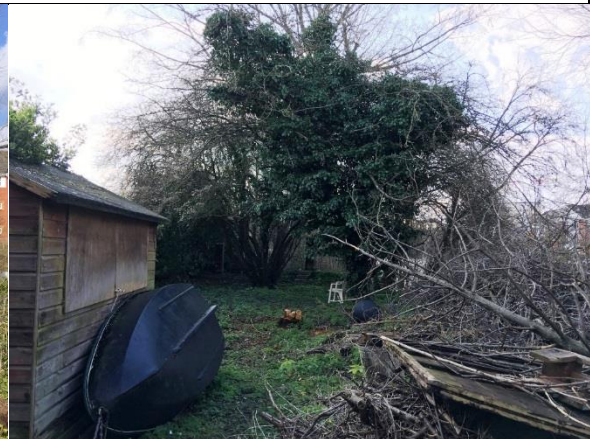
Photograph 4: Timber shed and brash pile with ivy-covered tree and coppiced tree in the background.
