**Project:** 20\_5837\_09\_28  
**Site:** 12 Penroath Avenue, Reading, RG30 2ED  
**Client:** Nabeel Mughal

| Document Title: | Arboricultural Implications Assessment |
| Project Title: | 12 Penroath Avenue, Reading, RG30 2ED |

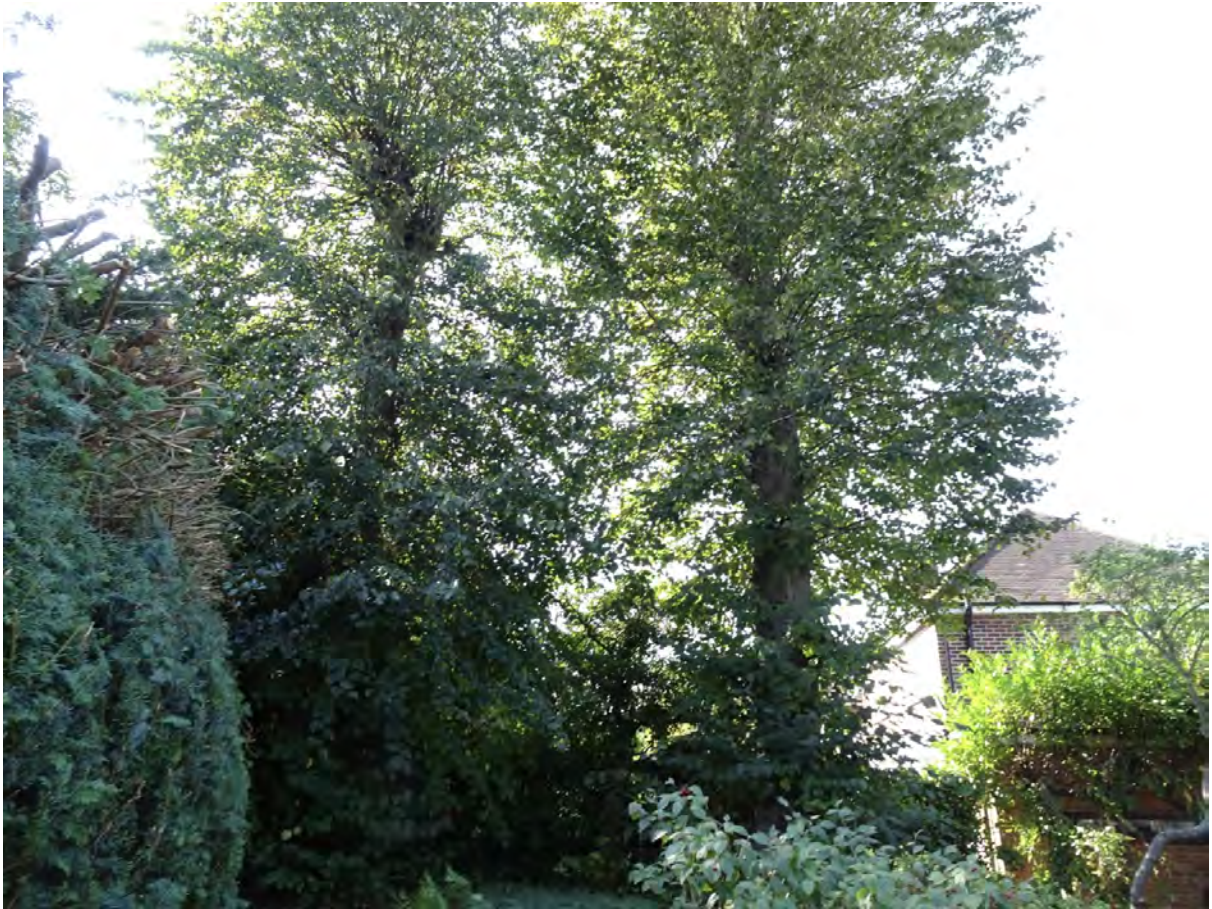
*Photographic plate showing trees T2 and T1, both of which are mature Large-leaved Limes.*

- 4.8 Trees T1 and T2 are mature Large-leaved Limes located on the sites boundary. Both are suffering from epicormic growth. Their branches are encroaching upon the adjacent building. The epicormic growth should be removed. A crown reduction is advised for both trees to prevent the branches from encroaching upon the adjacent building.

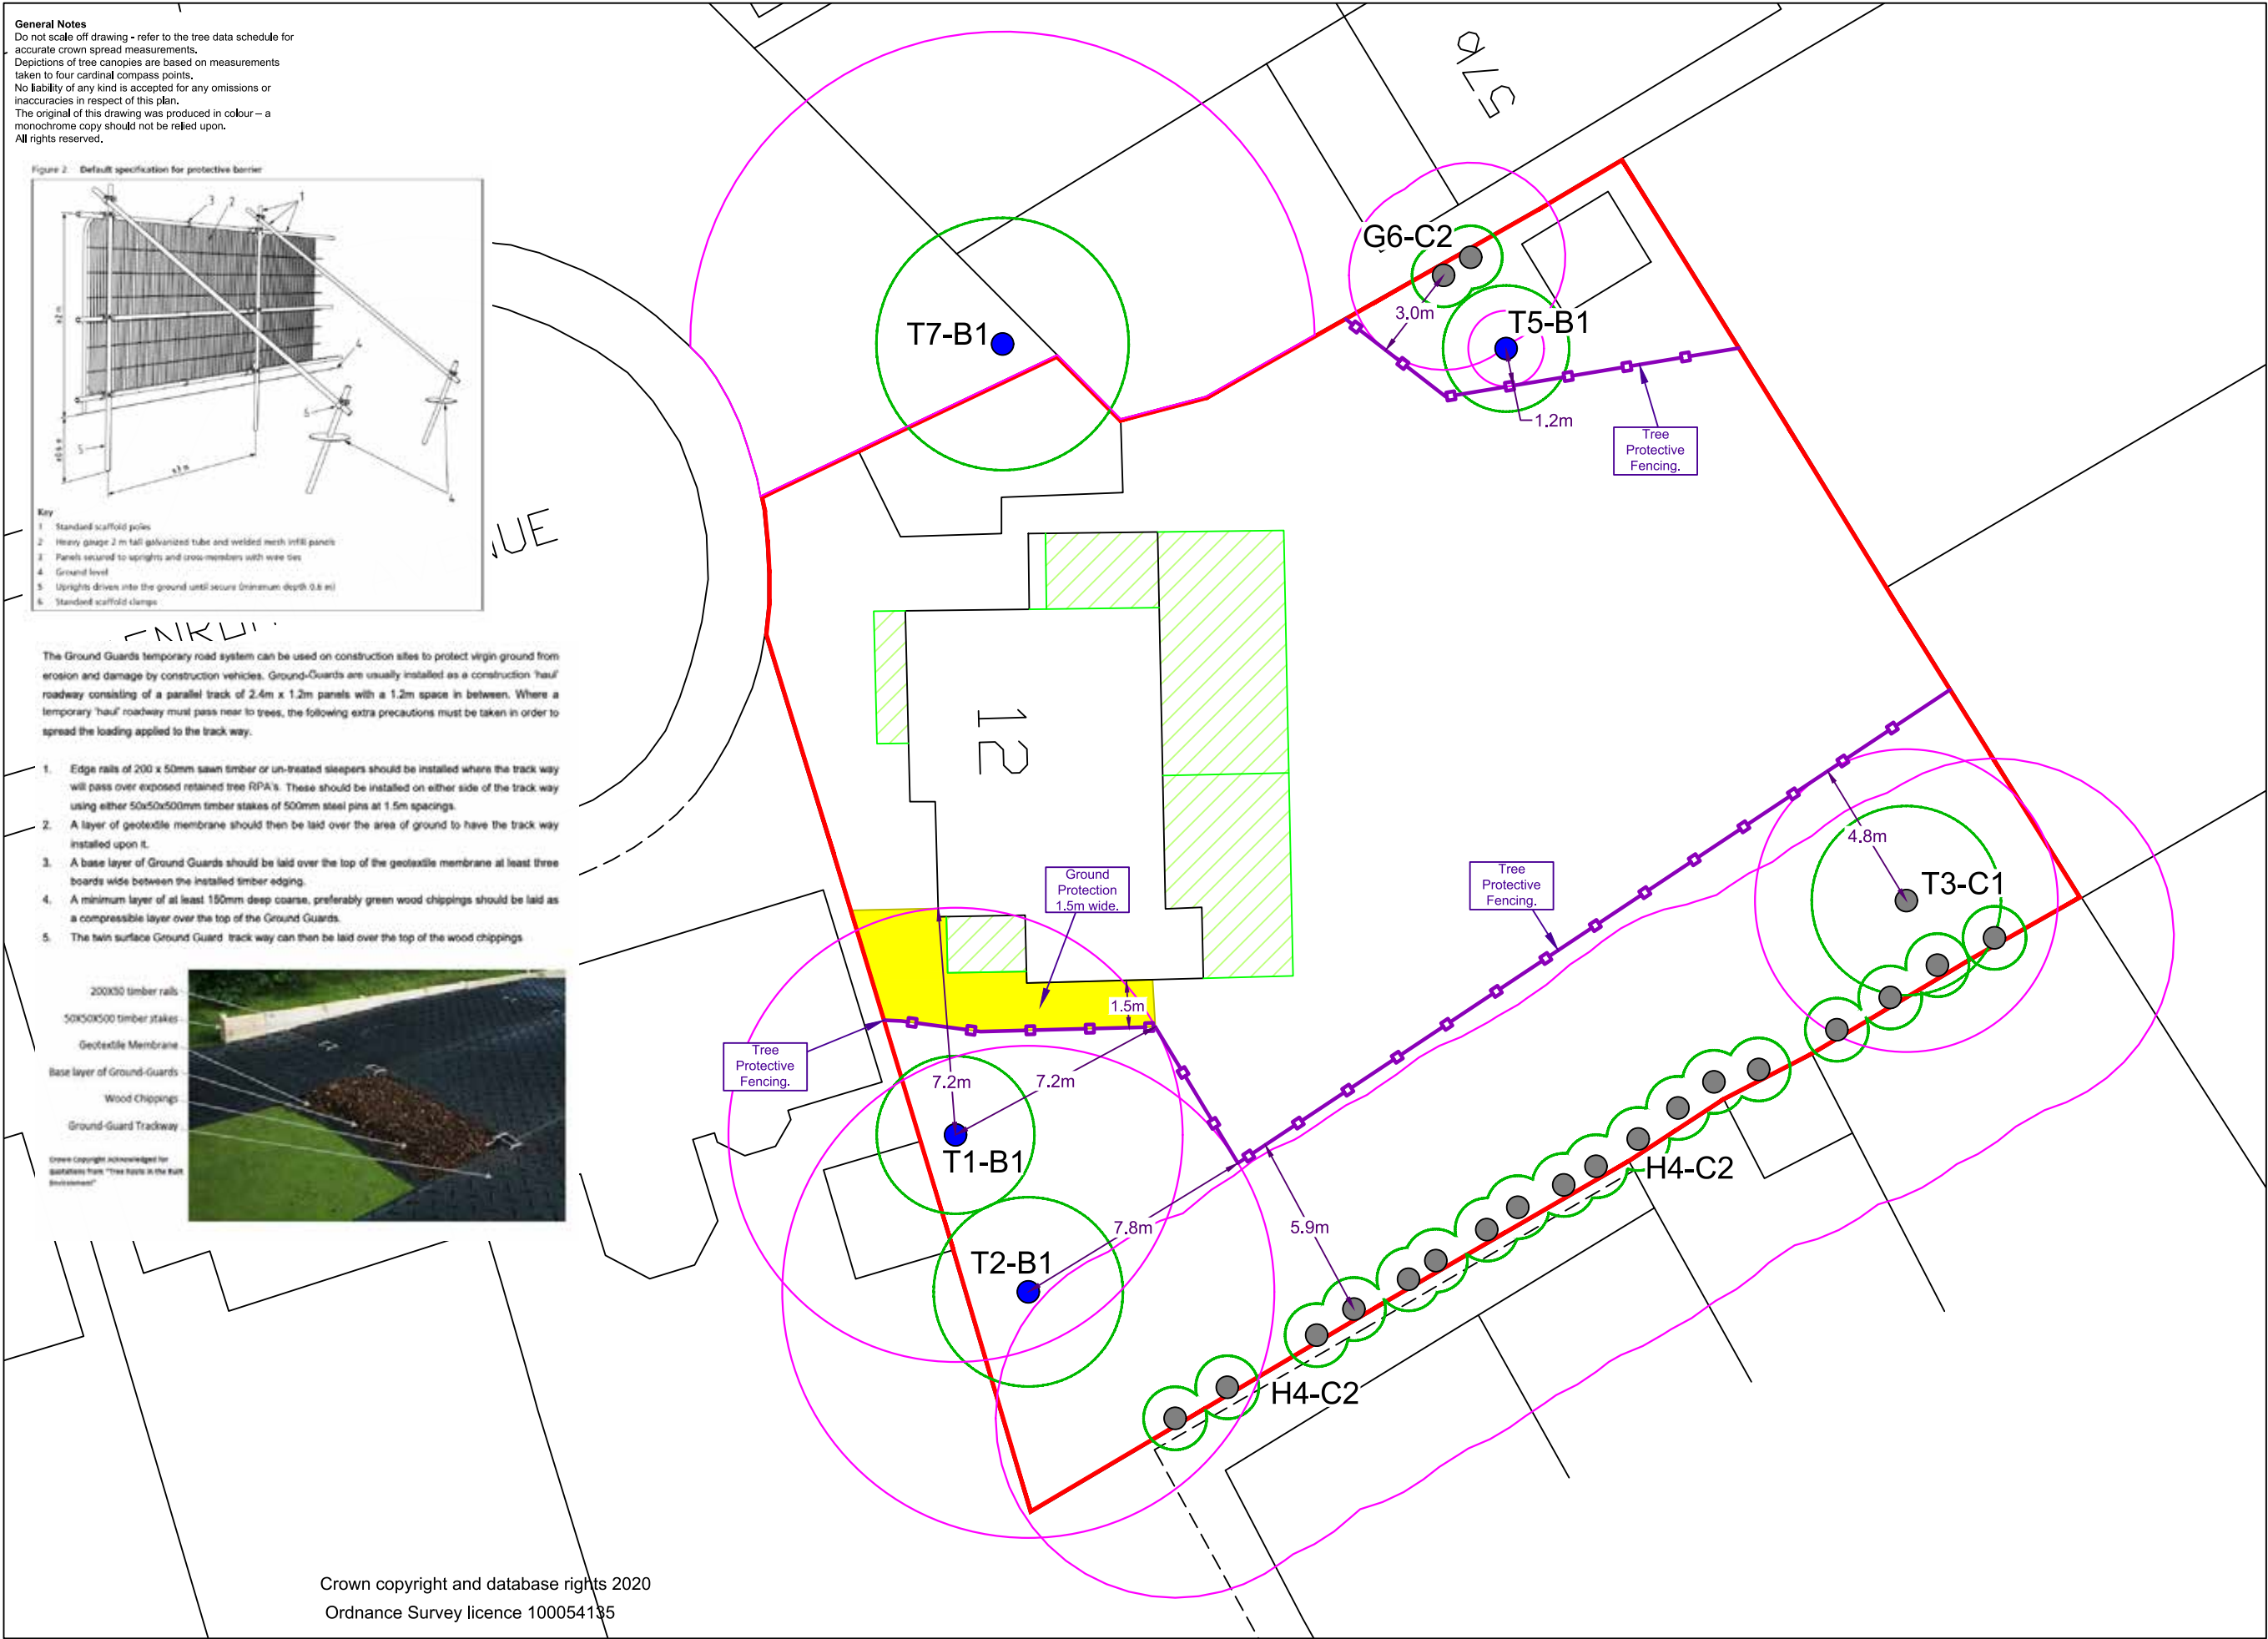
The southern foundations sit within the radial RPA of tree T1 and a precautionary approach is to be adopted.

A precautionary approach should be adopted when removing the hardsurface for the southern extension.

If any roots are encountered then guidance should be sought from the project ACoW.
