ARBORICULTURAL METHOD STATEMENT REPORT

PURSUANT TO DISCHARGE CONDITION 2 OF  
CONSENT REFERENCE 191422

Crossway Point, Norwood Road, Reading RG1 3LF

**OUR REF: SHA 1140**

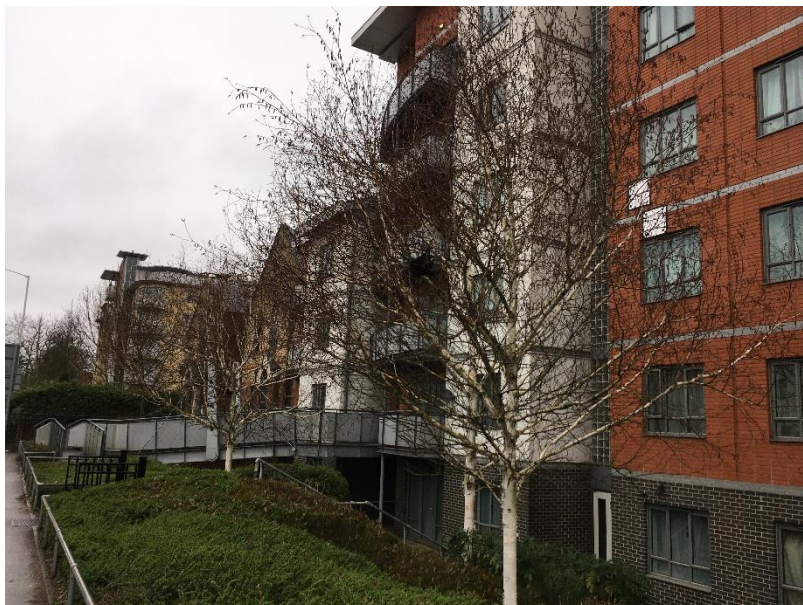
These are three semi-mature trees located within a raised, sloping shrub bed. They have no major defects and reasonable condition, but still have a significant amount of growing to do before they mature.

Photo 1 – T1 & T2 are located the far side of the footbridge, with T3-T5 in the foreground

| Tree Number | Botanical Name (Common name) | Age | Dia (mm) | Stems | Height (crown height) | Ult ht (m) | N | E | S | W | Cond | Life Exp | BS Cat | RPR (m) | RPA (m <sup>2</sup> ) | Comments | Recommendations |
|---|---|---|---|---|---|---|---|---|---|---|---|---|---|---|---|---|---|
| T3 | Betula utilis Jacquemontii (Jacquemontii Birch) | SM | 160 | 1 | 6(3) | 14 | 4 | 4 | 4 | 3 | Fair | 20+ | C1 | 1.92 | 11.58 | Located 5.25m from balcony in raised bed. No major defects, reasonable form and condition. | |
| T4 | Betula utilis Jacquemontii (Jacquemontii Birch) | SM | 160 | 1 | 6(3) | 14 | 4 | 3 | 3 | 3 | Fair | 20+ | C1 | 1.92 | 11.58 | Located 5.3m from building in raised bed. No major defects, reasonable form and condition. | |

*Arboricultural impact:* T3 & T4 will require a modest level of pruning to provide sufficient clearance from the building to enable the approved construction to be carried out.

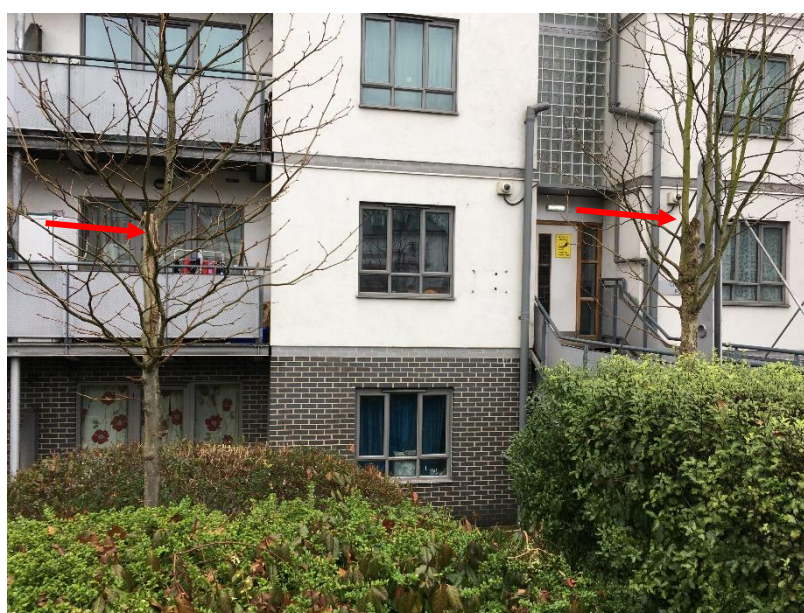
These are two young trees which have sustained damage, and loss, of their original leaders. The trees are adapting to the damage with side branches taking on dominance. The impact of the damage to the future structure of the tree will need to be monitored.

Photo 2 – Trees T6 & T7, arrows indicating point of damage and loss of original leaders

| Tree Number | Botanical Name (Common name) | Age | Dia (mm) | Stems | Height (crown height) | Ult ht (m) | N | E | S | W | Cond | Life Exp | BS Cat | RPR (m) | RPA (m <sup>2</sup> ) | Comments | Recommendations |
|---|---|---|---|---|---|---|---|---|---|---|---|---|---|---|---|---|---|
| T6 | Platanus X hispanica (London Plane) | SM | 90 | 1 | 6(3) | 14 | 1 | 1 | 1 | 1 | Fair | 20+ | C1 | 1.08 | 3.66 | Located 6.3m from building in raised bed. Leader has been lost with associated open tear wound on south of stem. Average form and condition. | |
| T7 | Platanus X hispanica (London Plane) | SM | 110 | 1 | 6(3) | 14 | 1 | 1 | 1 | 1 | Fair | 20+ | C1 | 1.32 | 5.47 | Located 6m from building in raised bed. Leader has been lost. Average form and condition. | |

*Arboricultural impact:* There are no foreseeable impact to these trees

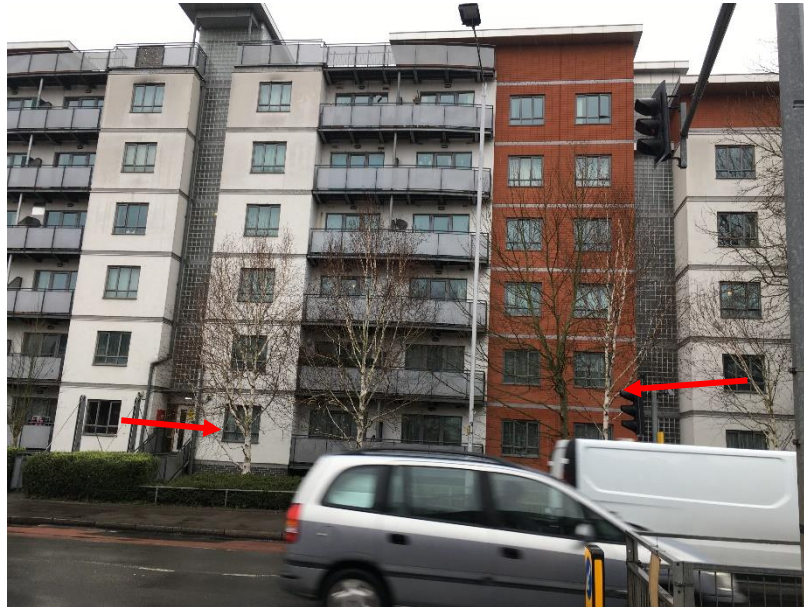
These are three semi-mature trees located within a raised, sloping shrub bed. They have no major defects and reasonable condition, but still have a significant amount of growing to do before they mature.

Photo 3 – T8 (left) and T11 (right), viewed from the opposite side of Kings Road

| Tree Number | Botanical Name (Common name) | Age | Dia (mm) | Stems | Height (crown height) | Ult ht (m) | N | E | S | W | Cond | Life Exp | BS Cat | RPR (m) | RPA (m <sup>2</sup> ) | Comments | Recommendations |
|---|---|---|---|---|---|---|---|---|---|---|---|---|---|---|---|---|---|
| T8 | Betula utilis Jacquemontii (Jacquemontii Birch) | SM | 200 | 1 | 8(2) | 14 | 3 | 3 | 4 | 4 | Fair | 20+ | C1 | 2.4 | 18.1 | Located 4.3m from building in raised bed. No major defects, reasonable form and condition. | |

| Tree Number | Botanical Name (Common name) | Age | Dia (mm) | Stems | Height (crown height) | Ult ht (m) | N | E | S | W | Cond | Life Exp | BS Cat | RPR (m) | RPA (m <sup>2</sup> ) | Comments | Recommendations |
|---|---|---|---|---|---|---|---|---|---|---|---|---|---|---|---|---|---|
| T11 | Betula utilis Jacquemontii (Jacquemontii Birch) | SM | 140 | 1 | 7(2.5) | 14 | 1 | 3 | 3 | 3 | Fair | 20+ | C1 | 1.68 | 8.87 | Located 7.8m from building in raised bed. No major defects, but rather suppressed by adjacent tree to north. Average form and condition | |

*Arboricultural impact:* T8, T9 & T10 will require a modest level of pruning to provide sufficient clearance from the building to enable the approved construction to be carried out.

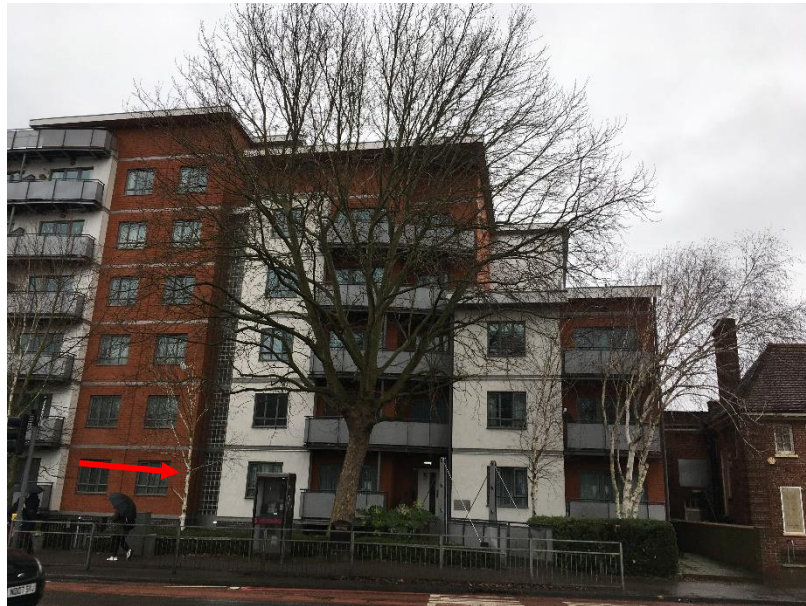
T13 is the only mature tree located to the front of the building, and is a visually important feature. Unfortunately, the dominance of T13 has rather suppressed all the adjacent trees (T12 & T14-T16). In addition, T16 is located very close to the building and has had to be heavily pruned to prevent conflict, and as such consideration should be given to its long-term retention.

Photo 4 – T13 dominating the centre of the picture, with T12 (left) & T14-T16 (right)

| Tree Number | Botanical Name (Common name) | Age | Dia (mm) | Stems | Height (crown height) | Ult ht (m) | N | E | S | W | Cond | Life Exp | BS Cat | RPR (m) | RPA (m <sup>2</sup> ) | Comments | Recommendations |
|---|---|---|---|---|---|---|---|---|---|---|---|---|---|---|---|---|---|
| T13 | Platanus X hispanica (London Plane) | M | 640 | 1 | 18(5) | 20 | 5 | 8 | 8 | 8 | Fair | 20+ | A2 | 7.68 | 185.32 | Located 5.6m from building in raised bed. No major defects, some pruning to clear building. Reasonable form and condition. | |
| T15 | Betula utilis Jacquemontii (Jacquemontii Birch) | SM | 250 | 1 | 7(2.5) | 14 | 2 | 5 | 4 | 1 | Fair | 20+ | C1 | 3 | 28.28 | Located 4.3m from balcony in raised bed. No major defects, but rather average form and condition. Pruned over footpath, resulting in large stubs | |

| Tree Number | Botanical Name<br>(Common name) | Age | Dia<br>(mm) | Stems | Height<br>(crown height) | Ult ht<br>(m) | N | E | S | W | Cond | Life<br>Exp | BS<br>Cat | RPR (m) | RPA (m <sup>2</sup> ) | Comments | Recommendations |
|---|---|---|---|---|---|---|---|---|---|---|---|---|---|---|---|---|---|
| T16 | Betula utilis<br>Jacquemontii<br>(Jacquemontii<br>Birch) | SM | 210 | 1 | 7(2.5) | 14 | 3 | 5 | 3 | 3 | Fair | 20+ | C1 | 2.52 | 19.95 | Located 1.9 m from balcony in raised bed. No major defects, but rather average form and condition. Heavily pruned away from building and over side footpath | |

*Arboricultural impact:* T13, T14 & T16 will require a modest level of pruning to provide sufficient clearance from the building to enable the approved construction to be carried out.

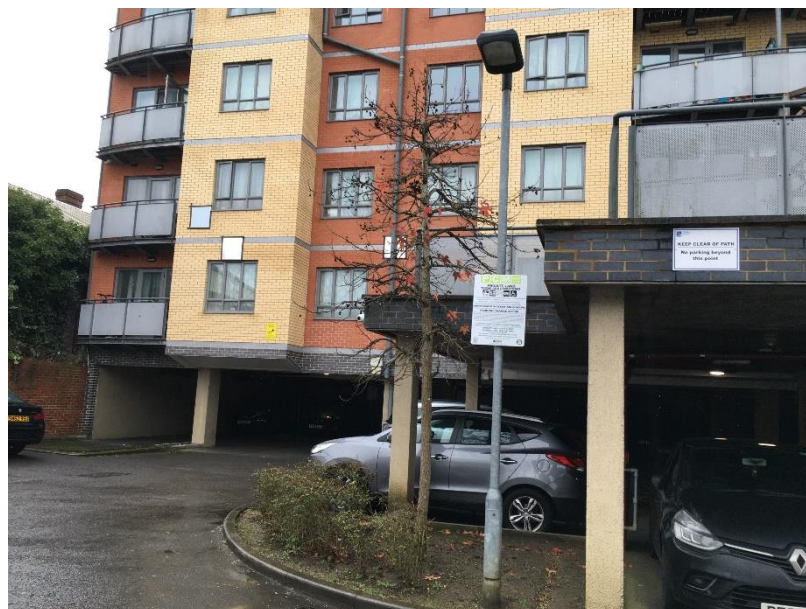
This is a young tree located in a shrub bed within the car park to the rear of the building. It is a well-chosen species for the confined growing location.

Photo 5 – T17 looking south, towards the rear of the building

| Tree Number | Botanical Name<br>(Common name) | Age | Dia<br>(mm) | Stems | Height<br>(crown height) | Ult ht<br>(m) | N | E | S | W | Cond | Life<br>Exp | BS<br>Cat | RPR (m) | RPA (m <sup>2</sup> ) | Comments | Recommendations |
|---|---|---|---|---|---|---|---|---|---|---|---|---|---|---|---|---|---|
| T17 | Liquidambar<br>styraciflua (Sweet<br>Gum) | SM | 110 | 1 | 5(2) | 12 | 2 | 1 | 1 | 1 | Fair | 20+ | C1 | 1.32 | 5.47 | Located in centre of planting bed. No major defects, reasonable form and condition. | |

*Arboricultural impact:* There are no foreseeable impact to this tree.

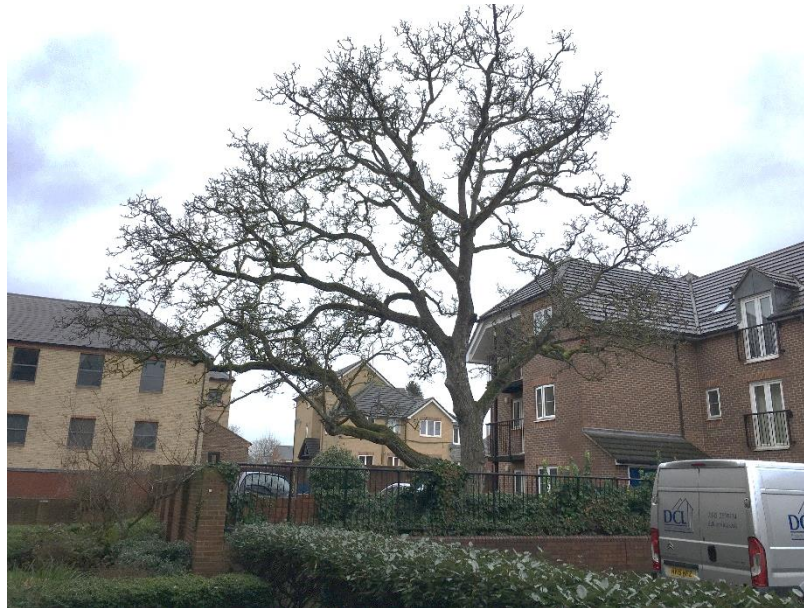
This is a mature offsite tree located close to the boundary wall of the rear car park. Although it was only inspected from a distance and from the east, it appears to be in

reasonable health and condition. There is a modest overhang of the crown on the east, over the car park, and south, over a garden area.

Photo 6 – Offsite T18 looking west

| Tree Number | Botanical Name<br>(Common name) | Age | Dia<br>(mm) | Stems | Height<br>(crown height) | Ult ht<br>(m) | N | E | S | W | Cond | Life<br>Exp | BS<br>Cat | RPR (m) | RPA (m <sup>2</sup> ) | Comments | Recommendations |
|---|---|---|---|---|---|---|---|---|---|---|---|---|---|---|---|---|---|
| T18 | Juglans regia<br>(Walnut) | M | 600 | 1 | 10(2.5) | 12 | 6 | 5 | 8 | 6 | Fair | 20+ | B1 | 7.2 | 162.88 | Offsite tree located 1.7m from boundary wall. 3m crown overhang but at at reasonable height over car park, and approximately 3.5m height over garden. Reasonable form and condition. | |

*Arboricultural impact:* Providing the site office and welfare structures are single storey there is no foreseeable impact to this tree. Should the welfare structures be more than single storey a modest level of pruning will be necessary to the overhanging branches on the east of the tree.
