### **16 Vale Crescent – Preliminary Roost Assessment**

Ecology by Design were commissioned to conduct a bat preliminary roost assessment (PRA) of 16 Vale Crescent, Reading, RG30 6ED (central grid reference SU 67391 74313). The survey is to inform a planning application for the demolition of the garage and utility room and the construction of a garden room in the same location.

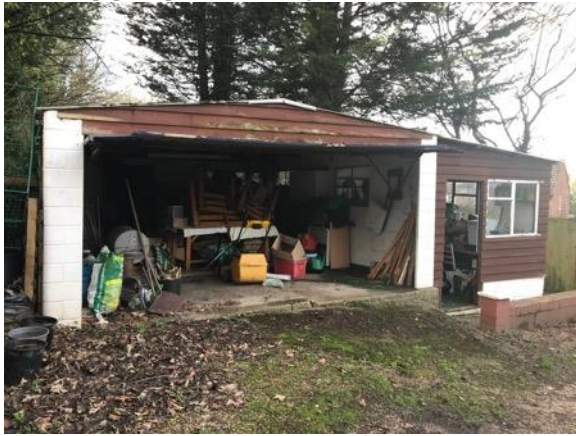
**Photograph 1:** South east aspect of the building showing garage and utility room

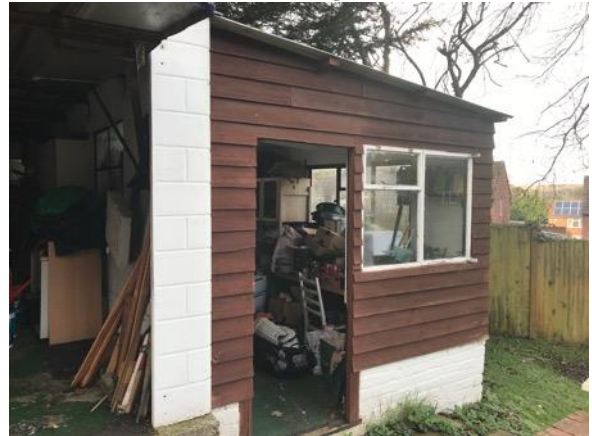
**Photograph 2:** South east aspect of the utility room with wooden cladding

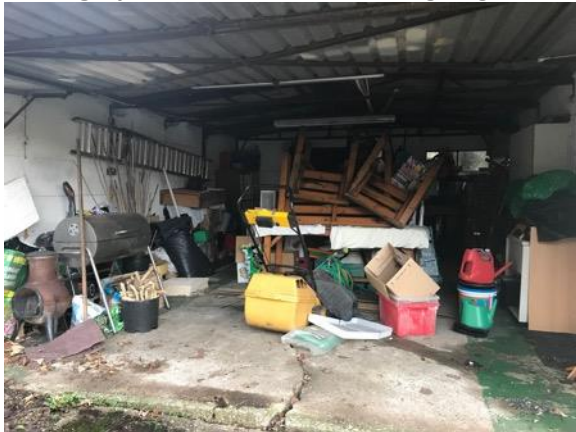
Internally, the building was well lit by the windows and no loft void was present. A small cavity was present above the utility room and two holes were noted leading into the cavity. However, no ingress points were noted into the utility room itself therefore it is considered that the cavity is not accessible to bats. No bats or evidence of bats in the form of droppings, scratching, or staining were observed during the survey.

**Photograph 3:** Internal view of the garage

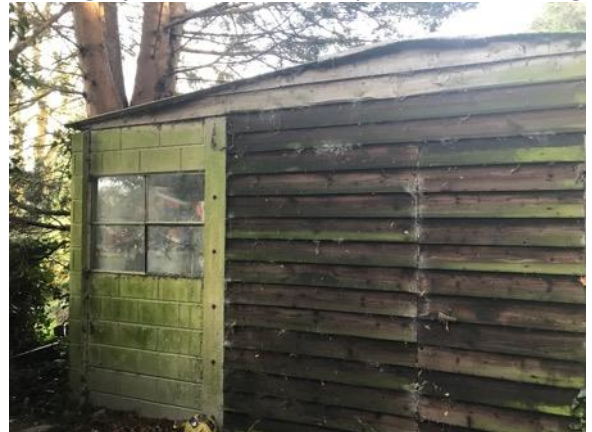
**Photograph 4:** North west aspect of the building

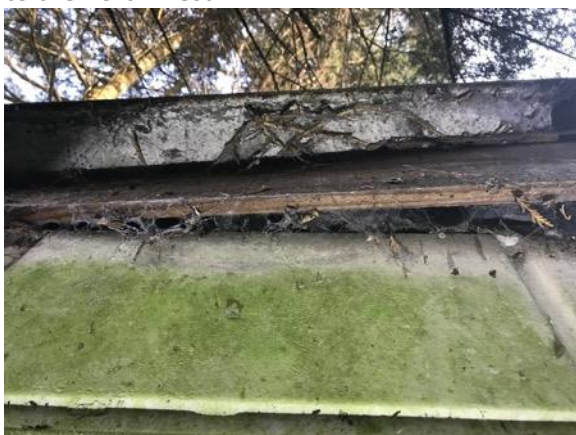
A few features were recorded externally including a raised fascia to the north west of the building, a small hole in a window surround and a small hole at the apex to the south east. These features were very densely cobwebbed or did not form, or lead to, a suitable roosting feature for bats. Furthermore, no evidence of bats was recorded externally in the form of droppings, scratching or staining.

**Photograph 5:** Heavily cobwebbed raised fascia to the north west

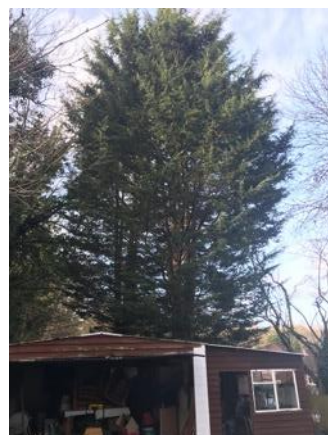
Two Leyland cypress (*Cupressus × leylandii*) trees were recorded to the north of the building which are also to be removed as part of the proposed works. These trees were in good condition with no features which could support roosting bats or evidence of bats recorded.

The trees were assessed as having negligible potential to support roosting bats however, they would provide suitable habitat to for nesting birds.

**Photograph 6:** Two Leyland cypress north of the building

The trees would support a number of nesting bird species. All nesting birds are protected under the Wildlife and Countryside Act 1981 (as amended) which makes it an offence to intentionally kill, injure or take any wild bird or take, damage or destroy its nest whilst in use or being built, or take or destroy its eggs. Any dense vegetation removal should be completed outside of the bird-nesting season

(March to August inclusive) or preceded by a check for nests by an experienced ecologist. If nests are found, they should be left undisturbed until the nest is no longer active.
