**Project:** 20\_5837\_09\_28  
**Site:** 12 Penroath Avenue, Reading, RG30 2ED  
**Client:** Nabeel Mughal

| Document Title: | Arboricultural Implications Assessment |

Arboricultural implications assessment to BS 5837 2012 of trees at:

12 Penroath Avenue, Reading, RG30 2ED.

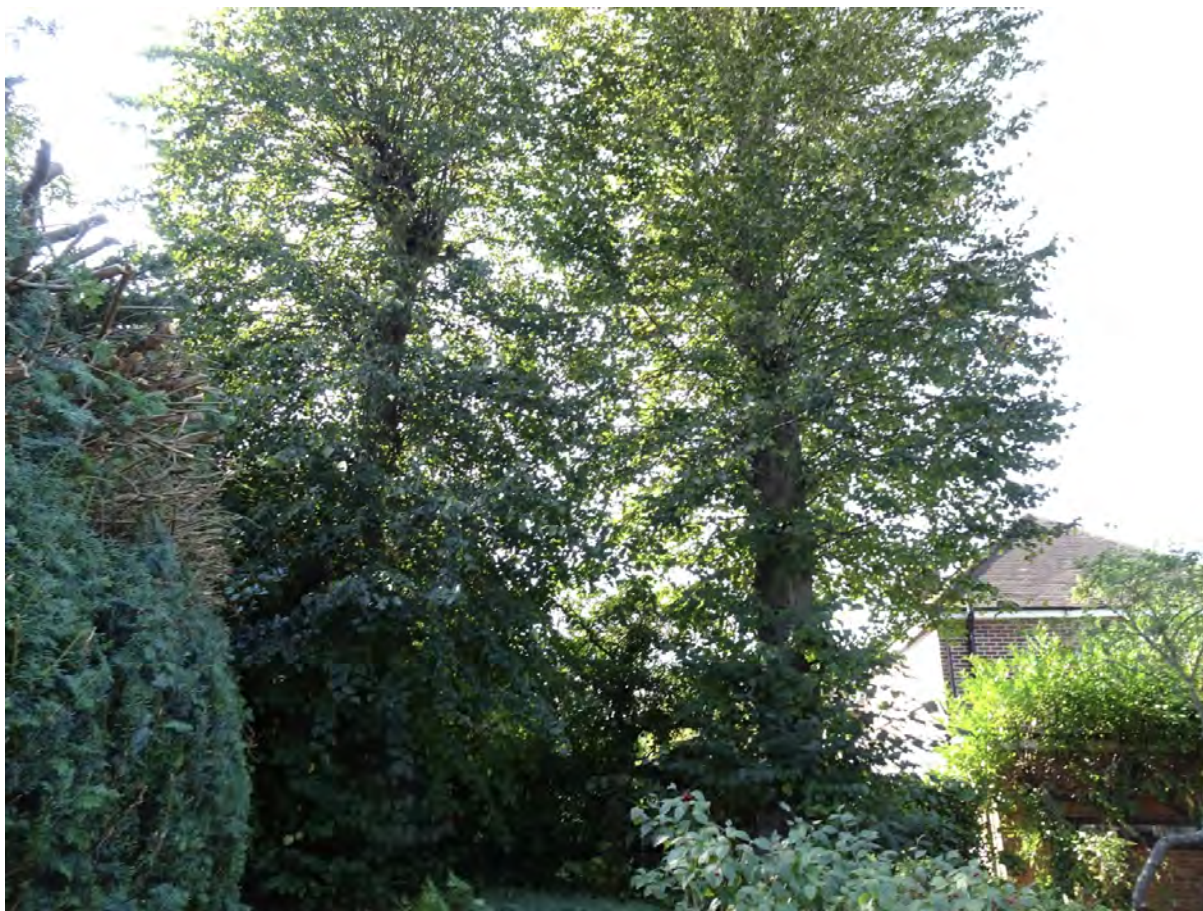
*Photographic plate showing trees T2 and T1, both of which are mature Large-leaved Limes.*

8.5.1. The proposed development conflicts with the Root Protection Area of tree T1. However, as the area is an existing hard surfaced area it is likely that the roots are offset. A precautionary approach is recommended. The paving should be lifted by hand to check for fibrous roots. If roots are detected, arboricultural advice should be sought.

The paving should be excavated by hand to check for roots. If fibrous roots are detected then further arboricultural advice should be sought in order to facilitate the project which may require bridged foundations.

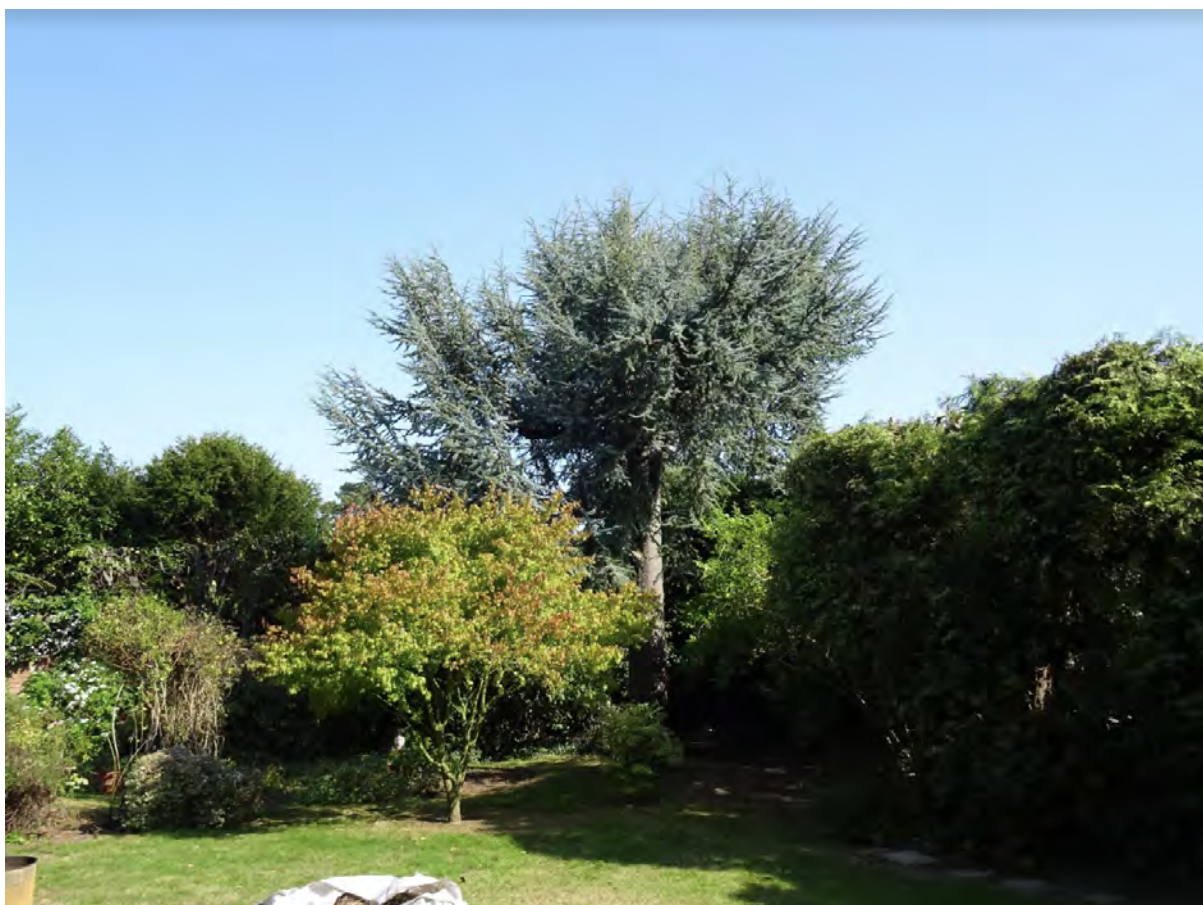
*Photographic plate showing tree T3, a mature Atlantic Cedar.*

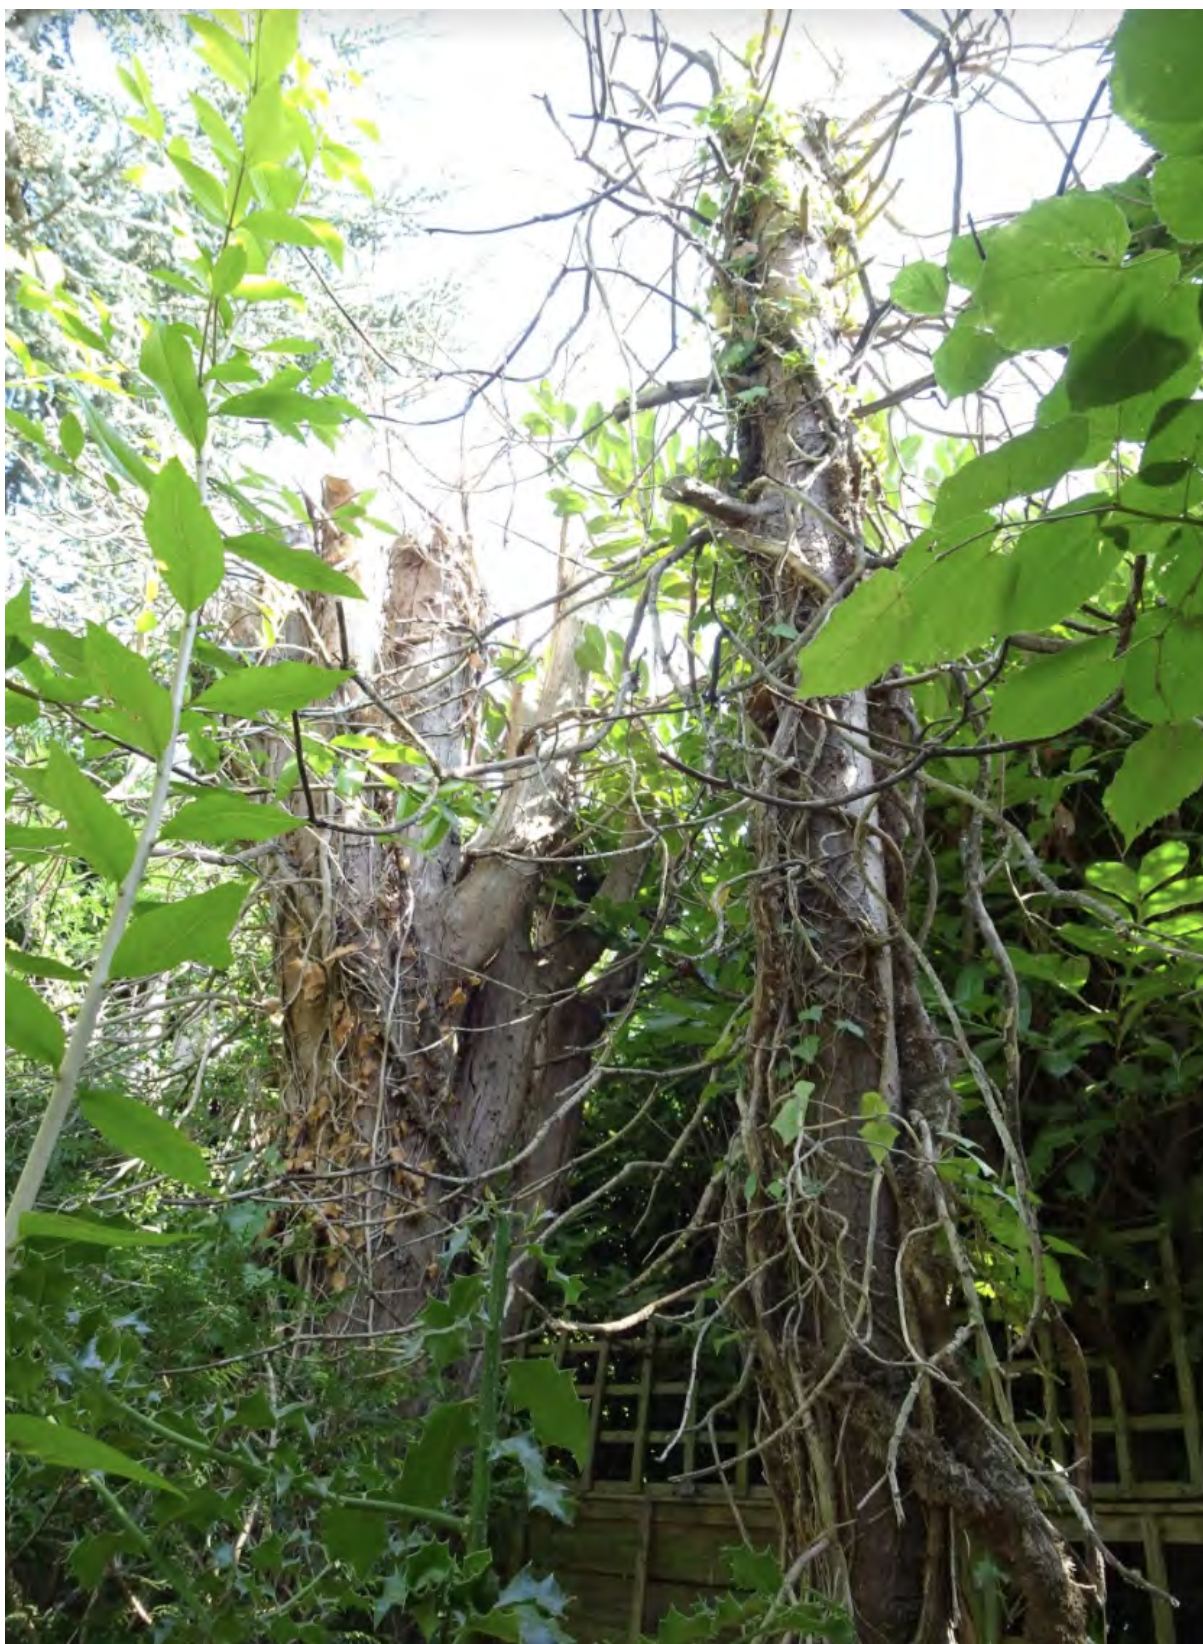
*Photographic plate showing hedge H4, consisting of mature Leyland Cypress.*

- 4.10 Hedgerow H4 consists of mature Leyland Cypress located on the sites boundary. The hedge is in decline and has broken branches within its crown. There is overgrown vegetation at the base. The branches are hanging low over the adjacent footpath. It is recommended that the hedgerow be removed.

| Tree Number | Species | Age Class | DBH | Height (crown height) | N | E | S | W | Condition | Life Expectancy | Physical Description | Comments | Managment Recommendations | RPA offset from stem. | Category Rating |
|---|---|---|---|---|---|---|---|---|---|---|---|---|---|---|---|
| H4 | <i>X Cupressocyparis leylandii</i> (Leyland Cypress) | EM | 00,250,10 | 5(2) | 1 | 1 | 1 | 1 | Poor | <10 | Declining. Unable to inspect stem due to undergrowth. Stem divides below 1.5m. Stem divides above 1.5m. Broken branches in crown. Low branches over road/footpath. | Heavily side pruned and will not recover | Fell | 5.69 | C2 |

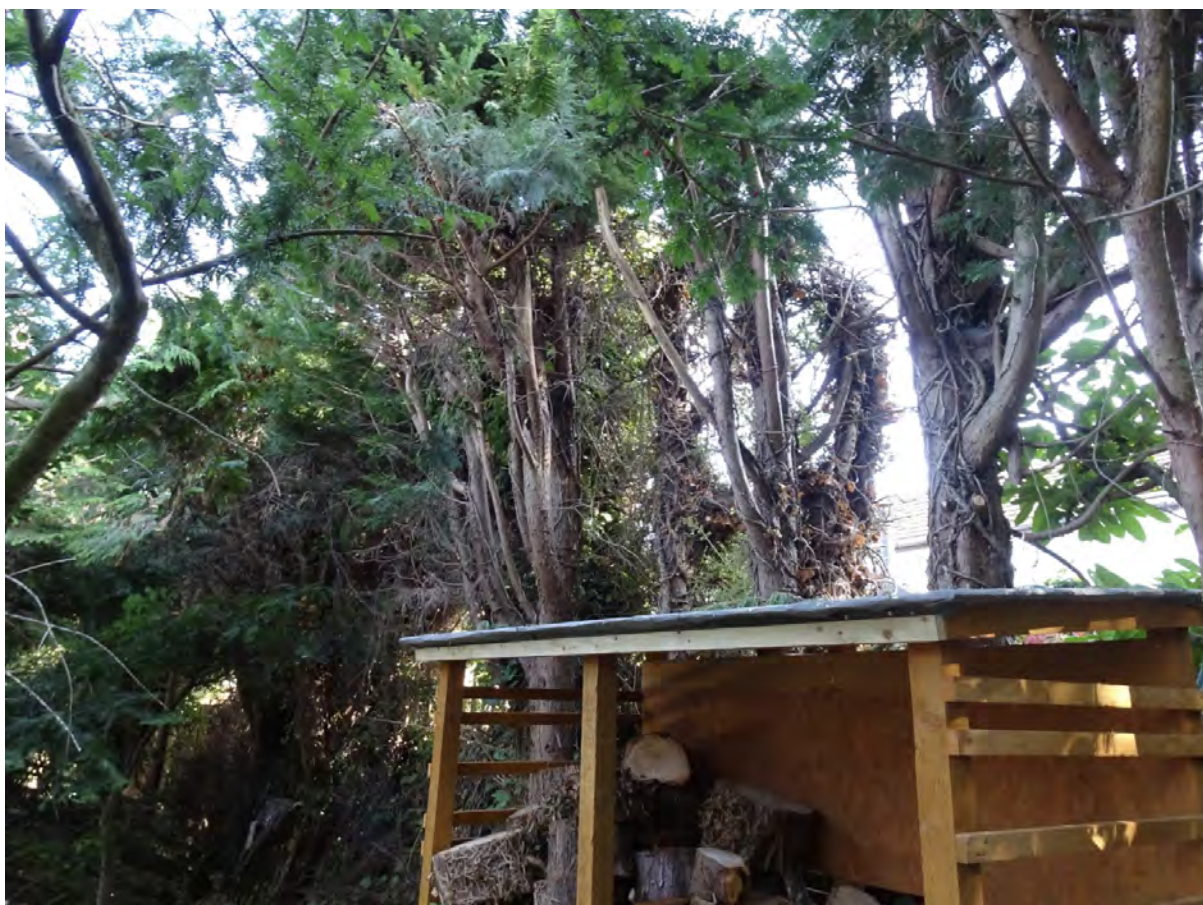
*Photographic plate showing hedge H4, located along the site boundary.*

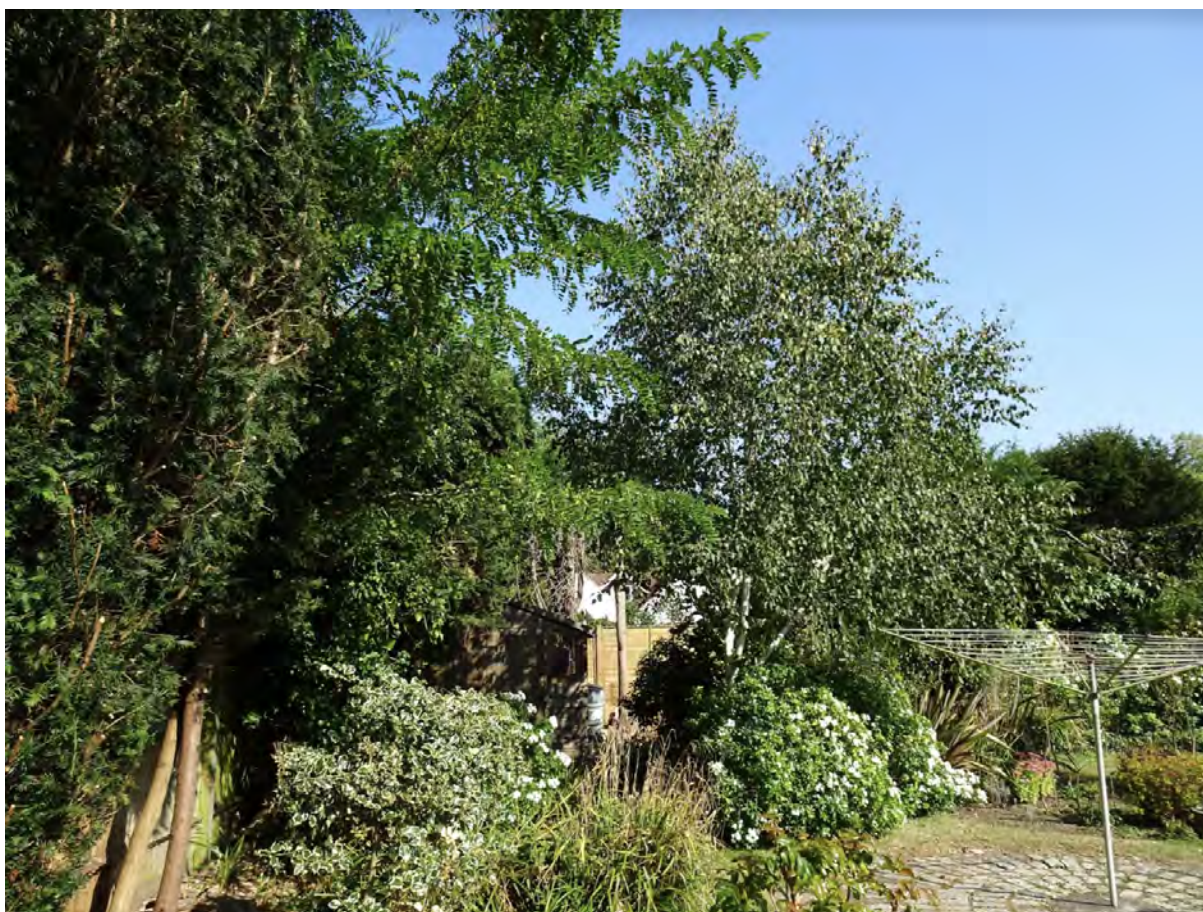
*Photographic plate showing tree T5, located on site.*

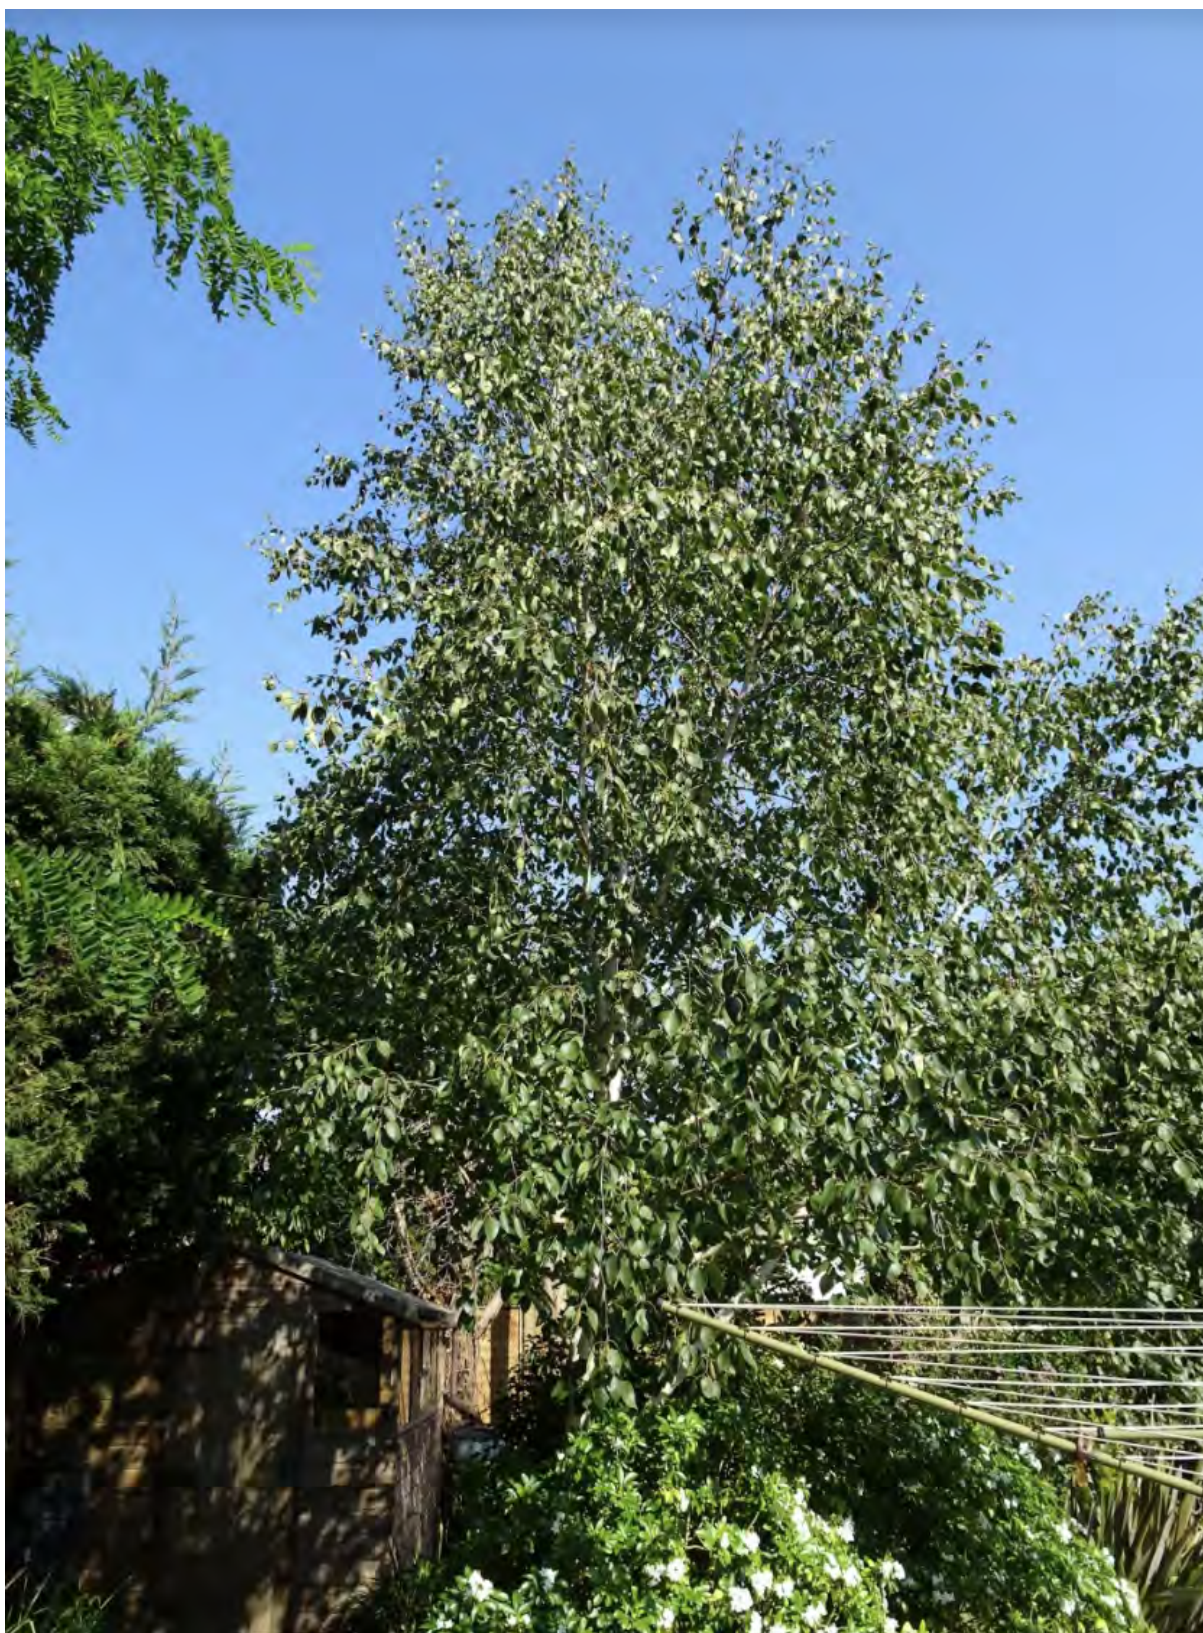
*Photographic plate showing tree T5, a mature Silver Birch.*

- 4.11 Tree T5 is an early-mature Silver Birch located on site. The tree is showing good structure, form and vitality, however, would benefit from some formative pruning.

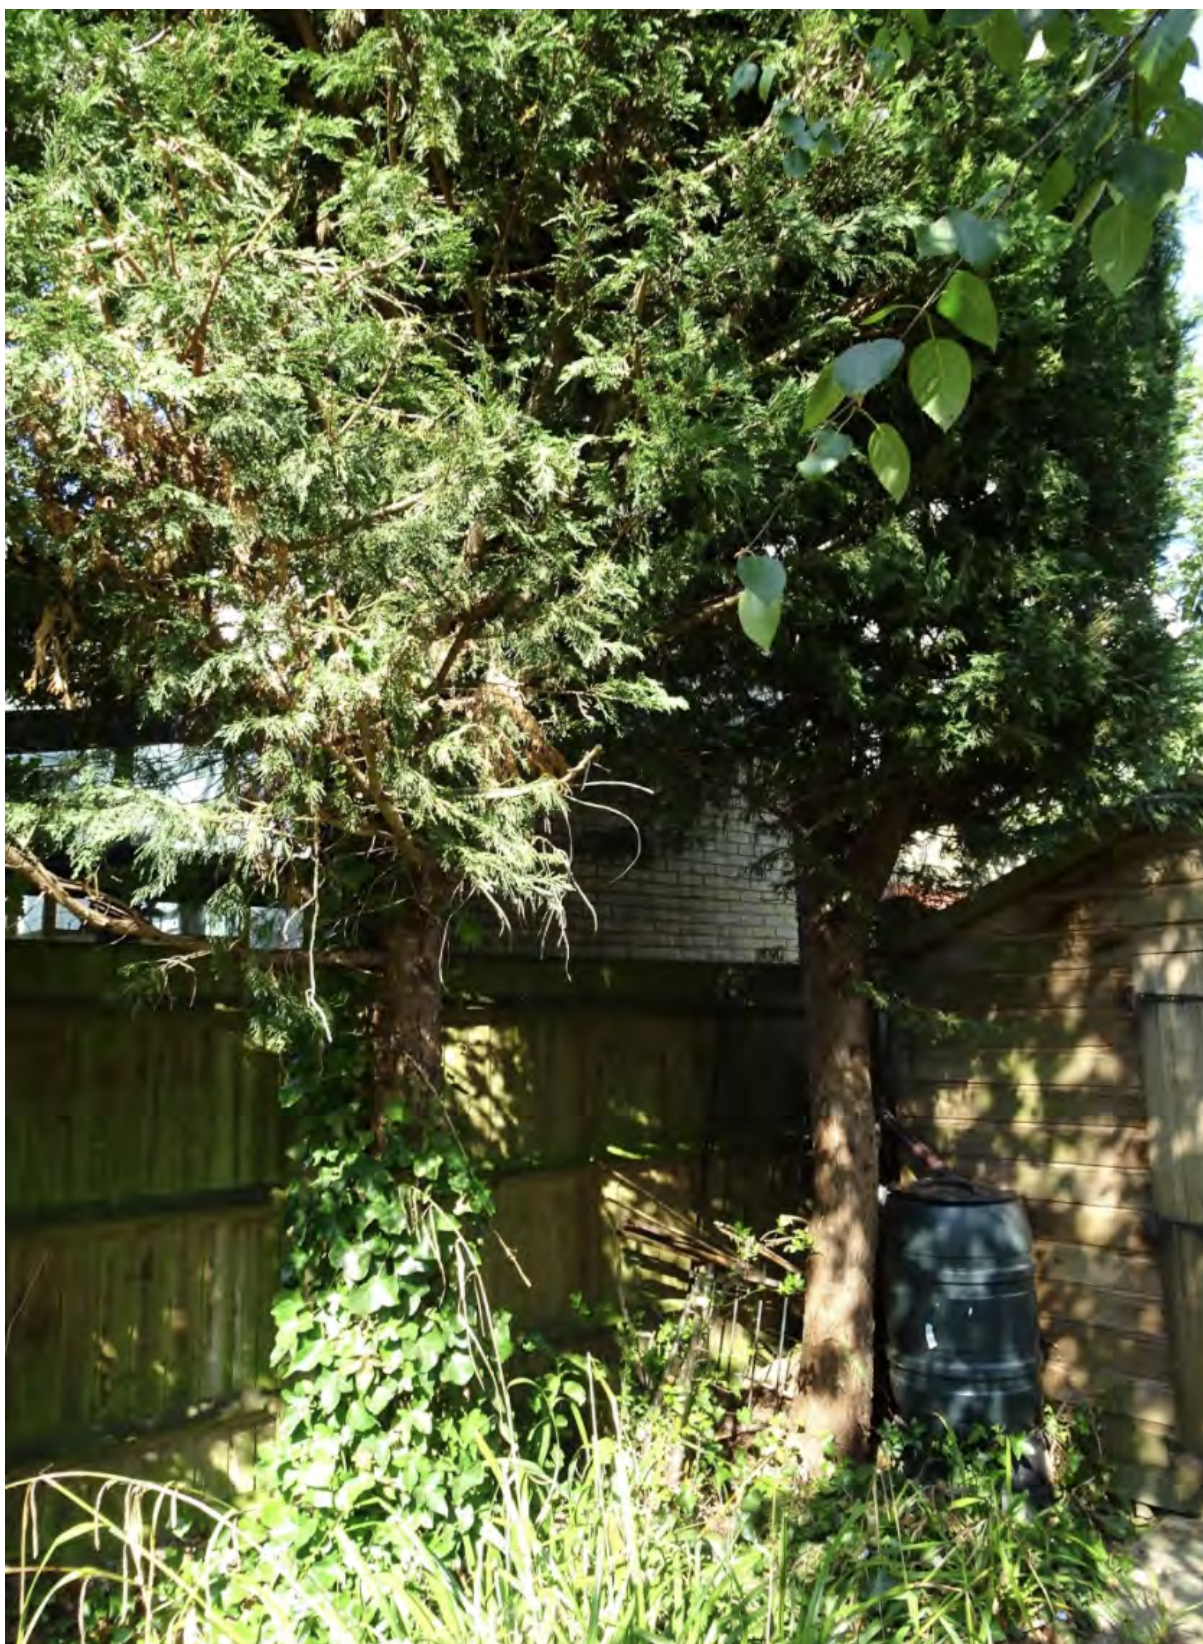
*Photographic plate showing tree group G6, consisting of mature Leyland Cypress.*

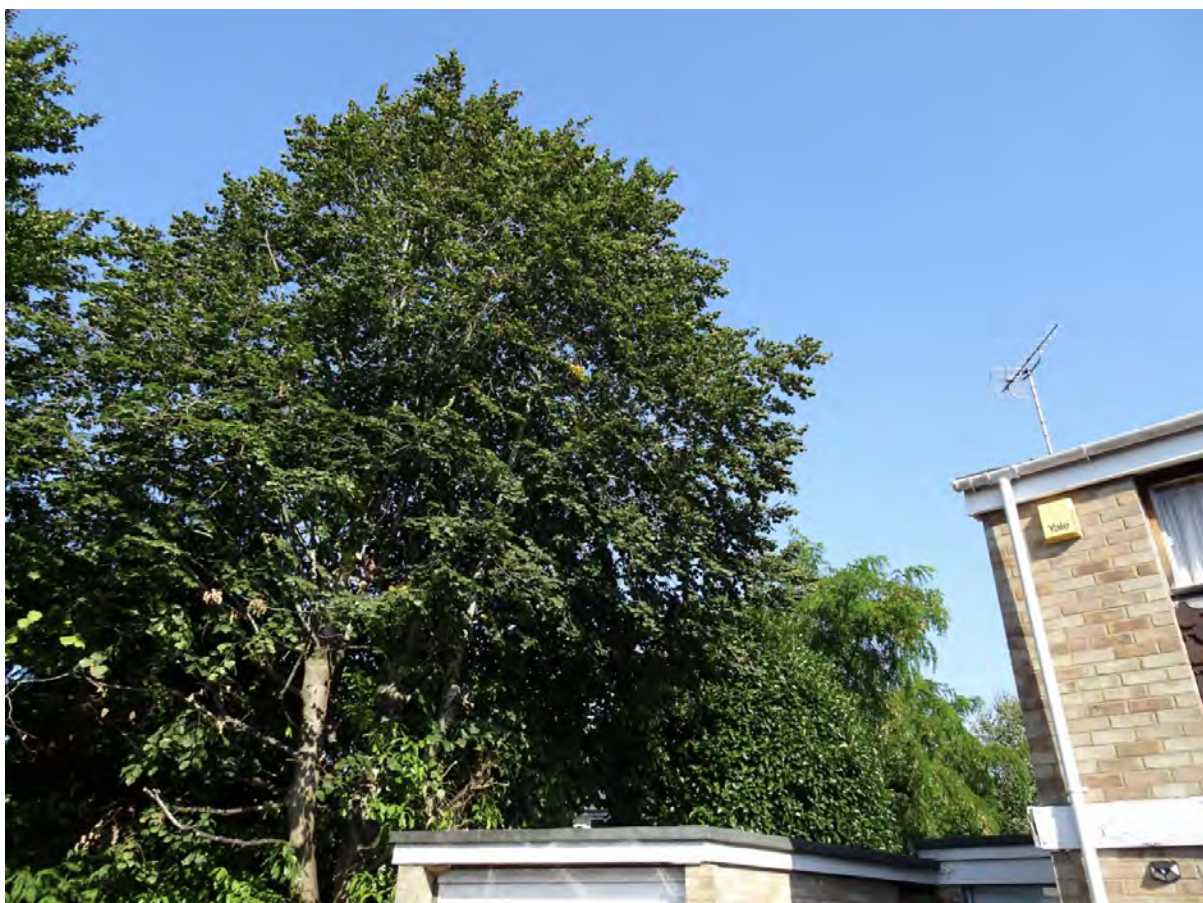
*Photographic plate showing tree T7, located adjacent to the garage.*

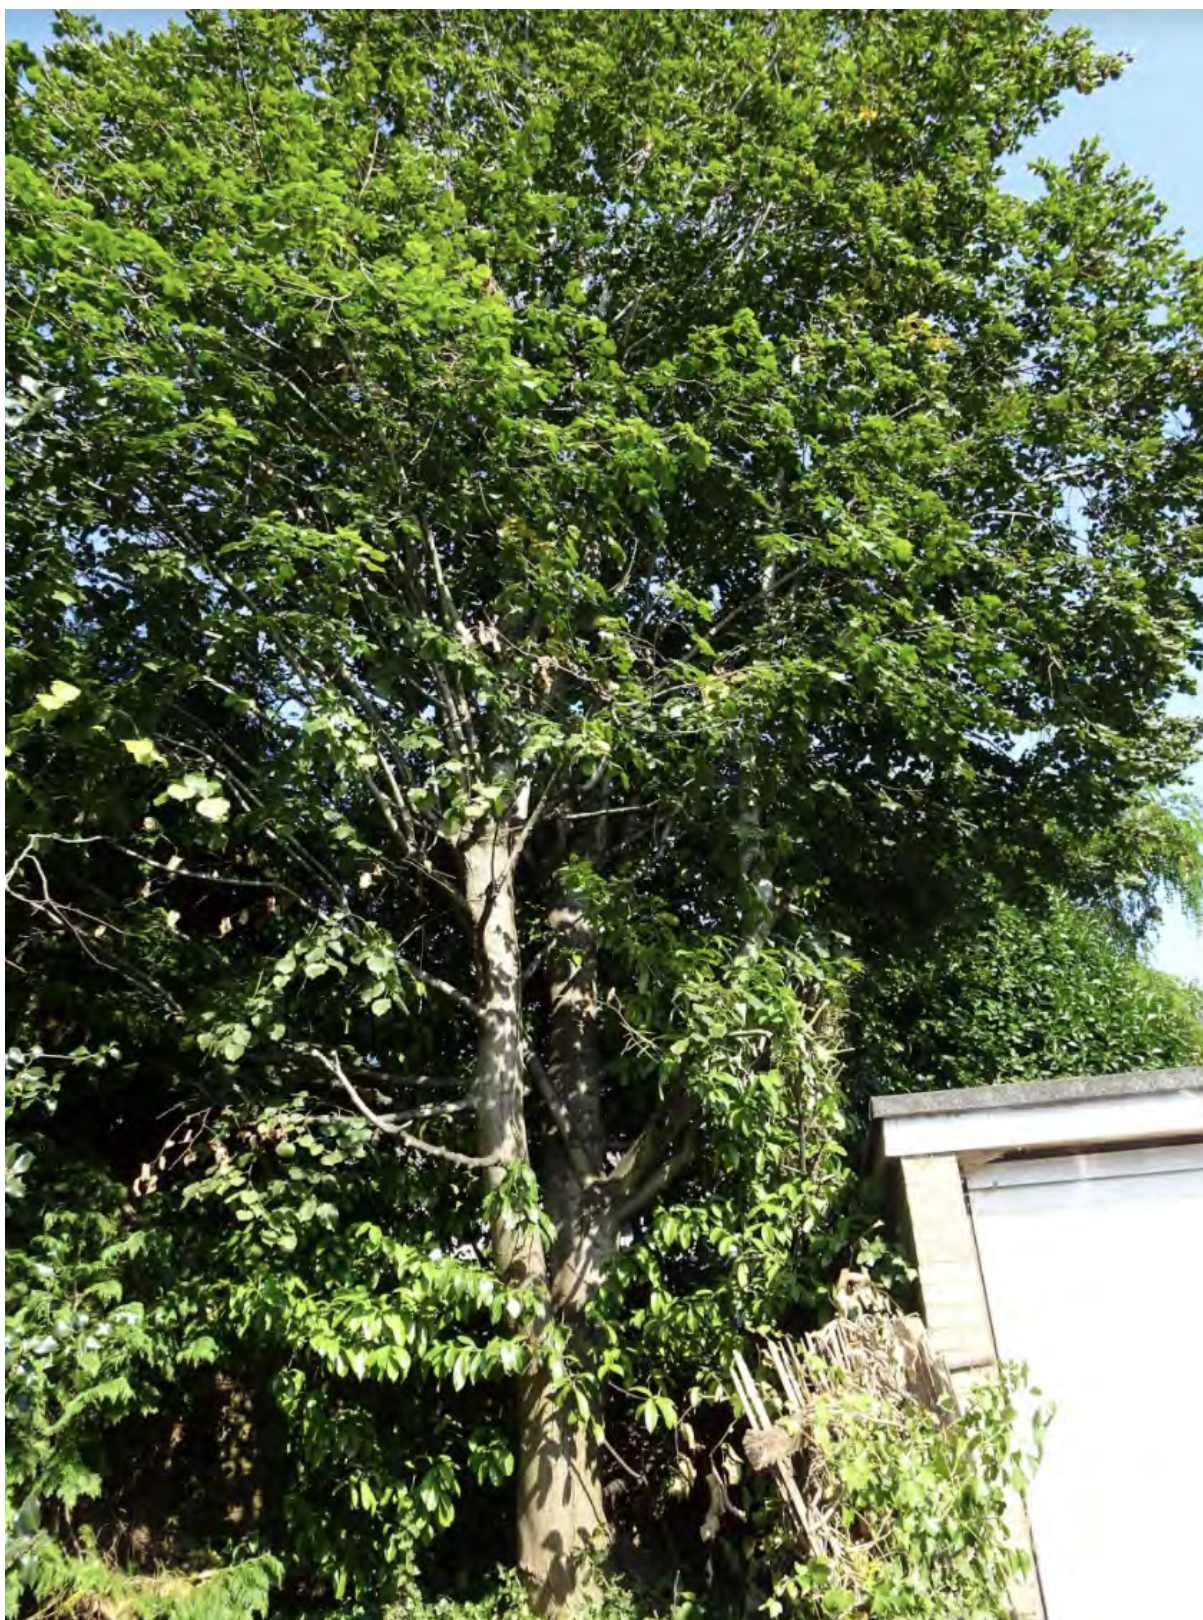
*Photographic plate showing tree T7, a mature Large-leaved Lime.*
