**8 Kelmscott Close  
Caversham  
Berkshire  
RG4 7DG**

# **Preliminary Bat Roost Assessment**

**Ref: R2216/a**

**May 2019**

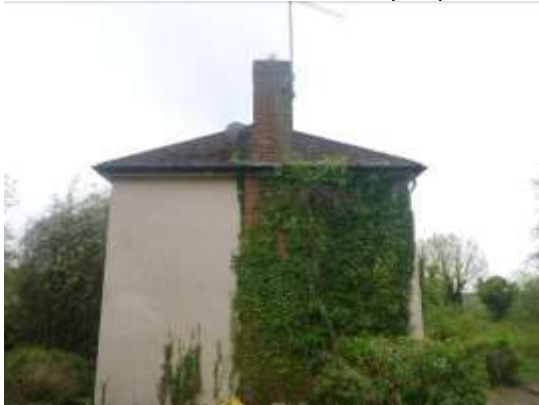
**3.2.4** The house's painted walls were in sound condition and lacked any cracks or crevices suitable for bats. A sparse covering of ivy had grown up part of the north facing side elevation (**Photograph 3; Target note 18**), but this did not provide crevices beneath suitable for roosting bats. A hole had been created in the wall - likely where a pipe formerly passed through - at a height of approximately 1m above the ground on the front elevation (**Photograph 10; Target note 5**). The hole was open to the cavity wall and showed no evidence of use by bats during a close inspection.

3. The house's northern end with ivy growth.

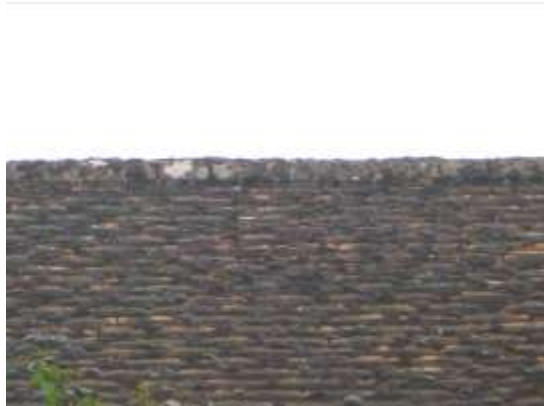
- 3.2.2** The main roof was covered with flat concrete tiles, which were intact and fitted tightly (**Photograph 6; Target note 1**). The ridge tiles and hip tiles were all in place and mortared fully (**Photographs 6 & 7; Target notes 2 & 3**) and the lead flashings around the chimneys were closely fitted (**Photograph 9; Target notes 19 & 20**). The timber soffit boxes at the eaves were all complete and fitted tightly to the external brickwork providing no visible opportunities for bats to gain access (**Photograph 8; Target Note 4**).

6. The flat and tightly fitted tiles and closely fitted ridge tiles.

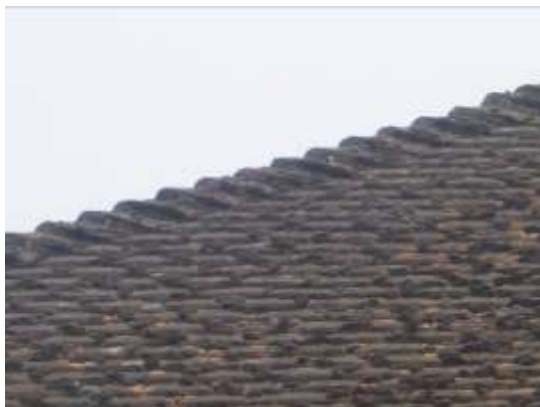
7. The hip tiles all in site and fully mortared.

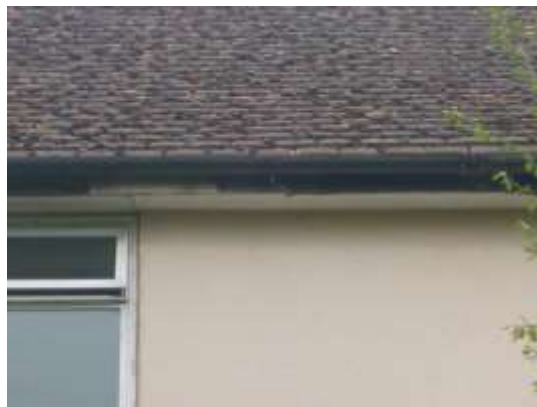
8. The complete and tightly fitted soffits.

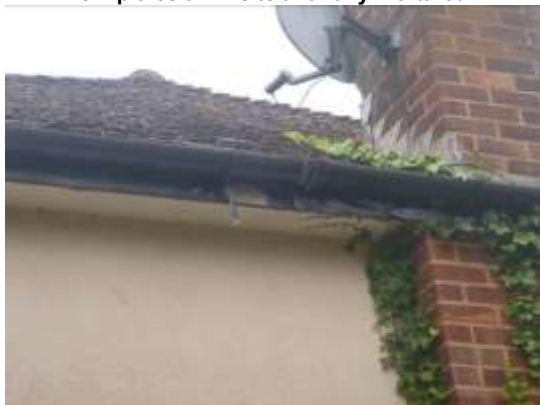
9. The flat and tight lead flashings around the chimneys.

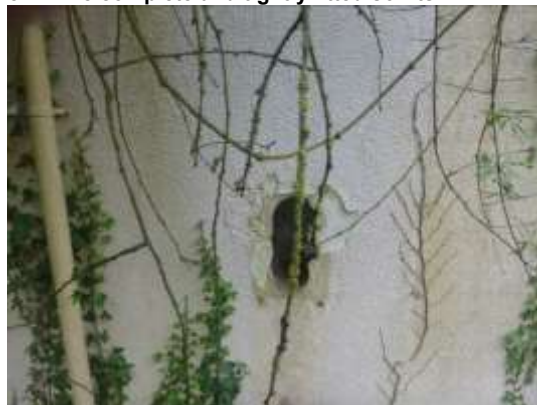
10. The hole into the wall on the front (eastern) side of the house.

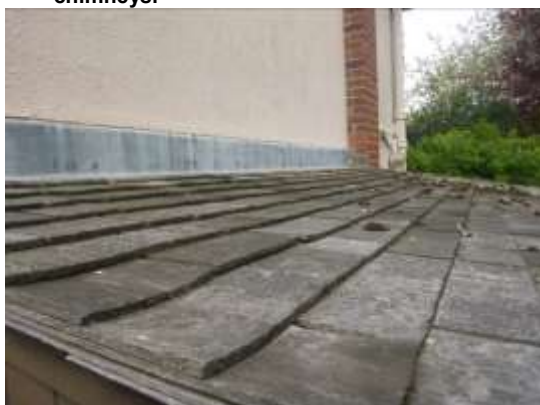
- 3.2.3** The single-storey pitched-roofed extension at the southern end of the house was of simple construction with timber frame and glass walls and a roof covered with timber shingles (**Photograph 11**). The shingles were largely flat with some minor warping at the bottom edge of the tiles creating superficial gaps that were unsuitable for bats (**Target note 6**). The lead flashing at the junction of the extension and house was tightly fitted. A gap was present between timber framework of the extension and house's wall on the western side, but this was cobwebbed and showed no evidence of use by bats during a close inspection (**Photograph 12; Target note 7**).

11. The timber shingles covering the single storey extension largely flat or with superficial gaps beneath.

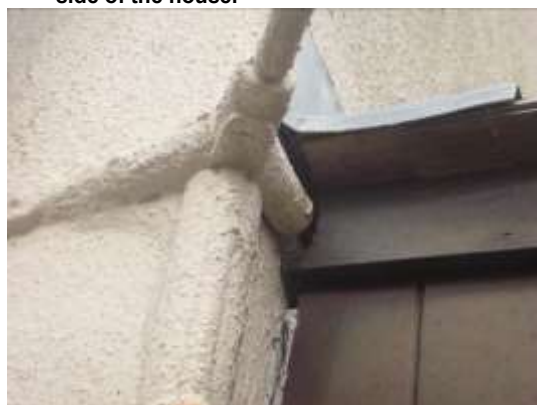
12. Cobwebbed gap at junction of the single storey extension and house.

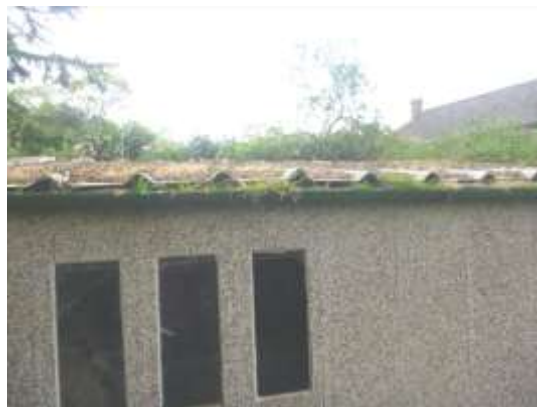
**3.2.5** The detached double garage was constructed from pre-fabricated concrete panel walls and had a shallow pitched, corrugated sheet roof; these lacked any visible opportunities for roosting bats (**Photographs 13 & 14; Target note 8**). There were small sections of timber cladding at each gable end (**Photograph 15; Target notes 9 & 10**). The cladding was interlocking vertically and provided no opportunities for roosting bats. Timber barge boards were visible on the southern elevation and these were mostly tight to the wall; a slight gap was visible towards the eastern end but a close inspection showed no evidence of use by bats (**Photograph 16; Target note 11**). The northern side of the garage was close to the boundary and obscured by dense vegetation.

**14. The garage's corrugated sheet roof.**

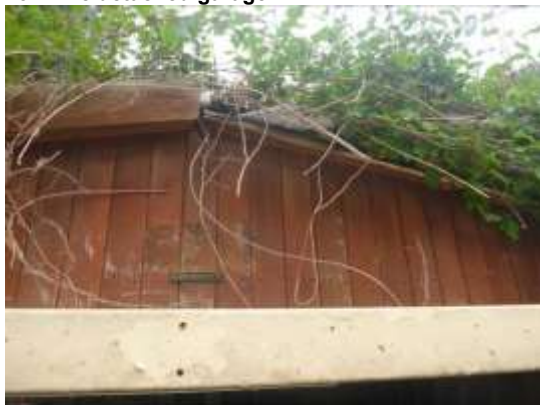
**15. The tightly interlocking timber cladding at each end of the garage.**

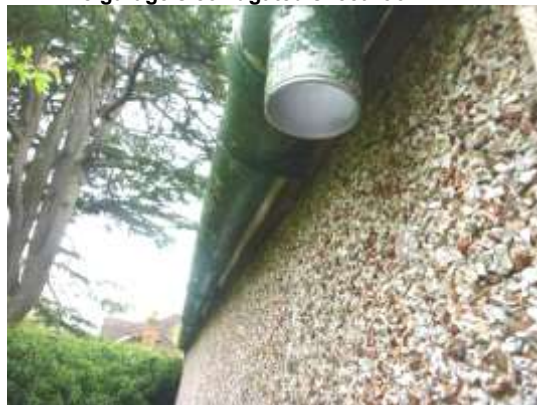
**16. Slight gap beneath barge board on garage showing no signs of use by bats.**

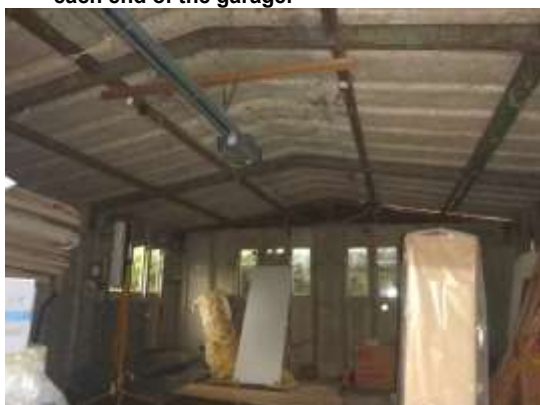
- 3.3.2** The interior of the detached garage was used for storage and the pre-fabricated concrete panel walls and underside of the sheet roof were visible throughout; these lacked any opportunities for bats (**Photographs 17 & 18; Target notes 12 & 13**). Daylight was widely visible where the roof met the walls. The corrugated sheet roof was supported by a metal framework that lacked any opportunities for bats. No evidence of bats was visible within the garage.

**17. The interior of the garage showing the metal frame supporting the corrugated sheet roof.**

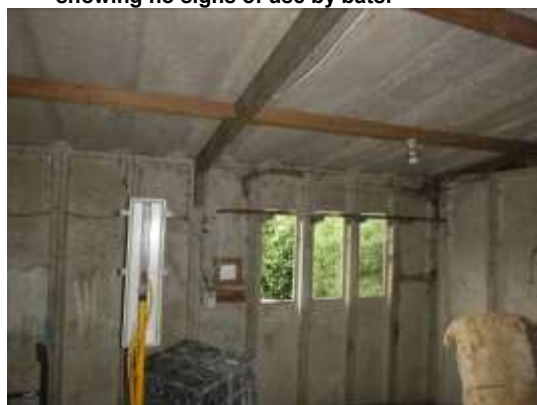
**18. The pre-fabricated concrete panel walls.**

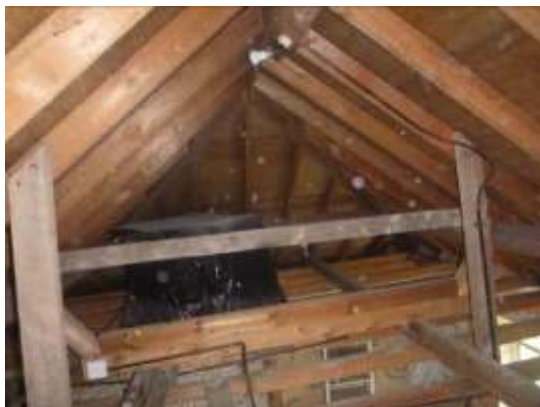
**3.3.1** The main roof space was accessed via a loft hatch in the south eastern corner and the void was approximately 1.75 metres from the floor to the ridge (**Photograph 19**). The floor of the space had a large section of ceiling missing in the south western corner but otherwise the floor was covered with loose vermiculite insulation (**Photograph 20; Target note 15**). The roof was of traditional 'cut and pitch' construction with exposed ridge beam and rafters. The roof was lined with paper backed felt that was largely intact (**Photograph 21; Target note 14**); a tear was visible at the north western hip (**Target note 17**). The ridge was heavily cobwebbed throughout (**Photograph 21**). The eaves were open to the loft space; no daylight was visible. Covered water tanks were situated at the south eastern corner and an old wasps' nest was visible at the eaves at the northern end of the roof (**Photograph 22; Target note 16**). No bats or evidence of bat activity was

19. The loft space looking towards the southern end and the water tanks.

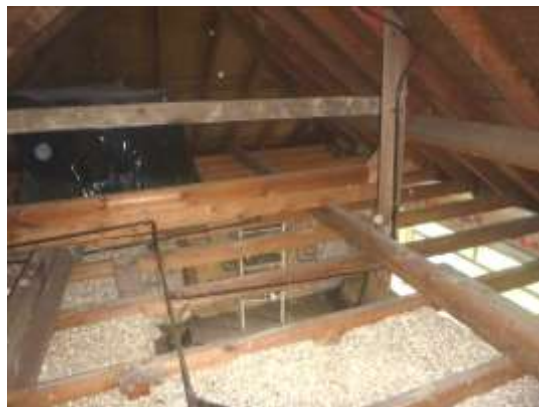
20. Section of removed ceiling in the south western corner of the loft space.

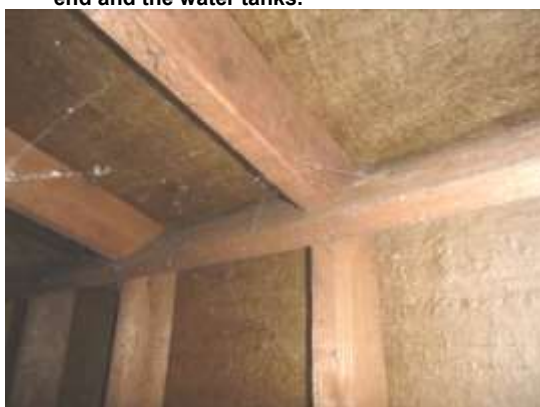
21. The largely intact paper backed felt widely cobwebbed at the ridge.

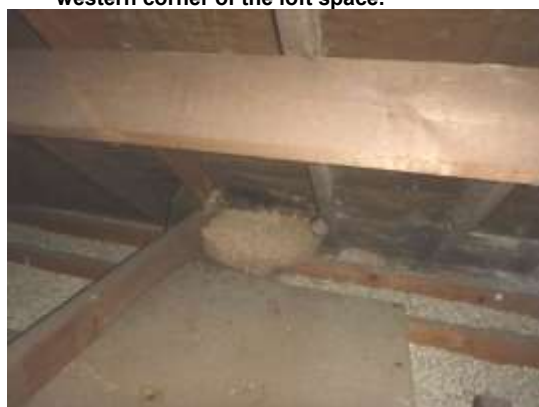
22. The old wasps' nest at the northern end of the loft.
