# ARBORICULTURAL METHOD STATEMENT

**Client:** Reading Community Hydro

**Site:** Caversham Weir  
View Island  
Caversham  
Reading

**Ref.:** THL-R20-44-AMS

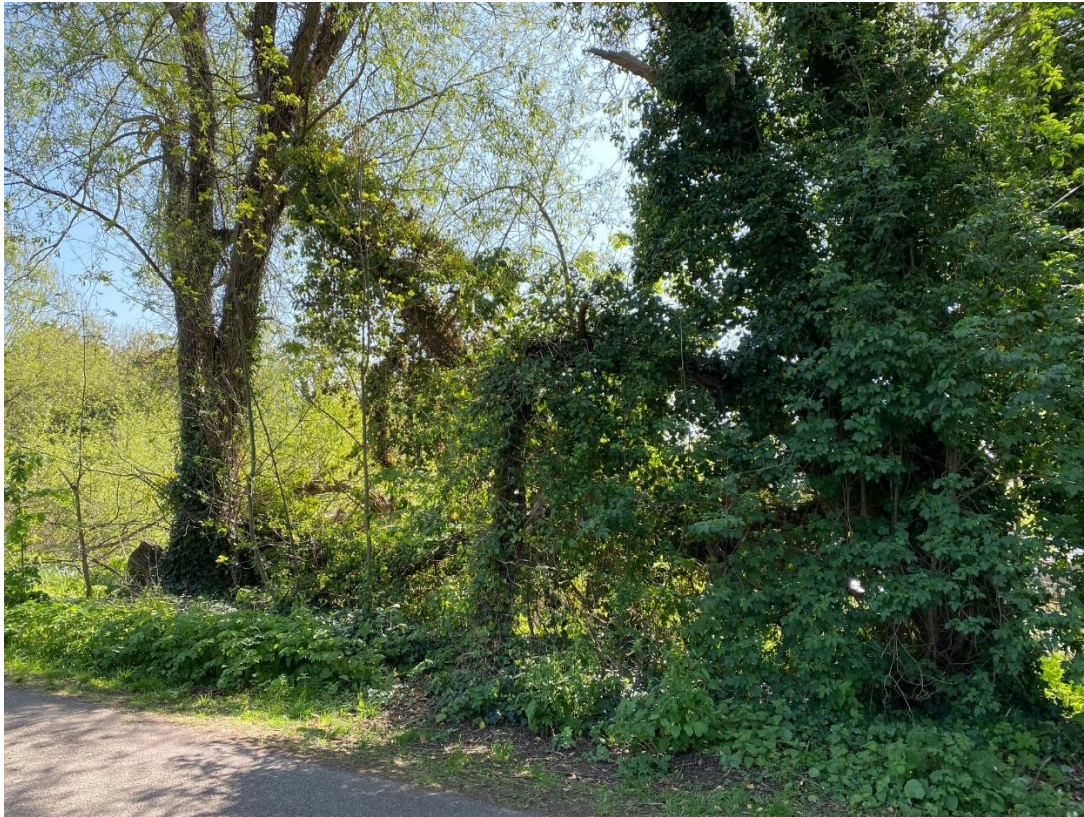
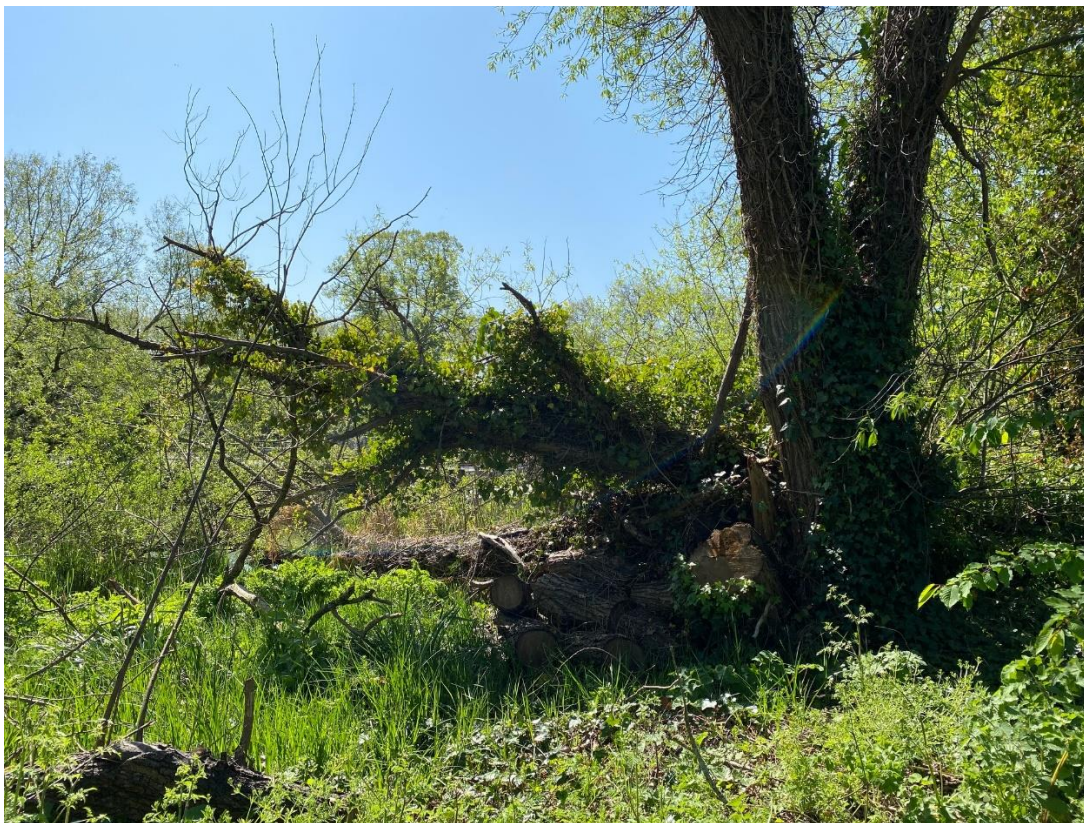
### Photos of T8 and T9

- 4.4 Located along either side of the river are several large over mature Willows. Several of these have started to break up and shed limbs, as is normal of this species. Photographs attached in appendix D of this report show the condition of the trees.

| Tree Ref. | Species | Height | Stem Diameter | Branch Spread | | | | Crown Clearance | FSB Height + Direction | Life Stage | Phys. Condition | Structural Condition | Recommendations | Estimated Remaining Contribution | Category Grading | RPA Radius |
|---|---|---|---|---|---|---|---|---|---|---|---|---|---|---|---|---|
| T8 | Salix fragilis (Crack Willow) | 17 | 650 | 8 | 6 | 8 | 5 | 4 | 5(N) | OM | Fair | Ivy on stem. Cavity on stem. Hanging branch/es in crown. Broken branch/es in crown. Major deadwood in crown. Tree considered dangerous. | For long term retention, this tree will require management to prevent it falling apart | <10 | U | 7.8 |
| T9 | Salix fragilis (Crack Willow) | 16 | 660 | 6 | 8 | 10 | 7 | 4 | 4(E) | OM | Fair | Decay present at base. Cavity at base. Hanging branch/es in crown. Broken branch/es in crown. Major deadwood in crown. Tree considered dangerous. | Pollard tree to make work area safe during the construction. | <10 | U | 7.92 |

- 4.5 For the safety reasons it is recommended that T9, T11, T12, T13 and T16 are all Pollarded to reduce the risk of further failure during the works. For details please see Tree Works Schedule attached to this report in appendix A.

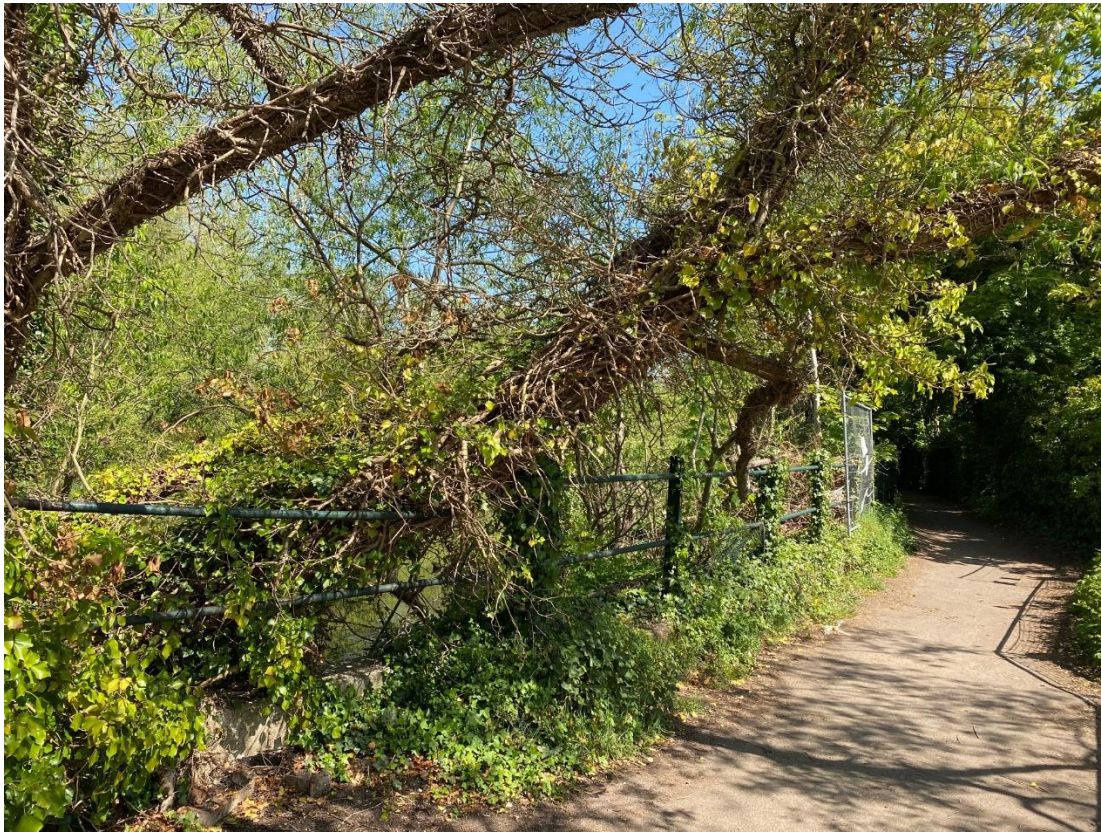
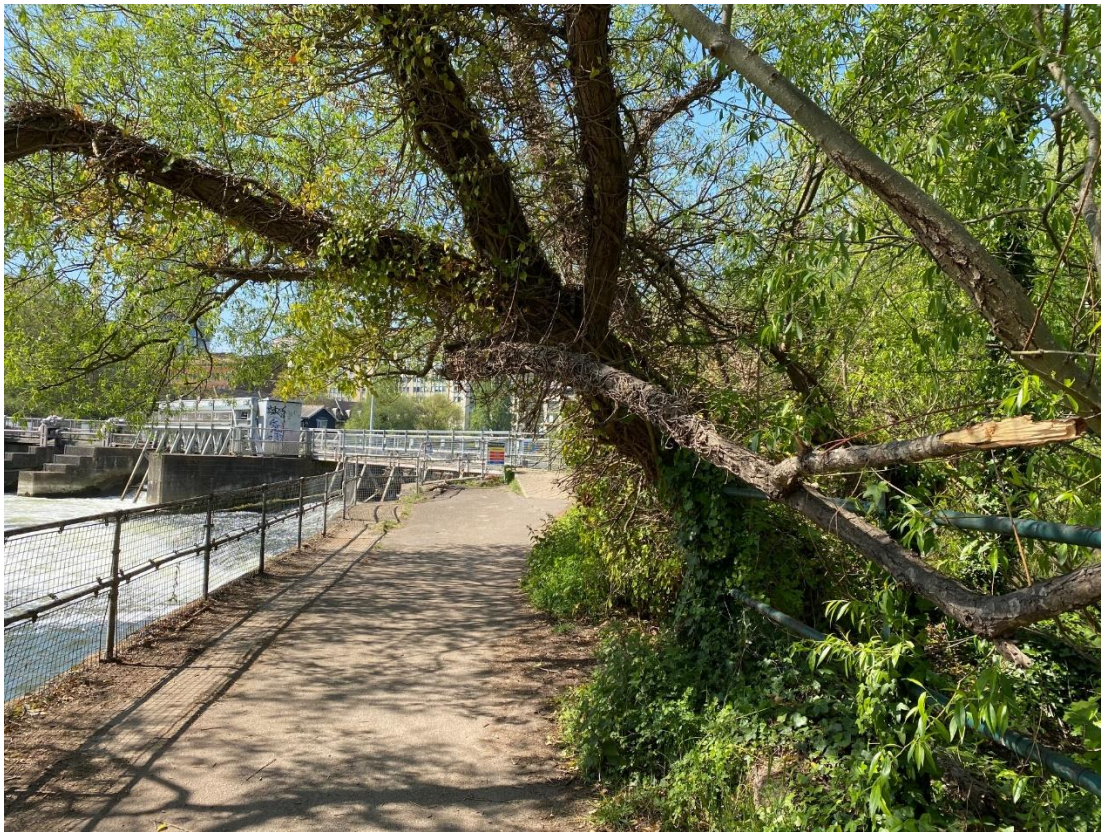
## Photos of T11

| Tree Ref. | Species | Height | Stem Diameter | Branch Spread | | | | Crown Clearance | FSB Height + Direction | Life Stage | Phys. Condition | Structural Condition | Recommendations | Estimated Remaining Contribution | Category Grading | RPA Radius |
|---|---|---|---|---|---|---|---|---|---|---|---|---|---|---|---|---|
| T11 | Salix fragilis (Crack Willow) | 7 | 190 | 2 | 2 | 1 | 4 | 1 | 1(W) | M | Poor | Ivy on stem. Dieback in crown. Minor deadwood in crown. | Pollard tree to make work area safe during the construction. | <10 | U | 2.28 |
