***19 St Peter's Hill***  
***Preliminary Bat Roost***  
***Assessment***  
***May 2018***

***Report Ref: DFA18041***

**Derek Finnie Associates Ltd**  
20 Soames Place  
Wokingham  
Berkshire  
RG40 5AT

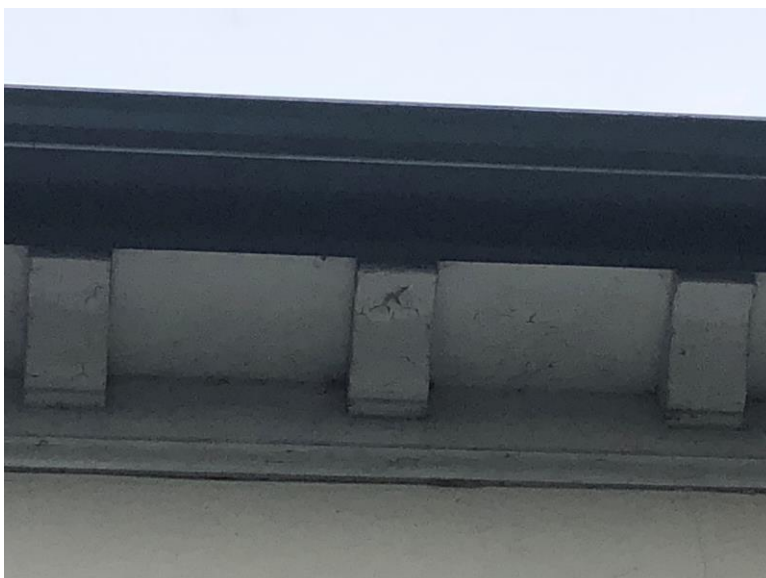
- 3.2.6 The soffit and fascia are in good condition, with no gaps apparent. Polymer sealant is absent, but any resulting gap is minimal, due to the upper storey of the wall being finished with render (Plate 6). The lead flashing around the chimney breast is also tight to the surrounding tiles.
