# Preliminary Roost Assessment

## Greyfriars Church, Reading.

October 2017

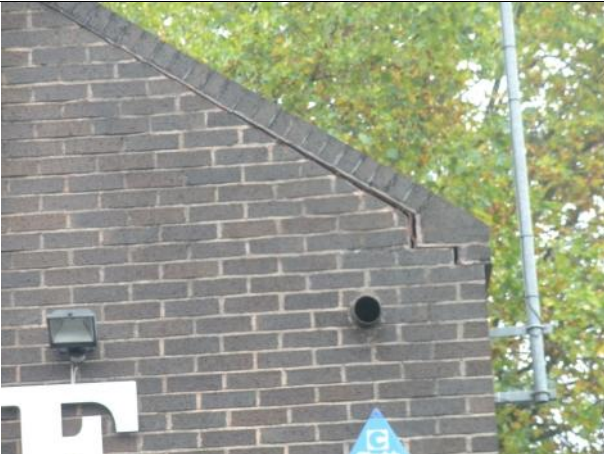
| | <p>1 – Coping brick layer appears to have lifted from the wall top creating a shallow gap. The feature could be inspected and no sign of bats was found.</p> |

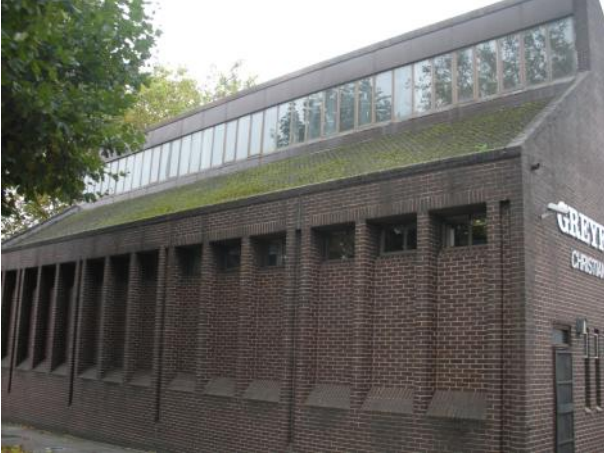
| | <p>2 – Hanging tiles at the roof edge could not be inspected and may offer potential for crevice dwelling bats. However, a similar feature (please refer to target note 3) on an adjacent roof did not provide any gaps suitable for bats. In addition, the vertical wall finish below the feature is formed from a smooth metal sheet. On balance, the feature probably offers low-negligible potential for bats although this could not be definitively proven during the site visit.</p> |

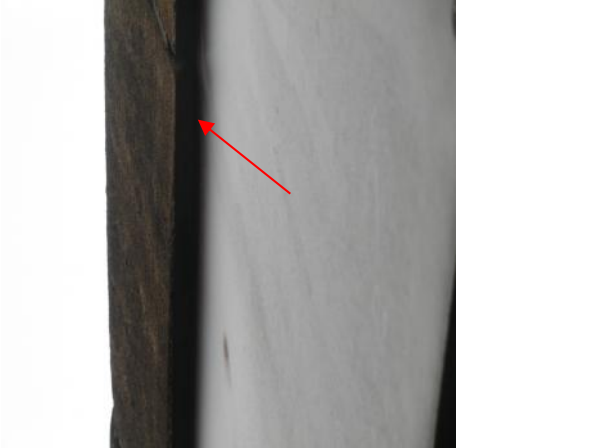
| | <p>3 – Underside of the hanging tile feature on the northern roof pitch. Gaps were considered insufficient to allow access for roosting bats. This feature appears identical to that of target note 2.</p> |

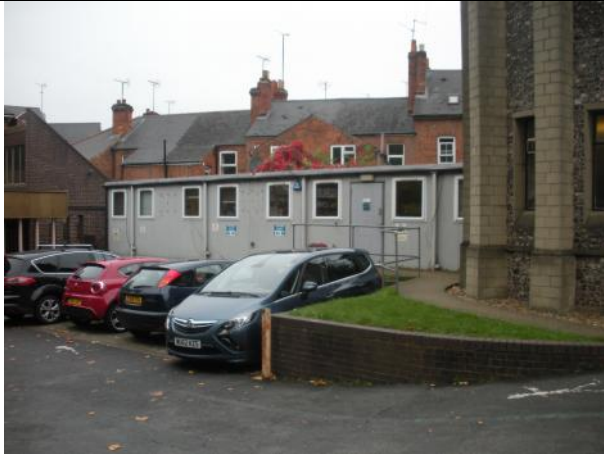
#### B - Portacabin

A Portacabin provides additional office space with the Greyfriars building complex but offers no potential for roosting bats.

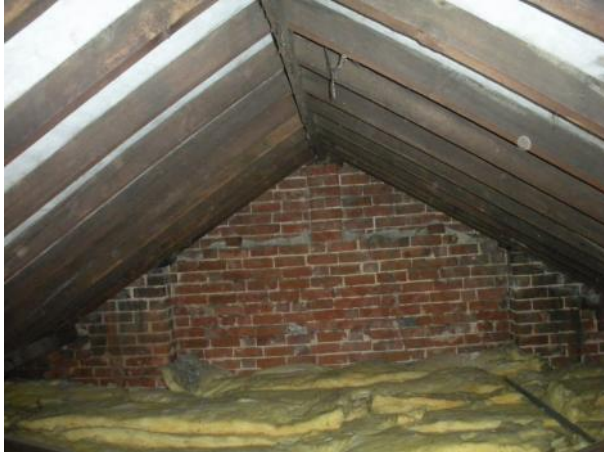
4 – The roof of the Sackville houses is finished in closely interlocking slates. The ridge line and roof edges are also well-pointed. Internally, the use of modern roofing membrane was evident and no sign of bats was found.

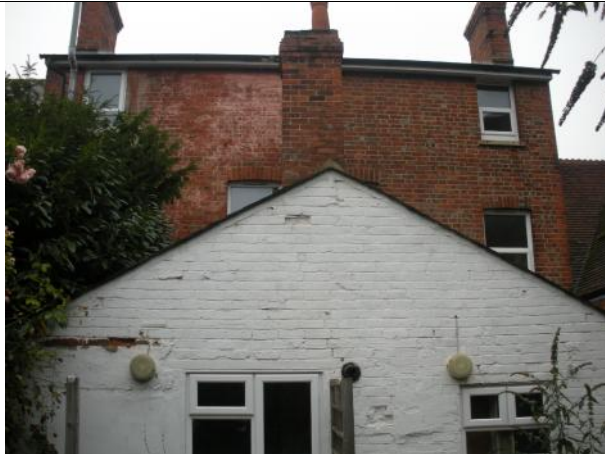
5 – An extension to the properties was also roofed with closely interlocking slates. No gaps were evident beneath soffits, at the ridge line or under flashing. Internally, no sign of use by bats was found.

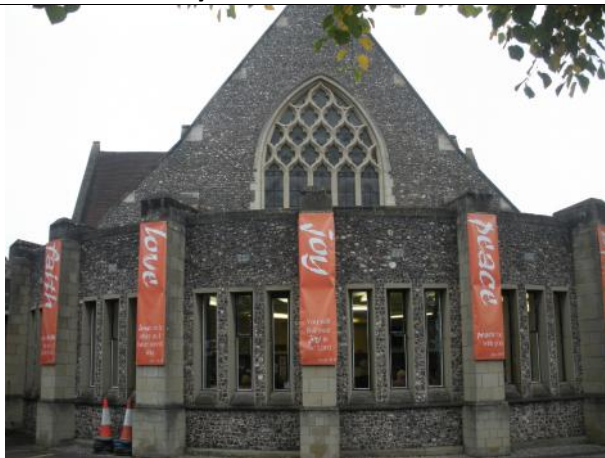
#### D – Entrance Foyer

The entrance foyer dates from the 1970s and is a single storey semi-circular structure with a flat roof. The walls are inset with stone to mirror the main body of the church. A low tower-like structure at the north-western end of the building hosts a water tank. No features with potential to support roosting bats were found.

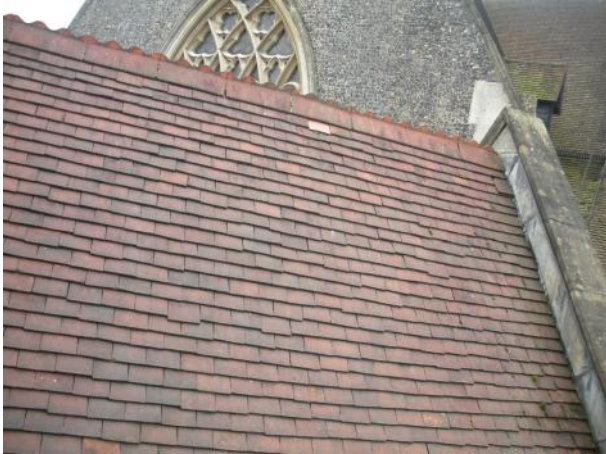
- 5.1.3 Buildings adjacent to the works, including the Memorial Hall and Greyfriars Church itself, support features that have moderate potential for bats. However, in terms of environmental setting, the urban character of the site and lack of natural linear features (such as watercourses and tree lines) provides sub-optimal habitat for bats. Emergence or roost return surveys would help clarify the status of these buildings as roosts but late seasonal timing means these could not take place until spring 2018 at the earliest.

| | <p>6 – Occasional damaged, lifted and missing tiles offer bats potential access to the roof structure.</p> |

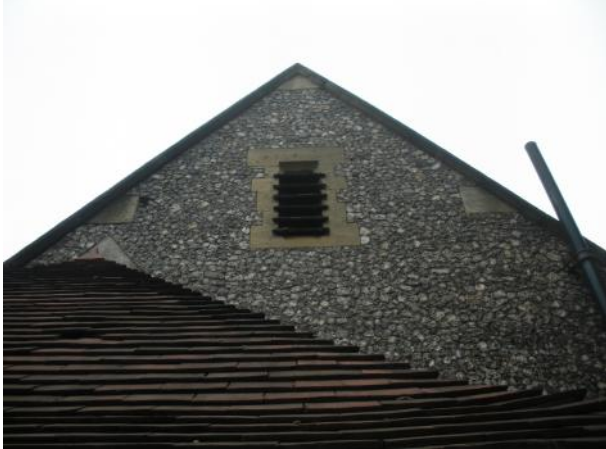
| | <p>7 – A louvred window offers a potential flyway into the structure of the building.</p> |

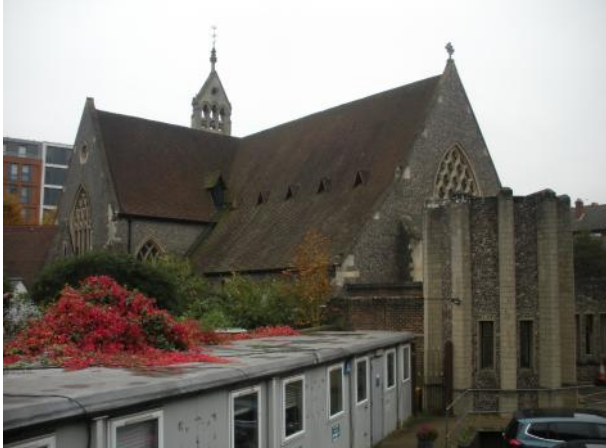
| | <p>Greyfriars Church dates from the 1311 but after falling into ruin was rebuilt in 1863. The walls are finished with inset stone and the roof with clay tiles.</p> <p>The proposals do not include works to the church.</p> <p>8 – In common with the Memorial Hall, occasional gaps under tiles offer potential for roosting bats.</p> |
