**FORMER DREWS BUILDING**

**71 - 73 CAVERSHAM ROAD  
READING  
BERKSHIRE**

**PRELIMINARY BAT ROOST ASSESSMENT**

**2019**

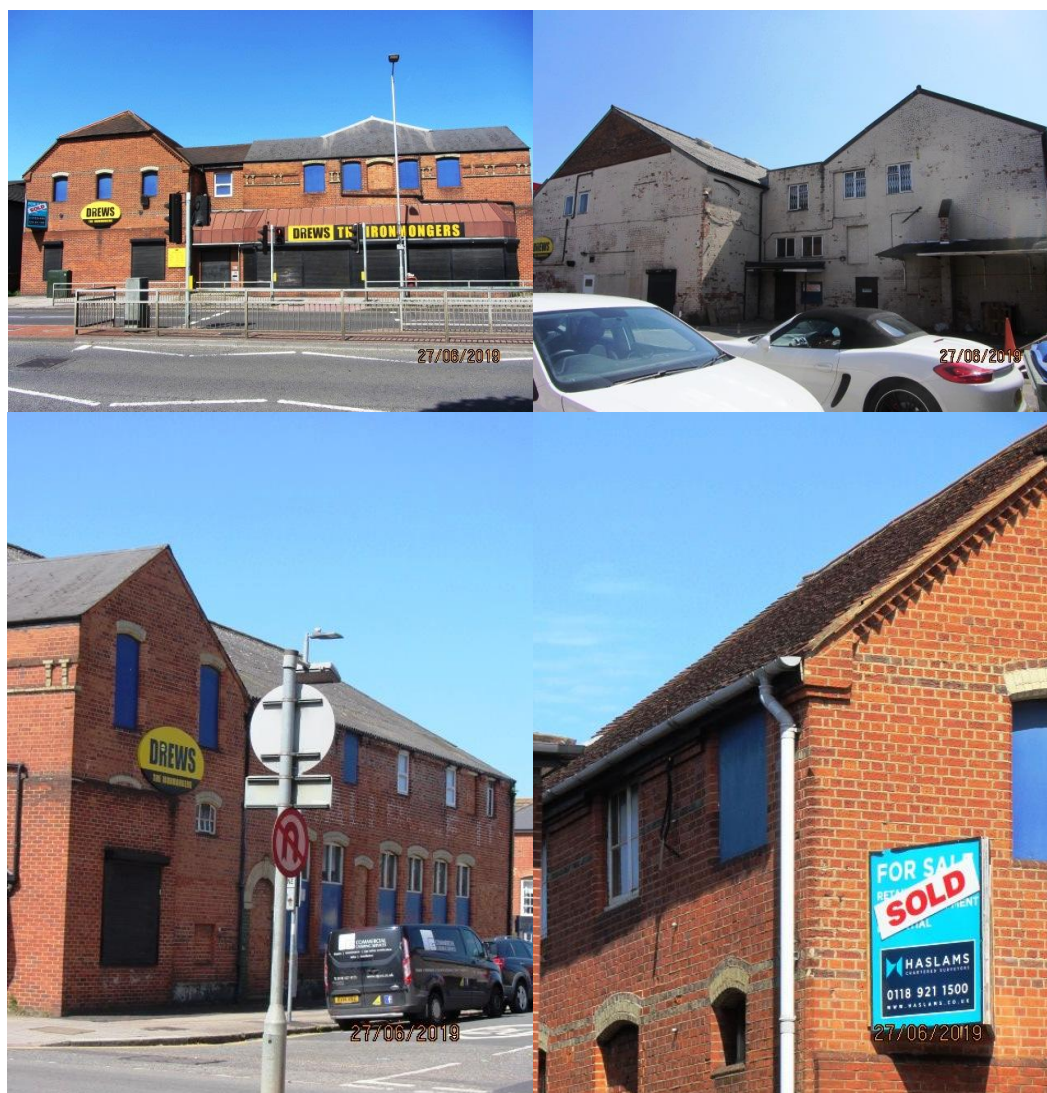
The site comprises a large two-storey, vacant light industrial building (see photographs 1 - 4 below) located in the urban part of central Reading close to the railway station. There are three roofs to the brick-built building, which dates from around the 1960s, all of which are at different levels.

The roof to the right, as viewed from the front elevation, has a pitched, slate covering that is in excellent condition. The central 50% of the ridge is covered with galvanised metal that appeared to be tight-fitting. The small middle roof is tiled and these also appeared to be in excellent condition. The last section of the roof, closest to the adjacent *Pure Gym* building, also has a tiled roof that has one or two damaged tiles present but nothing that could act as a potential ingress point for bats.

Photographs 1 - 4: Front, rear and side elevations

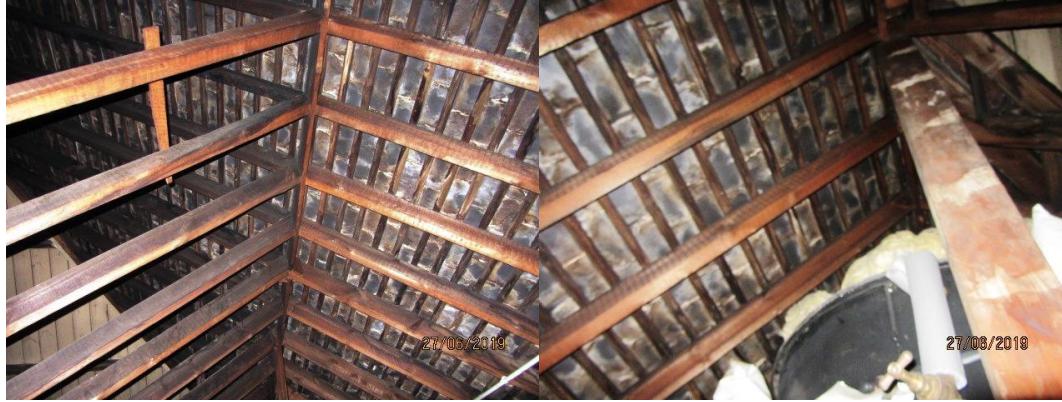
The roof spaces of these loft voids are unlined and un-insulated. The rafters are all modern-sawn timbers with no mortise joints typically utilised by bats as roosting locations and there is no large central ridge beam present (see photographs 5 - 6 below).

Photographs 5 - 6: Internal roof spaces (fronting Cavendish Road)

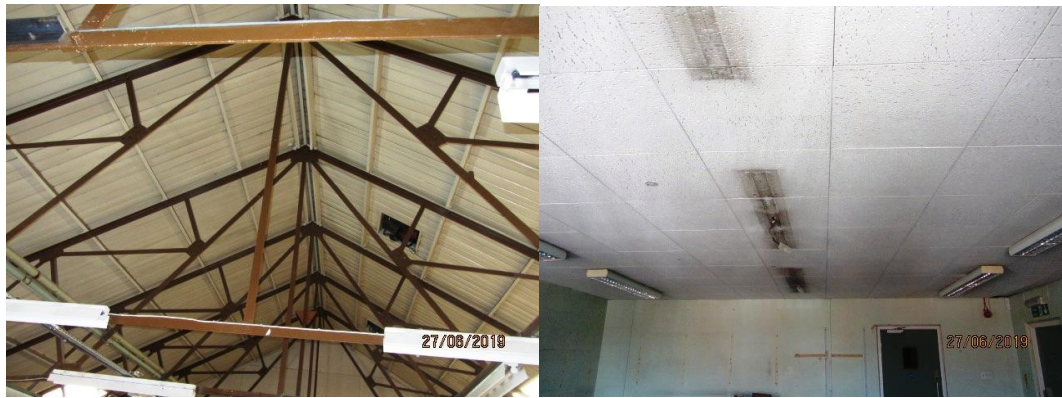
Two rear extensions, facing towards the car park area, are present. These have pitched asbestos roofs. The extension parallel with Northfield Road is supported by modern metal rafters and there is no ceiling present to form a void (see photograph 7 below). The extension parallel with the *Pure Gym* building has a false ceiling present to create the former office space (see photograph 8 below).

Photographs 7 - 8: Internal roof spaces (two rear extensions)

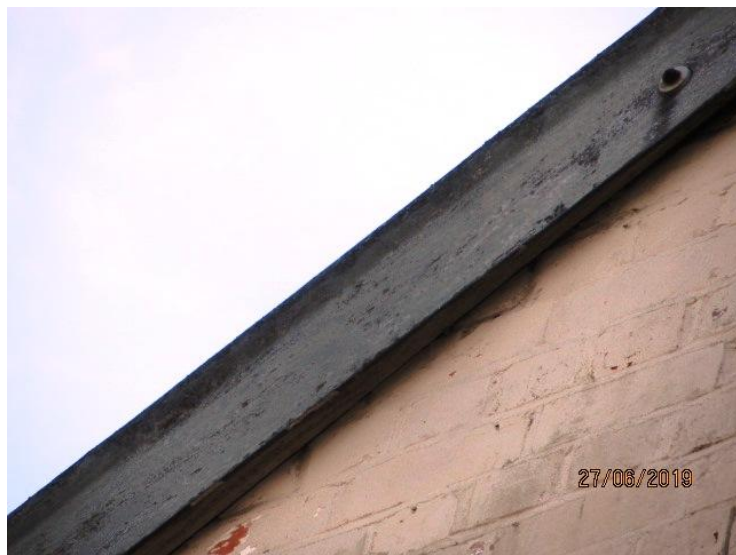
The soffits and fascias all appeared tight-fitting and no potential points of ingress were identified (see photograph 9 below).

Photograph 9: Close-fitting soffits / barge boards
