# **39 Grove Road**

## **Bat Assessment**

**May 2019**

Report Ref: DFA19037V2

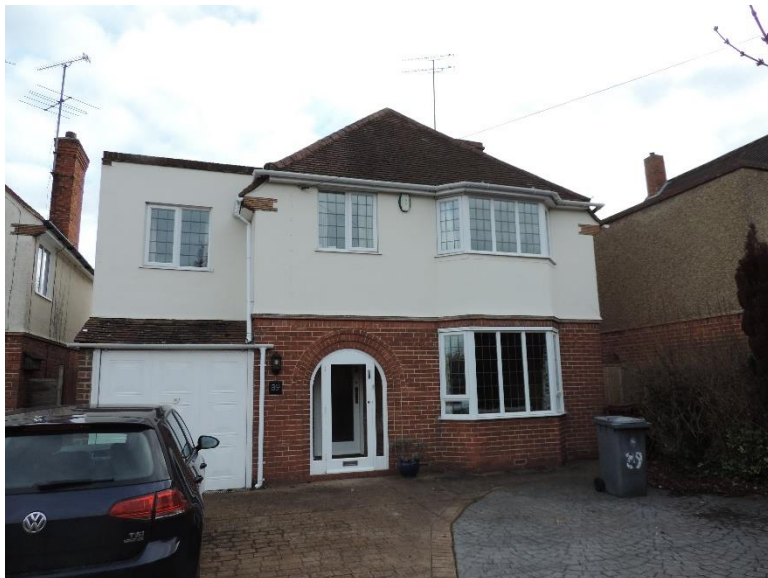
- 3.2.2 The roof of the property comprises a hip roof; a flat roofed, two storey extension is present on the eastern aspect, whilst a single storey flat roofed extension is present to the rear. There are no hanging tiles or weather boarding on any aspect of the building. A single chimney breast exists the roof on the rear (south eastern) aspect with a second present on the south western aspect (Plates 1 – 2).

Plate 1. General view of the front of the property.

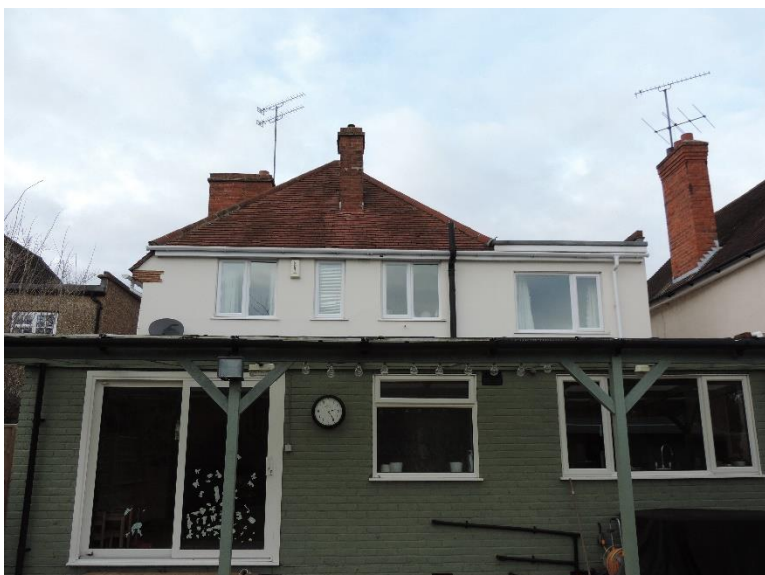
Plate 2. General view of the rear of the property.

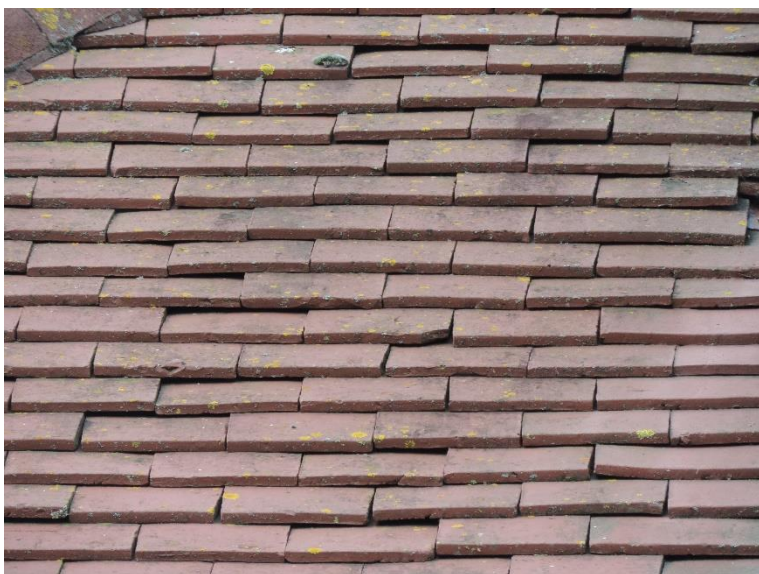
- 3.2.3 The roof of the house is finished with flat, interlocking clay tiles. The tiles are in moderate to good condition. However, several on the rear aspect are uneven, creating gaps that may allow bat ingress, whilst two tiles around the chimney breast are also missing (Plate 3). The ridge lines are intact.

- 3.2.5 The lead flashing around the chimneys is intact and tight with surrounding tiles.
- 3.2.6 Externally, potential ingress points have been created by the uneven and missing tiles on the rear aspect. These were assessed as being of Low potential to support roosting bats.

- 3.3.3 In summary, potential ingress points were identified on the rear aspect of the dwelling due to the presence of loose and uneven tiles. However, an emergence survey did not identify any bat usage of these features.

Plate 3. Typical view of the tiles on the rear aspect of the building.

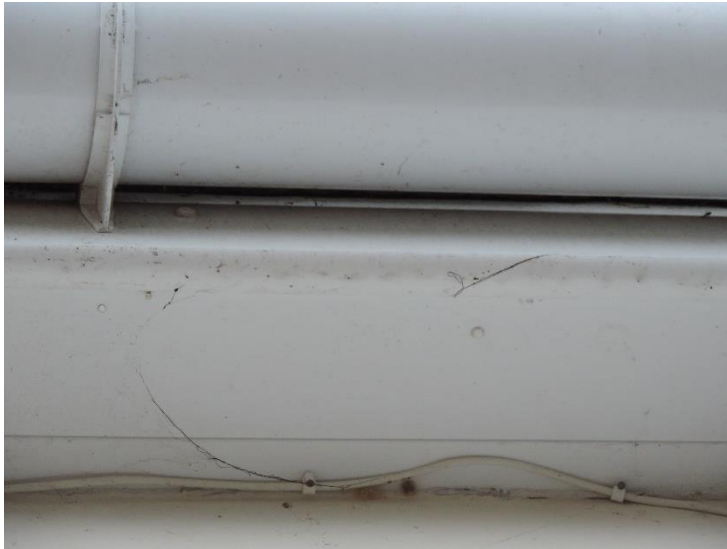
- 3.2.4 The plastic fascia soffit boards are sound throughout, with no gaps noted. Polymer sealant is present between the brickworks and soffit board, eliminating any potential gaps (plate 4).

Plate 4. Typical view of the soffit and fascia boards.

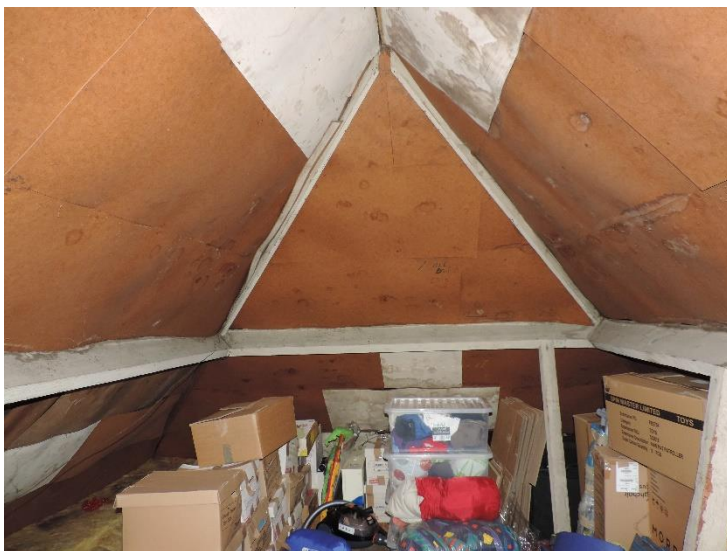
- 3.2.7 Internally, there is limited enclosed void space. What does exist has been boarded out such that the trusses are not visible. No evidence of droppings or feeding remains were noted within the void space (Plates 5 and 6).

Plate 5. General view of internal void space.

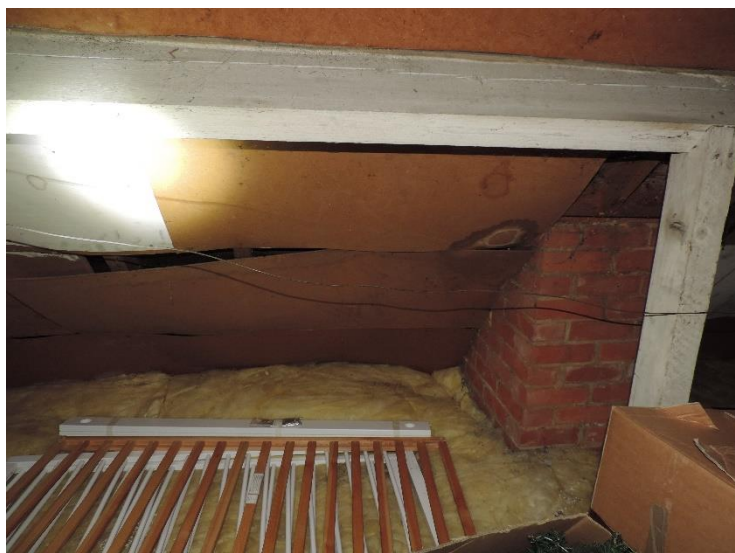
Plate 6. General view internal void space.
