# Town Planning Bureau

## Heritage Assessment

Site: Upper Floors of 1 to 15 Queen Victoria  
Street & 148 Friar Street, Reading RG1 1SY  
Application by: The Thackeray Estate  
Lead Consultant: Mr Paul S Bottomley  
Date: 25<sup>th</sup> January 2019.  
Our Ref: URB-482-ST7a.

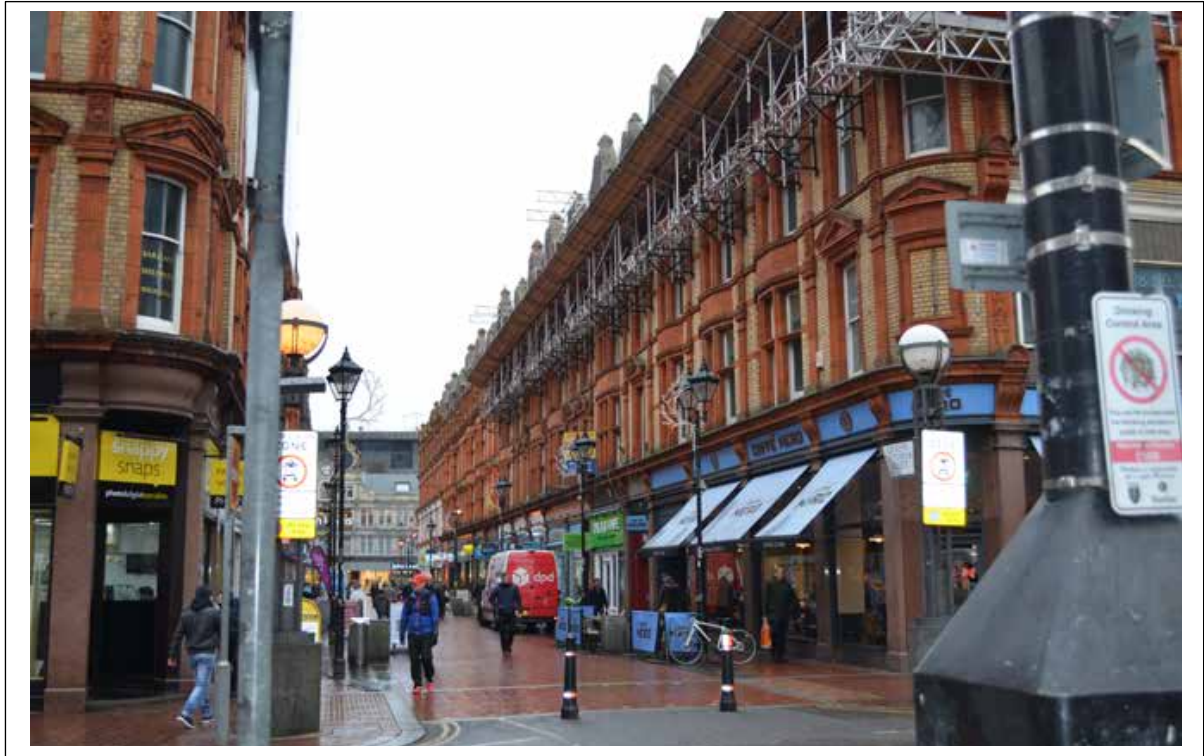
- 5.8 As advised, there is no change to the design or appearance of the building, more simply the works will sustain the heritage assets and by repairing, they will enhance the significance of the asset.
- 5.9 These works are essential for the future survival of the buildings, which have remained unrepaired for a number of years, which is self-evident by the structural supports that have had to be installed. Accordingly, the principle of repairing the building is essential and therefore acceptable.

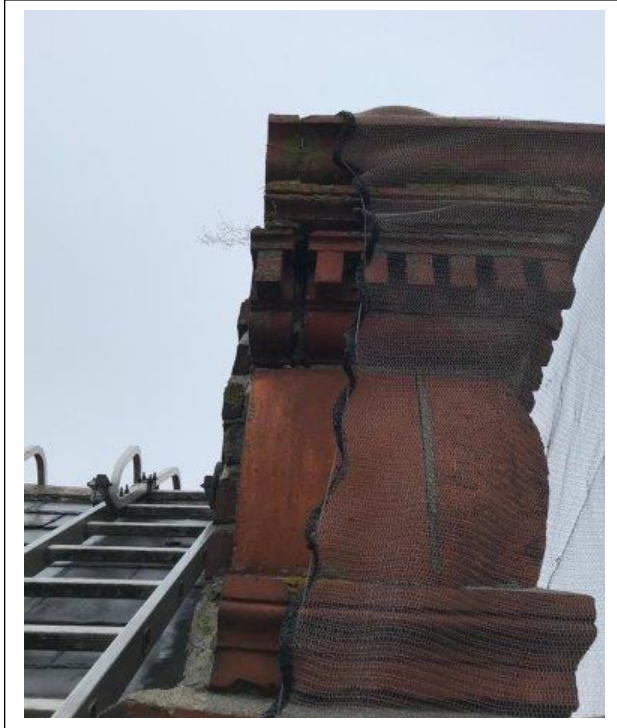
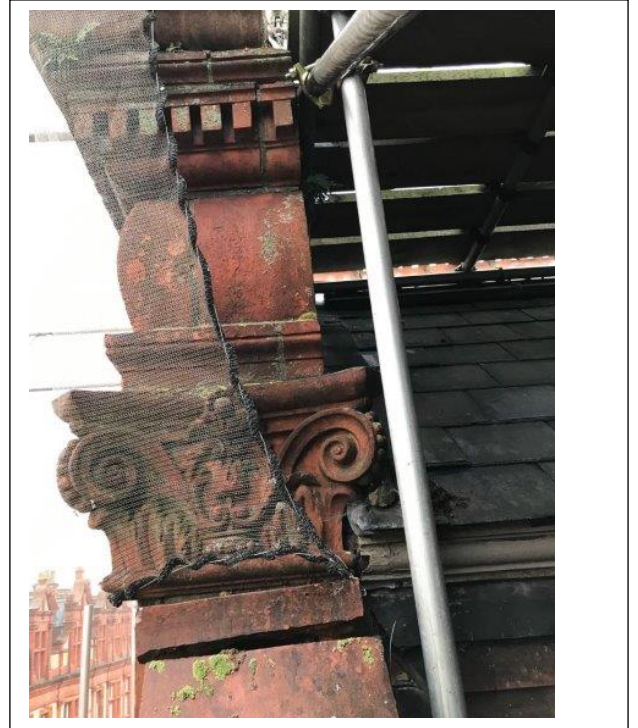
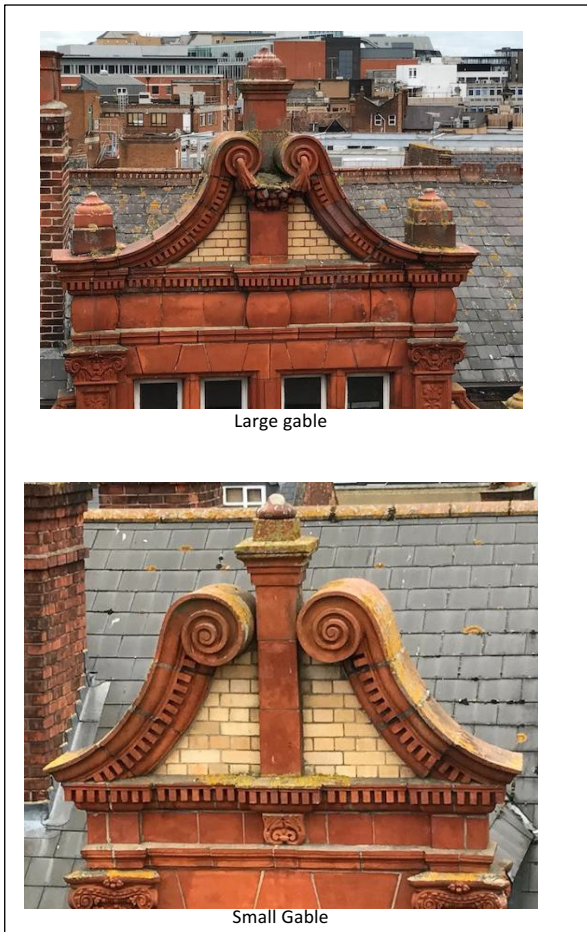
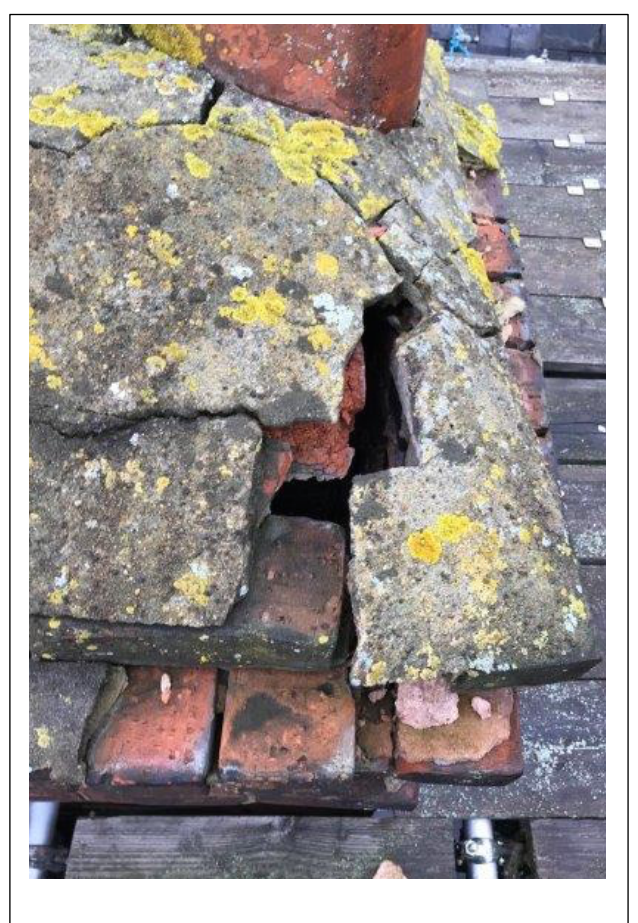
Gable Repair

- 3.4 The upper floors are in a very bad state of repair and scaffolding is currently required to hold the gables to the roof. This is a result of original structural defects, as the gables were not given proper restraint and support. Several of the gables have already been lost, including the larger ones above 148 Friar Street and 1-3 Queen Victoria Street, replaced with plain triangular pediments that detract from the original design and appearance of the buildings and terrace as a whole.

- 5.11 For a full précis of the gable works we refer to the Method Statements. Again, the gables are currently held in place by scaffolding, and are unsafe. The works will repair, restore and preserve the gables. As such, the heritage benefits are significant.
