# DESIGN AND ACCESS STATEMENT

Greenbank  
University of Reading London Road Campus

Roof Repairs

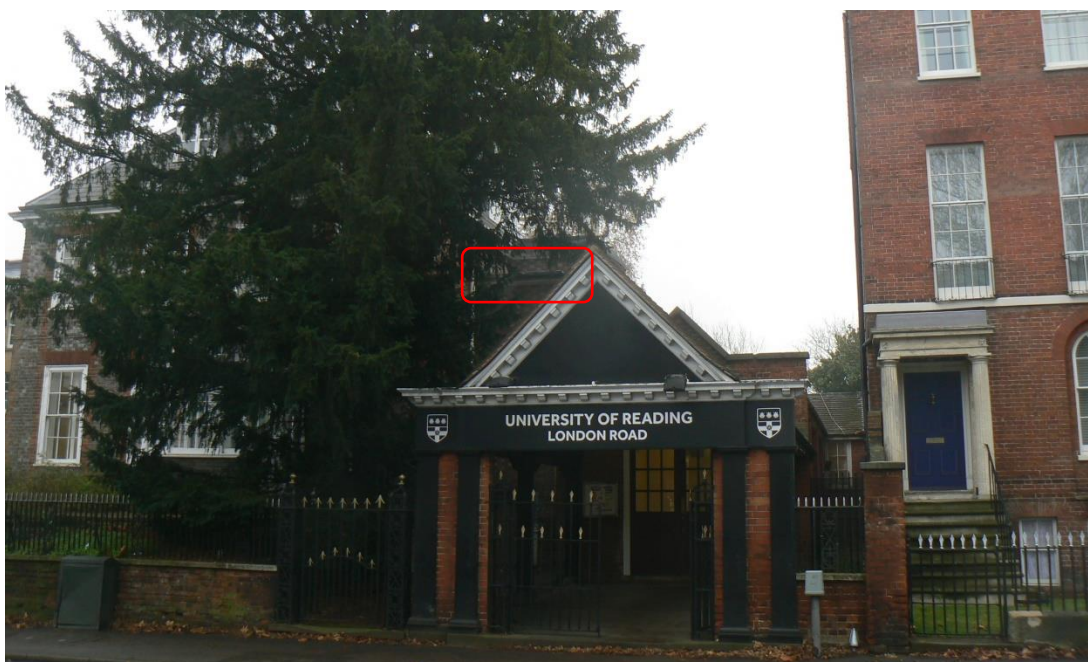
The previous lead roof covering was stolen in the autumn of 2018. This section of roof is attractive to thieves because of the sheltered position behind the large tree combined with easy access and getaway along the London Road (see Figure 2 below).

Figure 2: The subject roof is outlined in red

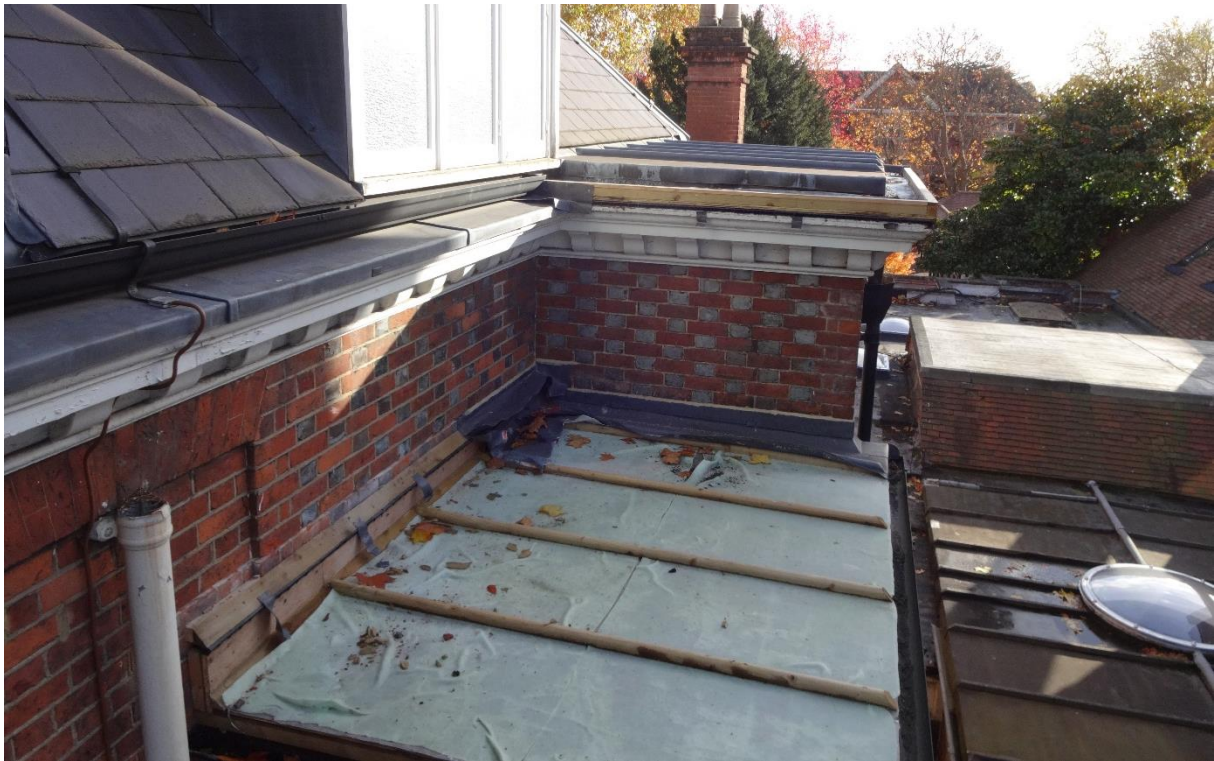
The lead has been stolen from the roof of the lower section of flat roof (see Figure 3 below) and from the lead gutter around the upper section.

*Figure 3: The effected roofs*

The upper, gutter section will be renewed in lead but it is proposed to replace the lower section with a liquid applied polymer coating. This will be lead grey in colour and incorporate “rolls” to mimic a traditional lead roof.

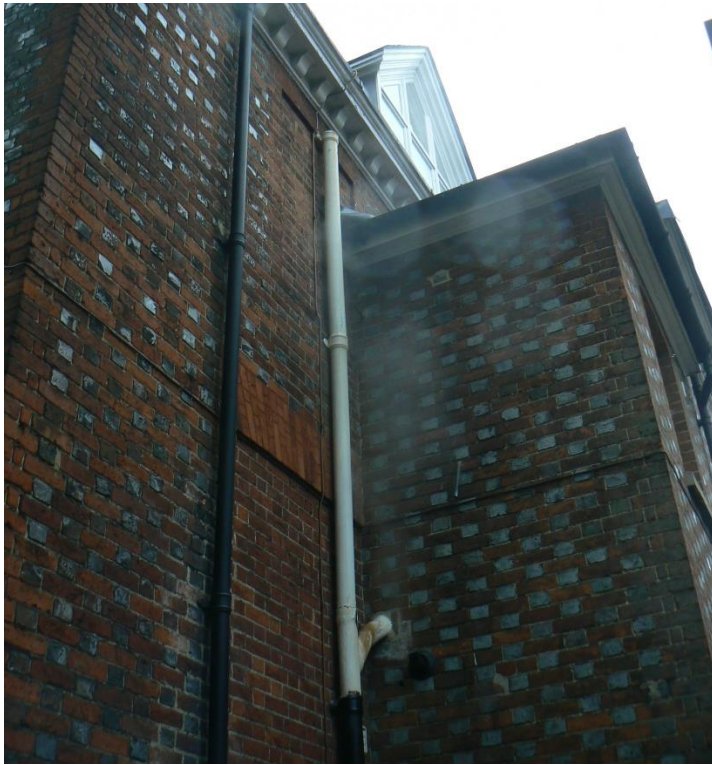
*Figure 5: The flat roof in question is on the top of the extension on the right. The soil pipe (white) was probably used to scale on to the roof, but is unnecessarily long*

Additional measures will be explored to deter theft, such as shortening the soil vent pipe (see Figure 5 below) and warning signage.
