***19 St Peter's Hill***  
***Preliminary Bat Roost***  
***Assessment***  
***May 2018***

## ***Preliminary Bat Roost Assessment***

***Report Ref: DFA18041***

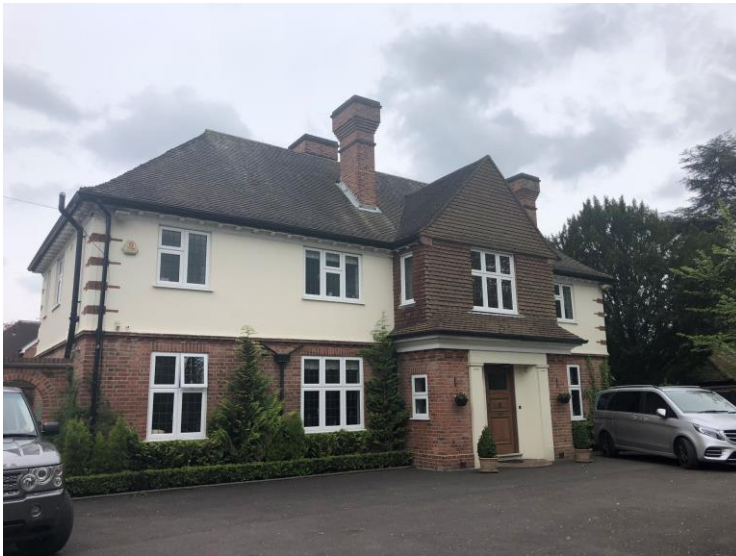
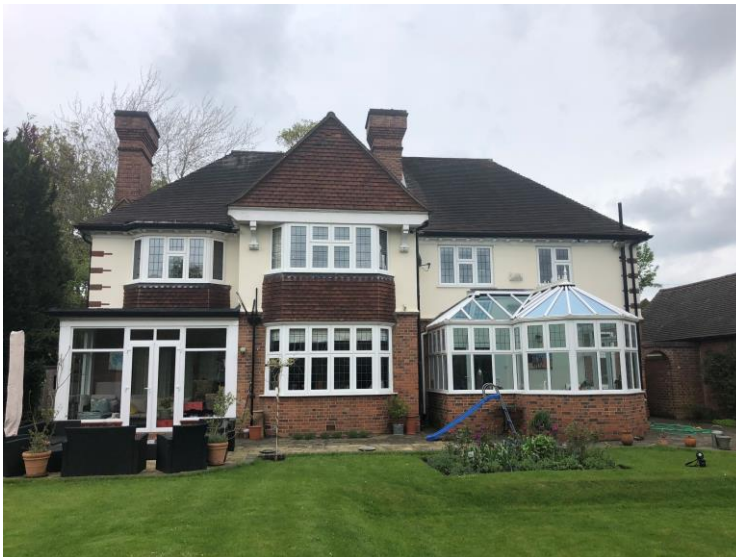
- 3.2.2 The roof of the main house is of basic hip design with the ridge line running more or less north west to south east; a cross gable extends to the front, with a second extending to the rear. Chimney breast are present on the front, rear and north west aspect of the roof. Hanging tiles are present on both the front and rear cross gables. (Plates 1 – 4).

- 3.2.4 The roof of the house is finished with flat, interlocking clay tiles. All the tiles are good condition throughout with no broken or loose tiles were noted; there is the occasional uneven tile towards the north west of the roof, but none of the resulting gaps were of sufficient size to allow bat ingress. The ridge lines are intact.

Plate 1. General view of the front of the property

Plate 2. General view of the rear of the property

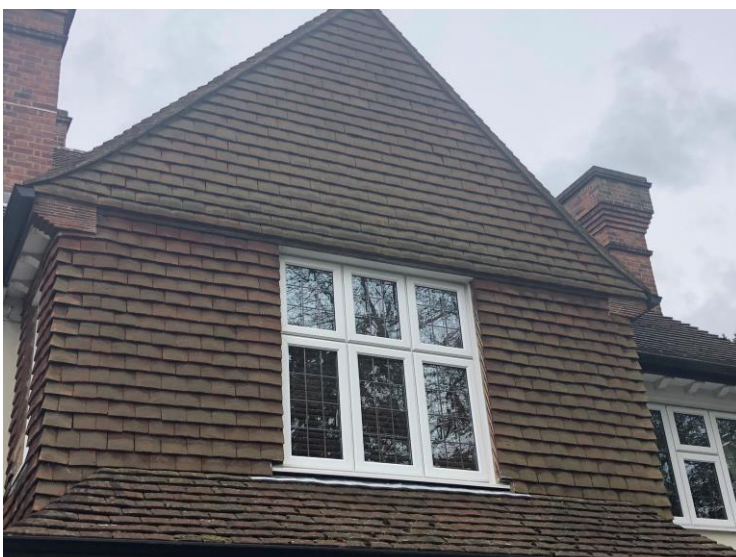
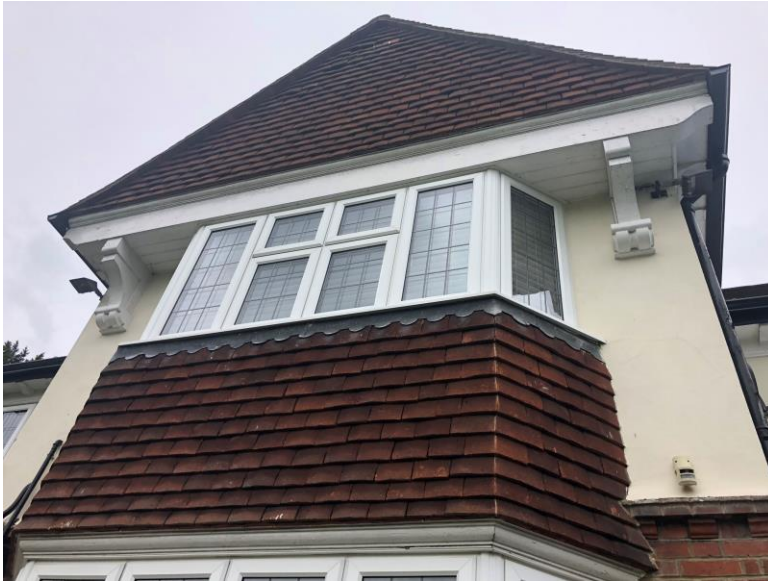
- 3.2.5 The hanging tiles on both the front and rear aspect are in good condition, with all tiles present and tight with one another. No gaps were noted. These features would not be affected by the current proposal.

Plate 3. General view of the front cross gable.

Plate 4. General view of the rear cross gable.

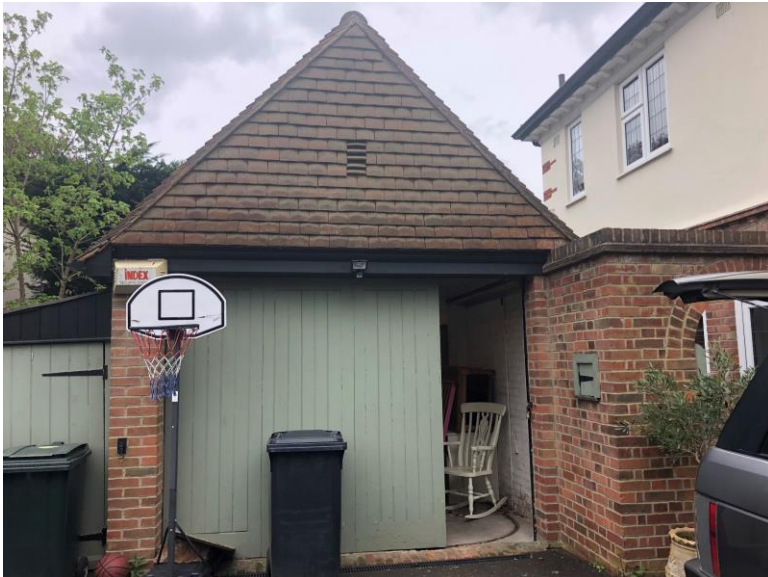
- 3.2.3 A detached garage is located to the south east of the main house (Plate 5). The garage supports a tiled, pitched gable roof. The front (north east) gable end wall is finished with hanging tiles with a grilled opening into the internal void space; a similar grilled opening is present on the rear gable end wall also.

Plate 5. View of the detached garage.

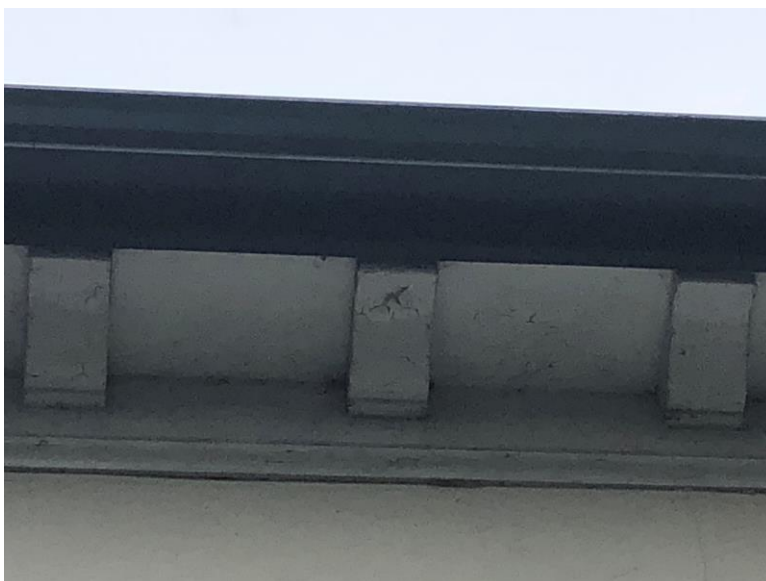
- 3.2.6 The soffit and fascia are in good condition, with no gaps apparent. Polymer sealant is absent, but any resulting gap is minimal, due to the upper storey of the wall being finished with render (Plate 6). The lead flashing around the chimney breast is also tight to the surrounding tiles.

Plate 6. General view of the soffit and fascia.

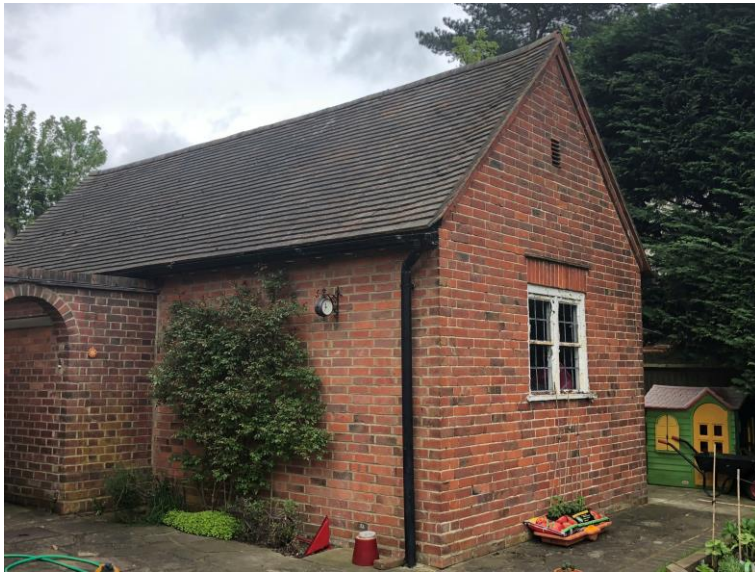
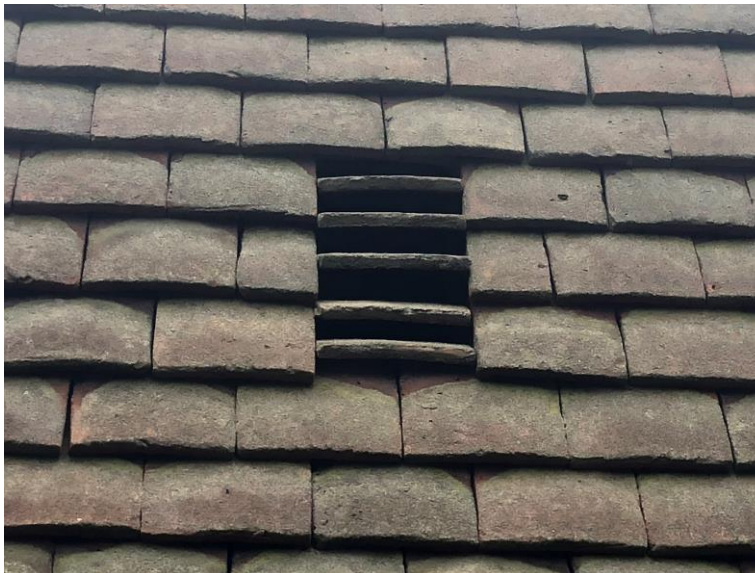
- 3.2.7 Externally, no potential ingress points were noted into the main dwelling.
- 3.2.8 The garage roof also supports similar flat, interlocking clay tiles which are all intact and tight with one another. As are the hanging tiles on the gable end. The vents on either gable end, however, do offer potential ingress points into the internal void (Plates 7 and 8).

Plate 7. General view of the rear of the garage showing pitched roof.

Plate 8. General view of the grilled vents on the garage gable ends.

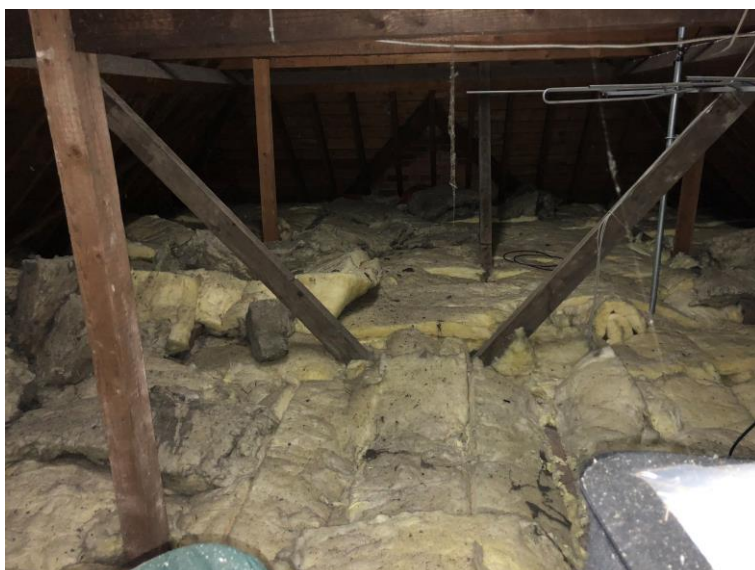
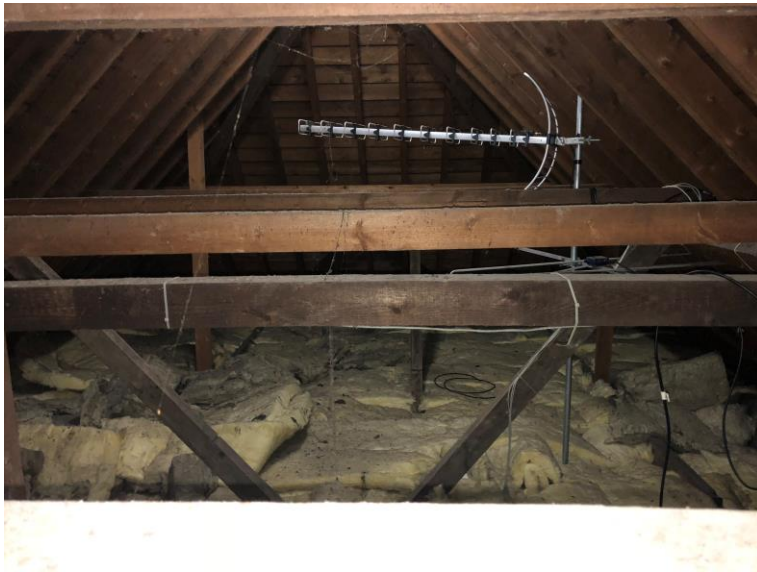
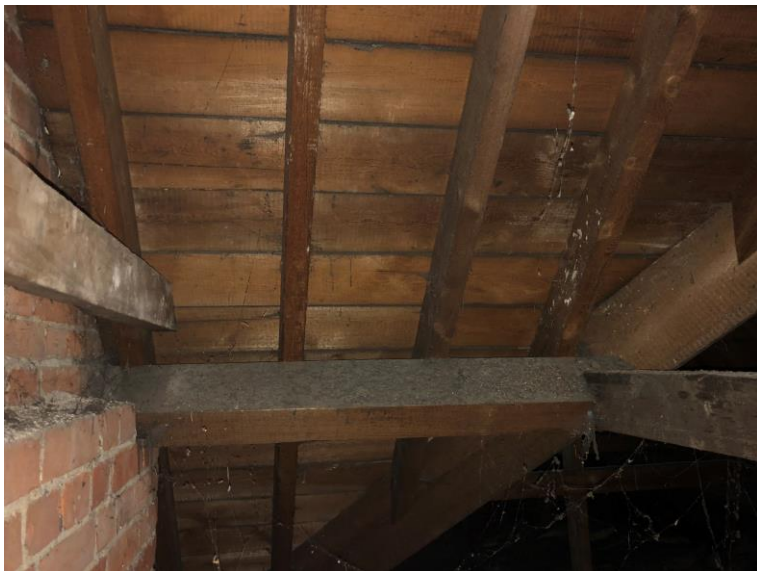
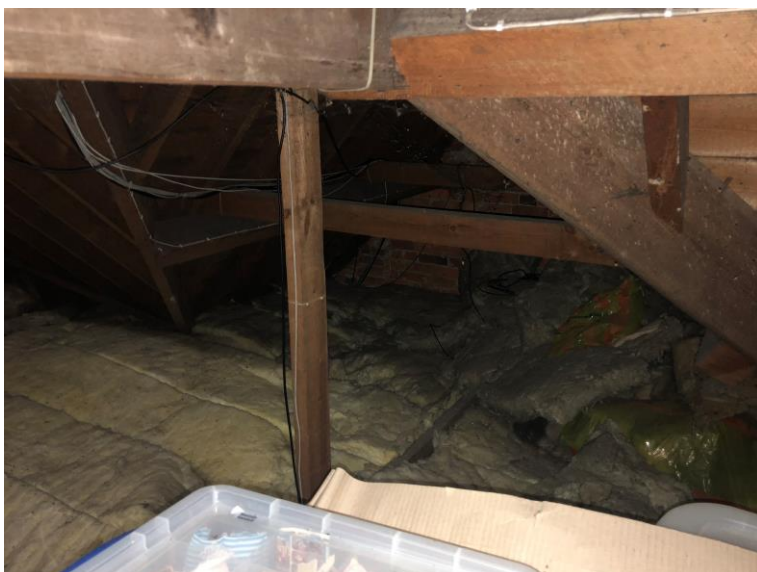
- 3.2.9 Internally, the joists and rafters within the void of the house are of a simple design, with the trusses being of a King post style. Nail plates are absent at the major junctions, but any resulting gap is minimal. A very heavy build-up of cobwebs was present around the junctions and throughout the void space in general, suggesting a lack of bat activity (Plates 9 - 12). No staining or scratch marks were noted along any of the beams, and there was no evidence of feeding remains. No droppings were noted despite a thorough inspection and the distinct smell often associated with bat roosts was absent.
- 3.2.10 The roof lining is formed of wooden boarding and is intact throughout.

- 
- 3.2.11 No evidence if bat activity was encountered within the roof void of the main house.
- 3.2.12 The void space within the garage is of a similar construction, although no roof lining is present, with the underside of the tiles visible (Plates 13 – 14). Again, a heavy build-up of cobwebs was present around the junctions. No staining or scratch marks were noted along any of the beams, and there was no evidence of feeding remains. No droppings were noted despite a thorough inspection and the distinct smell often associated with bat roosts was absent.

Plate 9. General view of the internal void space of the house.

Plate 10. General view of the internal void space of the house.

Plate 11. General view of the internal void space of the house.

Plate 12. General view of the internal void space of the house.

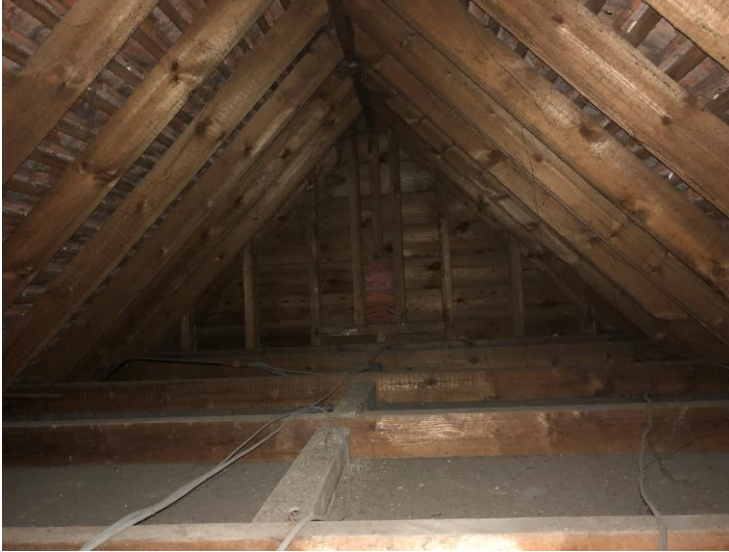
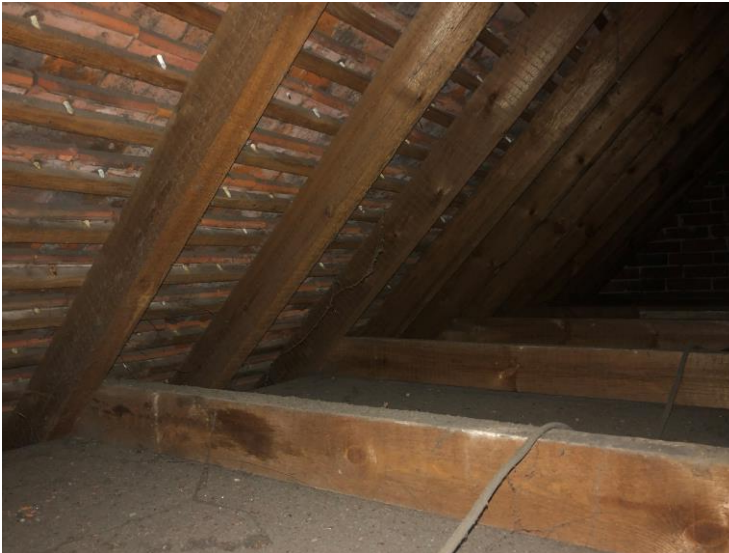
Plate 13. General view of the internal void space of the garage.

Plate 14. General view of the internal void space of the garage.
