## Bat Surveyy and Bird Survey of Garage Block at 17 Eldon Square, Reading

N1103.001

25 January 2012

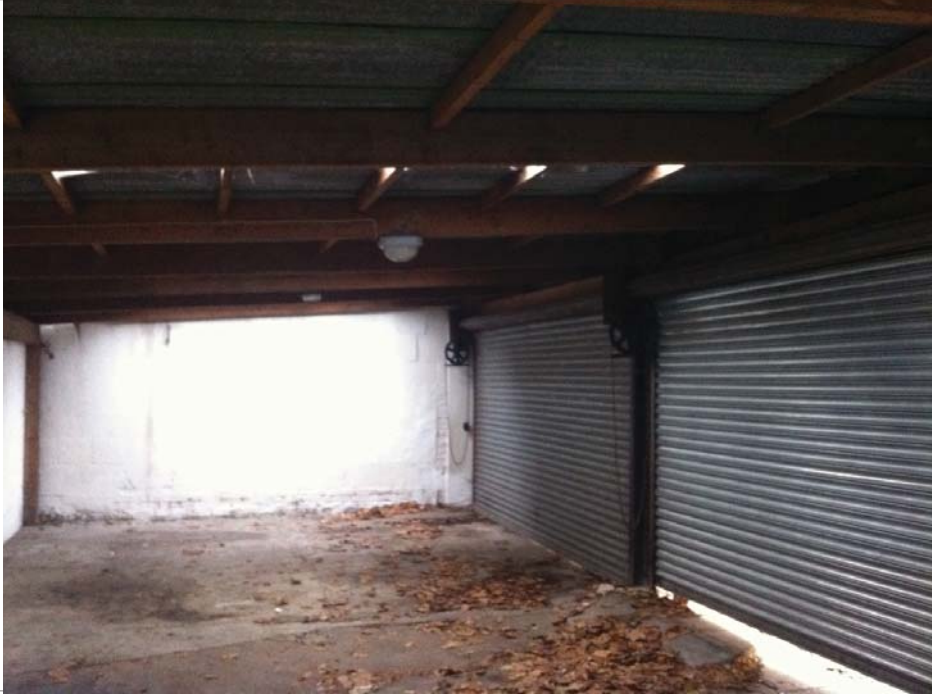
Photograph 2

- the south-facing eave; this is attached approximately 6-10cm away from the wall.
- 4.7. The interior of the building is very draughty and has a cool and exposed interior microclimate. The transparent roof panels create a very light interior. The building is in constant use as a garage and is heavily disturbed.
  - 4.8. There is no evidence of bat activity associated with any part of the building and no birds' nests were recorded within the building.
  - 4.9. There are areas of vegetation in close proximity to the south of the building, including two semi-mature trees and cypress and laurel trees. The semi-mature trees do not contain any bat roosting opportunities, but along with the hedgerows provide nesting opportunities for birds.

Interior of garage
