| Document Title: | Arboricultural Method Statement |
| Project Title | Proposed Development - Colliers Way, Tilehurst |

| Document Title: | Arboricultural Implications Assessment - initial tree survey |

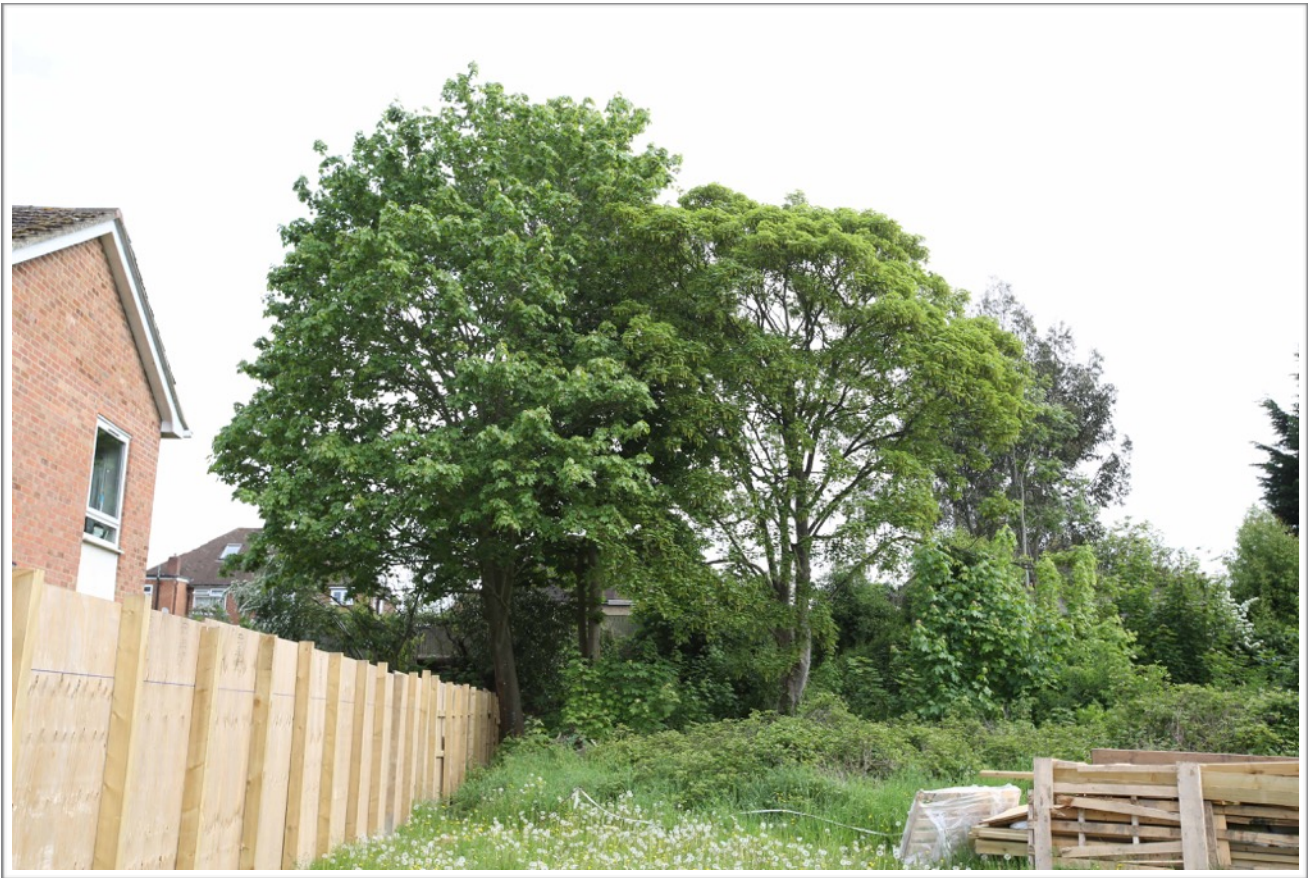
Of these removal both are category C1 having been downgraded due to their condition and limited useful life expectancy.

*Photographic plate showing T540 and T541, which should be removed due to their declining condition.*

6.1.1 In undertaking the development as indicated on the proposed plans a number no trees require direct removal however two should be removed due to their condition.

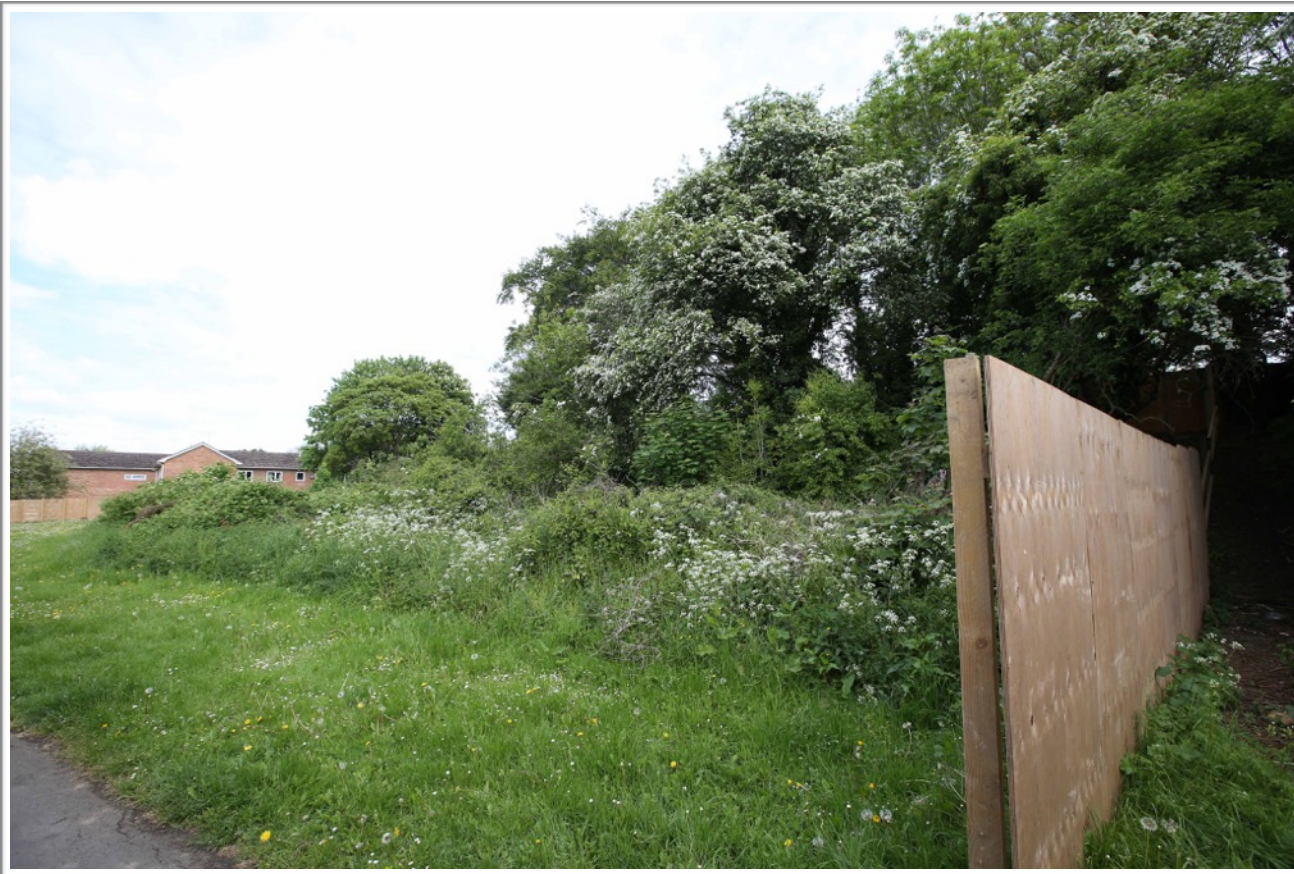
*Photographic plate showing Group G4 and the newly erected boundary fencing.*

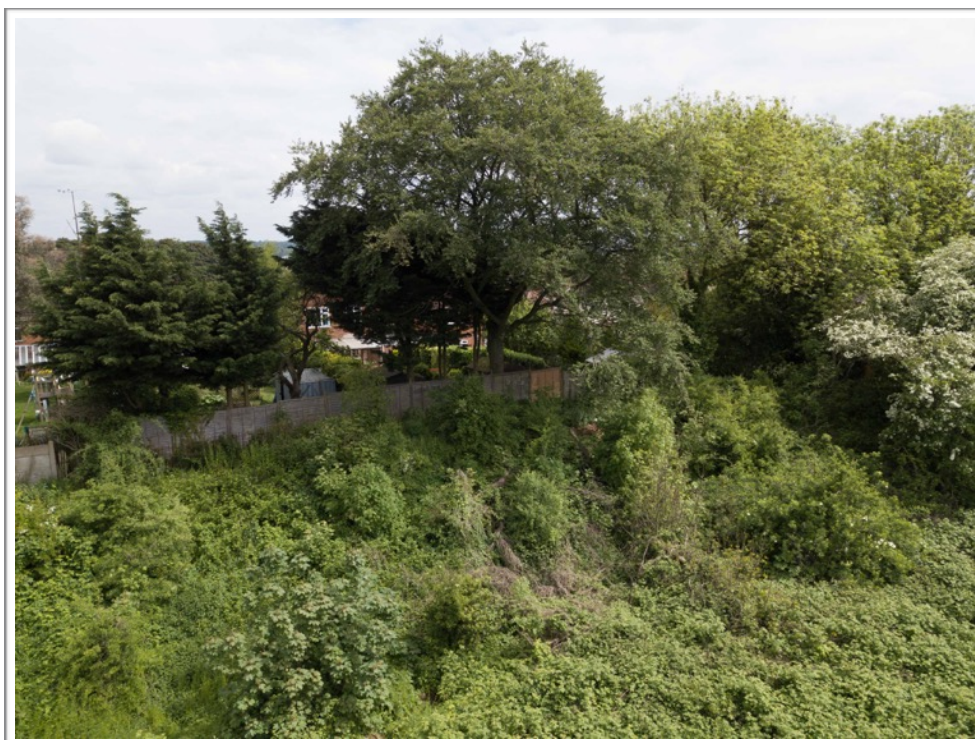
*Photographic plate showing the offsite section of G1, trees within the rear gardens of residential accommodation.*

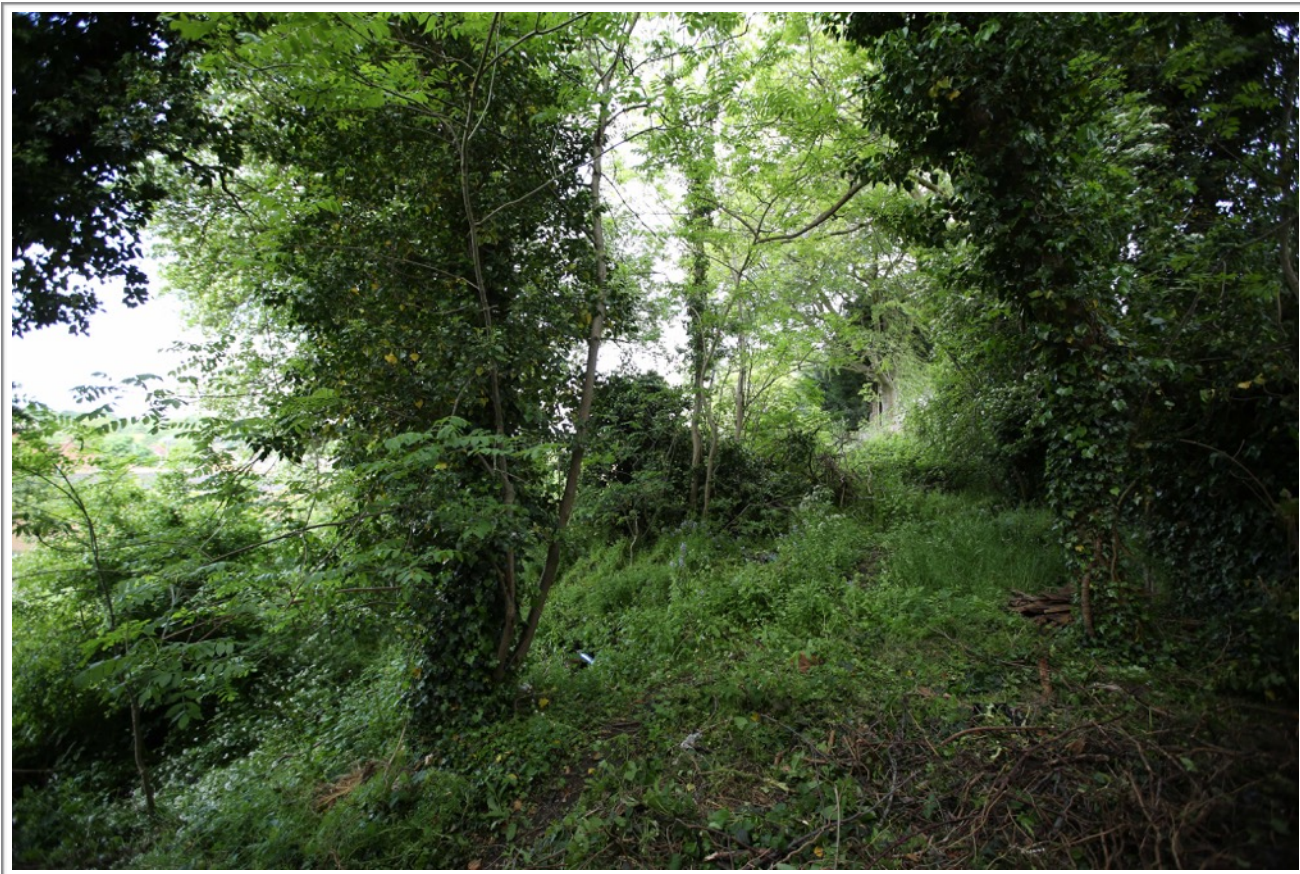
*Photographic plate showing the internal make up of the onsite section of Group G1, comprises several small forest growth form stems of poor structure and form.*

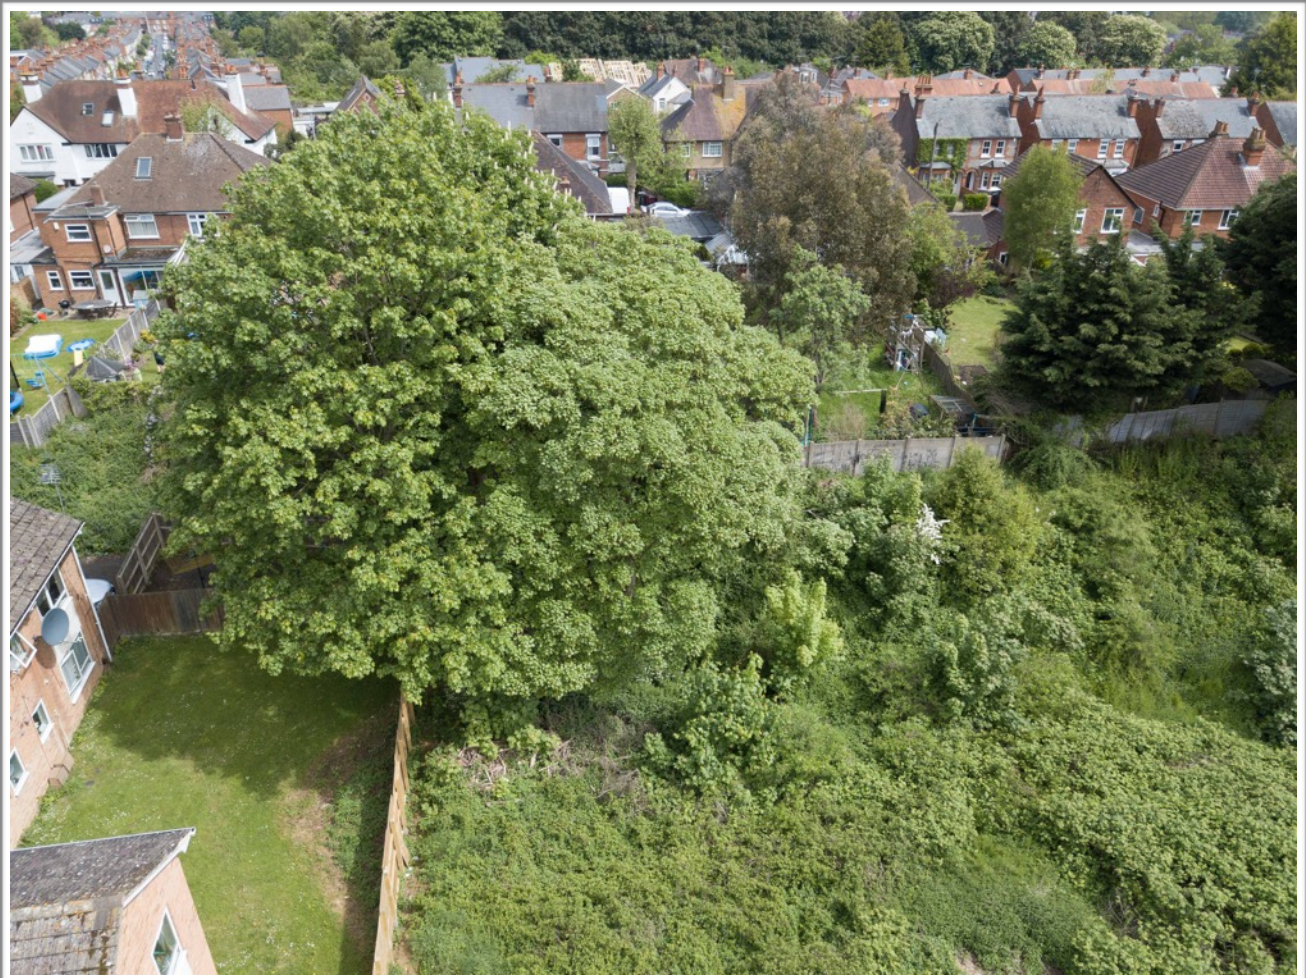
*Photographic plate showing T540 and T541.*

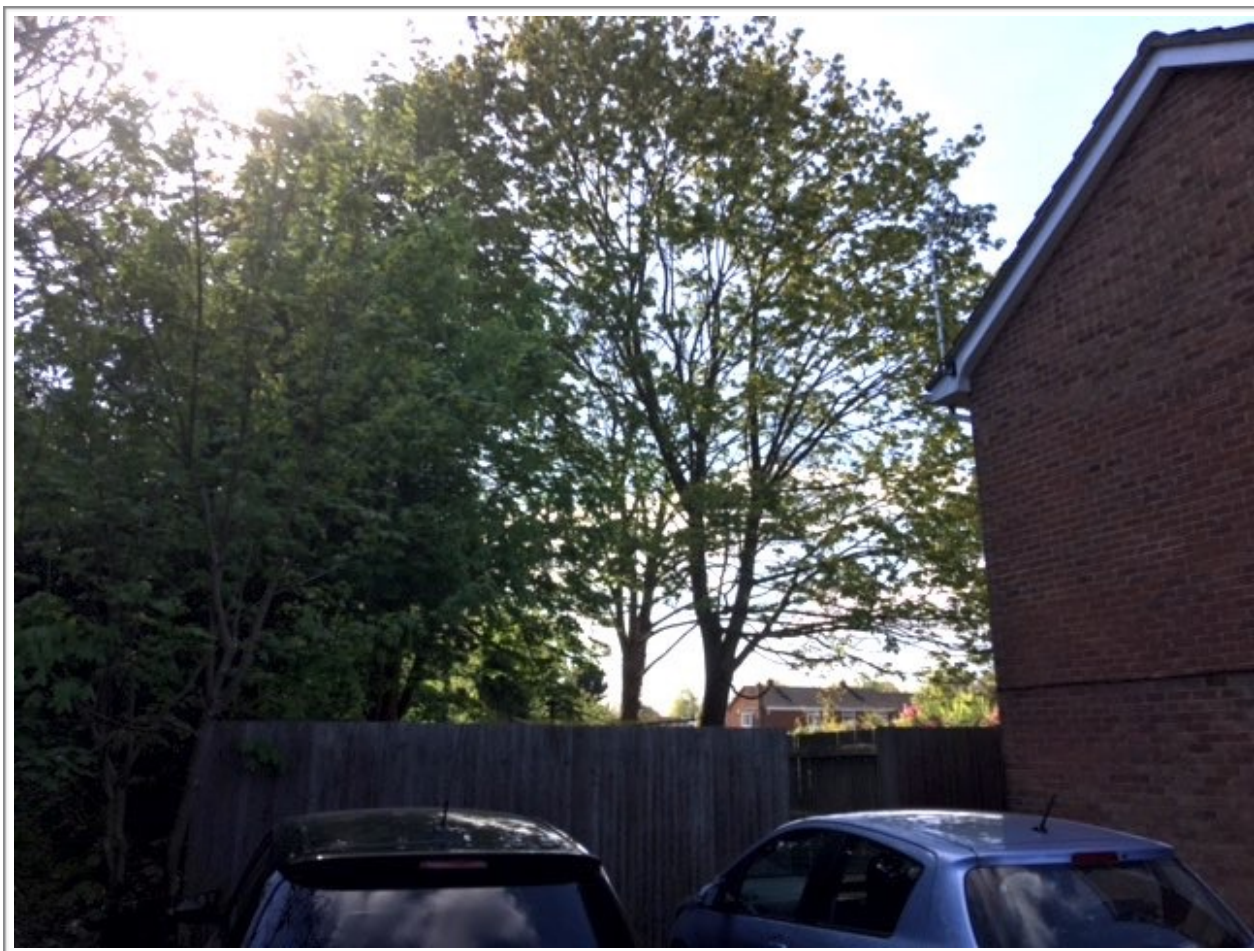
*Photographic plate showing trees T1 and T2 viewed from the carpark of Thorpe House*

- 4.4 T1 and T2 are located toward the northern extent of the site close to the built footprint. T1 is a mature Norway Maple with a crown spread of some 14m. The tree is in an overall fair condition but has been downgraded due to the thin asymmetric crown and lack of overall vitality.

- 4.5 T2 is a mature sycamore in poor condition. It is located near to the built footprint but further south than T1. The tree has very low vitality and a stag headed crown. We suspect there maybe a fungal pathogen present. The tree has a limited useful life expectancy and has been downgraded accordingly.

- 5.1 Some light pruning works have been recommended in the arboricultural data tables and we have suggested that T2 (00541) may require removal on safety grounds.
- 5.2 Trees T1 and T2 may require removal to facilitate any new construction to the south of the existing footprint as it would prove problematic to avoid the suggested root protection areas. No plans have been provided to us at this stage and given the limited useful life expectancy of these stems we can not see any valid objection on arboricultural grounds providing that the loss is mitigated for with some new robust, diverse and sustainable tree cover.

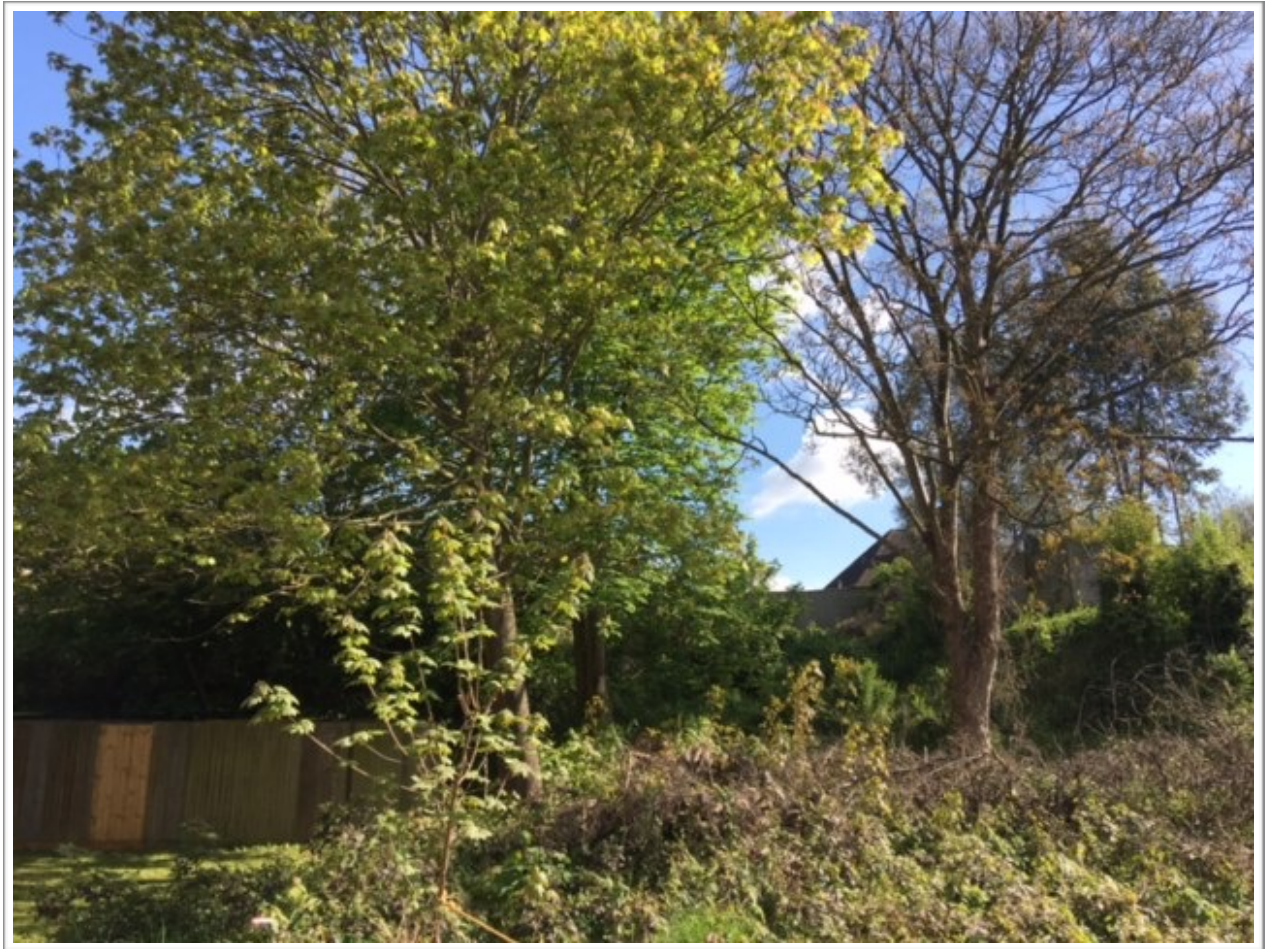
*Photographic plate showing trees T1 and T2 viewed from the rear of Thorpe House (T2 to the right)*

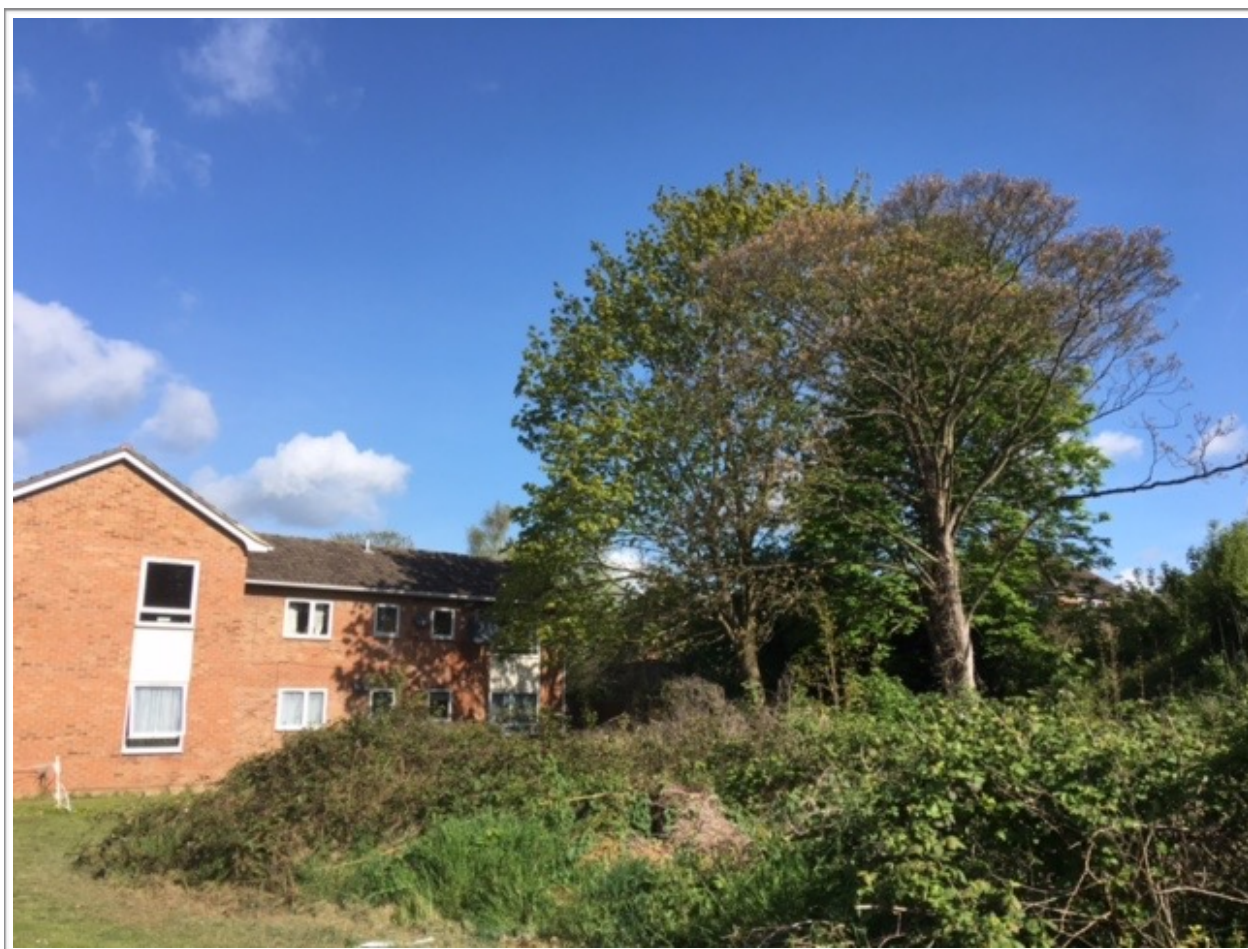
*Photographic plate showing trees T1 and T2 viewed from the rear of Thorpe House (T2 to the right)*

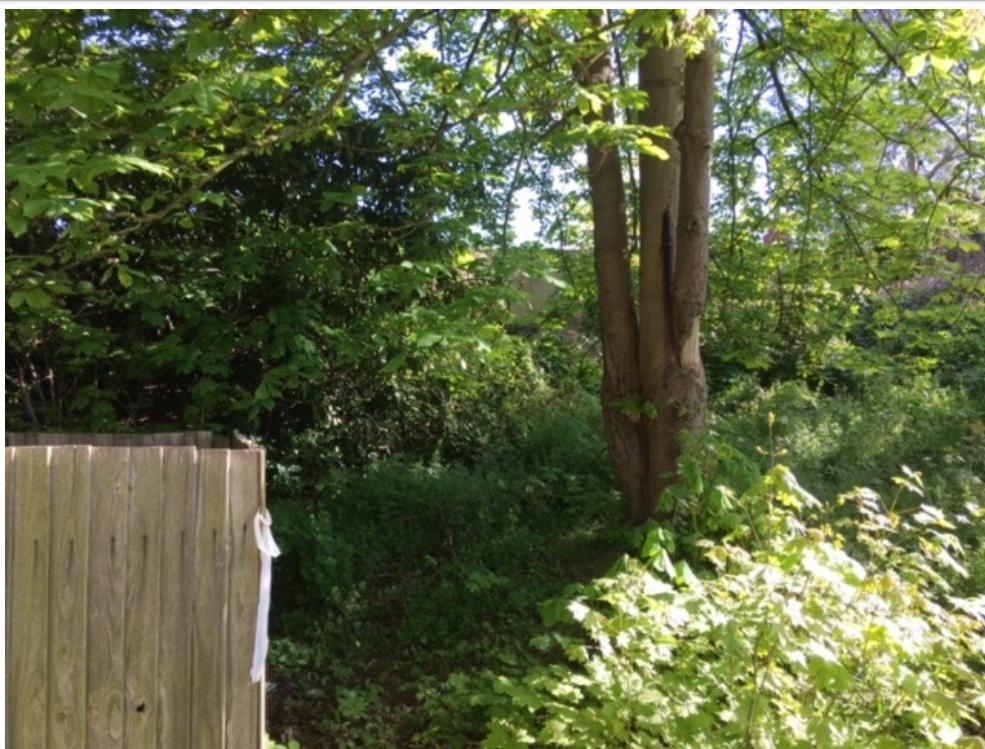
- 6.1 Tree cover at the site provides an important screening function and adds to a degree of seclusion when transiting from north to south on the footpath.
- 6.2 Trees T1 and T2 tagged 00540 and 00541 will most likely require removal to facilitate any new development. We would not object to this providing new robust planting is offered in mitigation.
- 6.3 The remaining three protected trees and also the band of un-surveyed vegetation will likely remain outside any development footprint and would be protected behind appropriate tree protection fencing.
- 6.4 A single horse chestnut sits adjacent to T1 and T2 slightly to the north. This tree is in very poor condition and although outside the scope of this survey should be felled for safety.

*Photographic plate showing  
tree referred to at 6.4*
