## Arboricultural Impact Assessment

Moorlands Primary School  
Church End Lane  
Tilehurst  
Reading  
Berkshire RG30 4UN

Survey Dates: 1<sup>st</sup> December 2016  
Report Date: 23<sup>rd</sup> January 2018  
Project no: 771

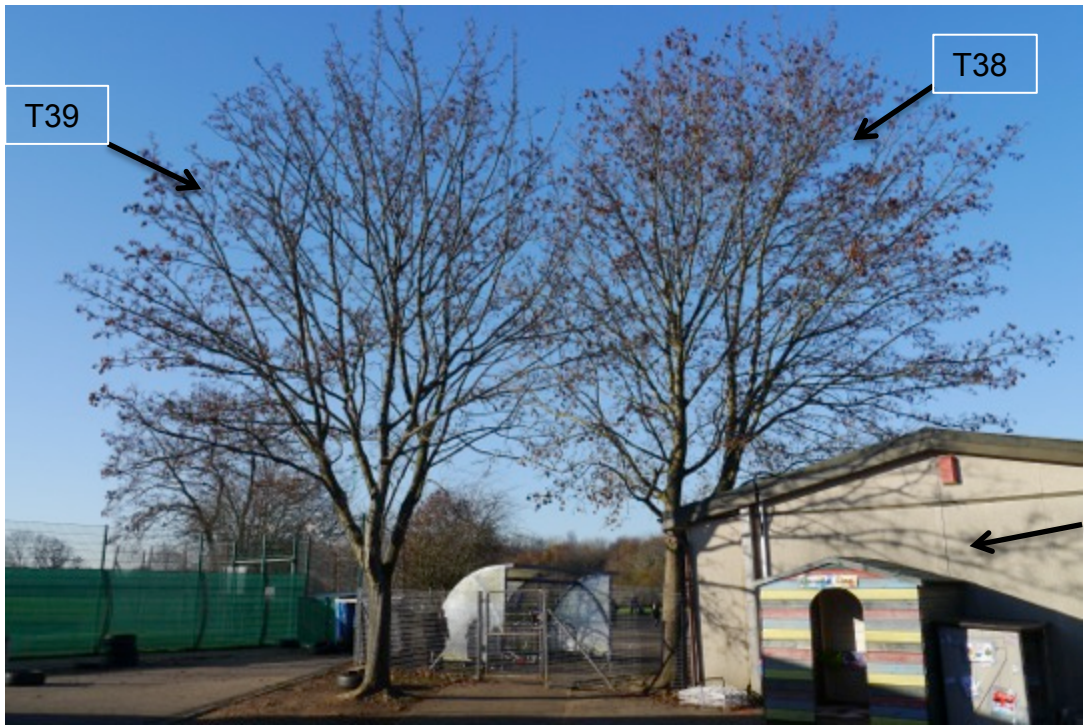
Existing modular classroom to be demolished.

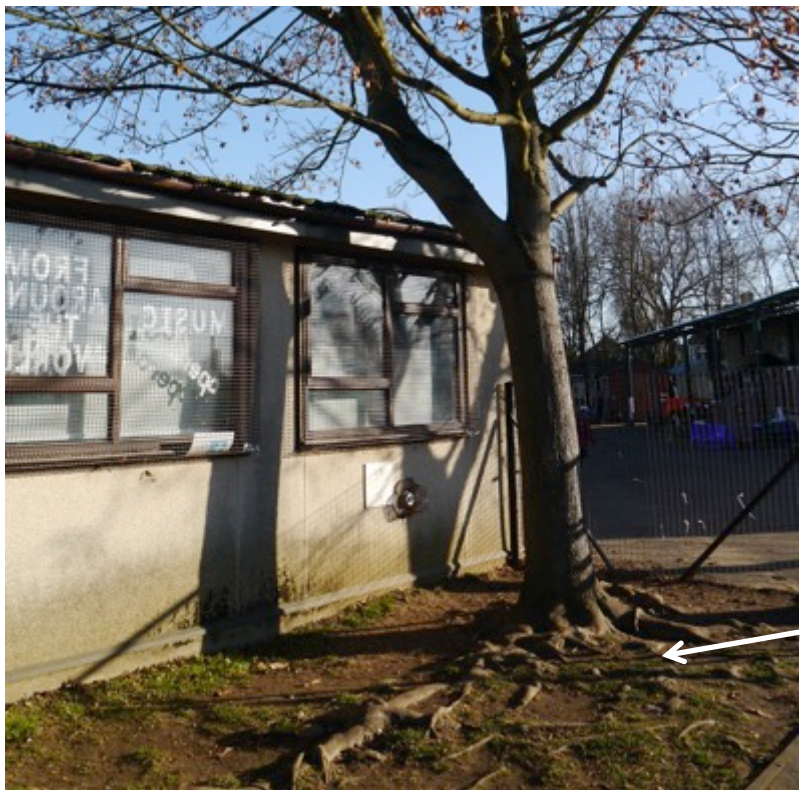
Compacted area around base of T38. A new astro turf surface is proposed over this area.

- 5.6.2 Following demolition of the existing modular classroom within the Root Protection Area of the Norway maple, T38, an excavator must only be used for the removal of the hard surfacing to the west and south sides of the tree, and the floor slab and/or foundations of the classroom, if it can work only from areas of hardstanding, or from outside the Root Protection Area. A banksman must be present during this operation and excavation must go no deeper than the existing base course and must cease immediately if roots are found. Once the hard surfacing and any building foundations have been removed, immediately either:
