## **THAMES VALLEY SCHOOL, READING.**

### **Arboricultural Impact Assessment & Method Statement report ref 117 01 11**

**Report by:** Steve Russell BSc (Hons)

**Date:** 28th December 2017

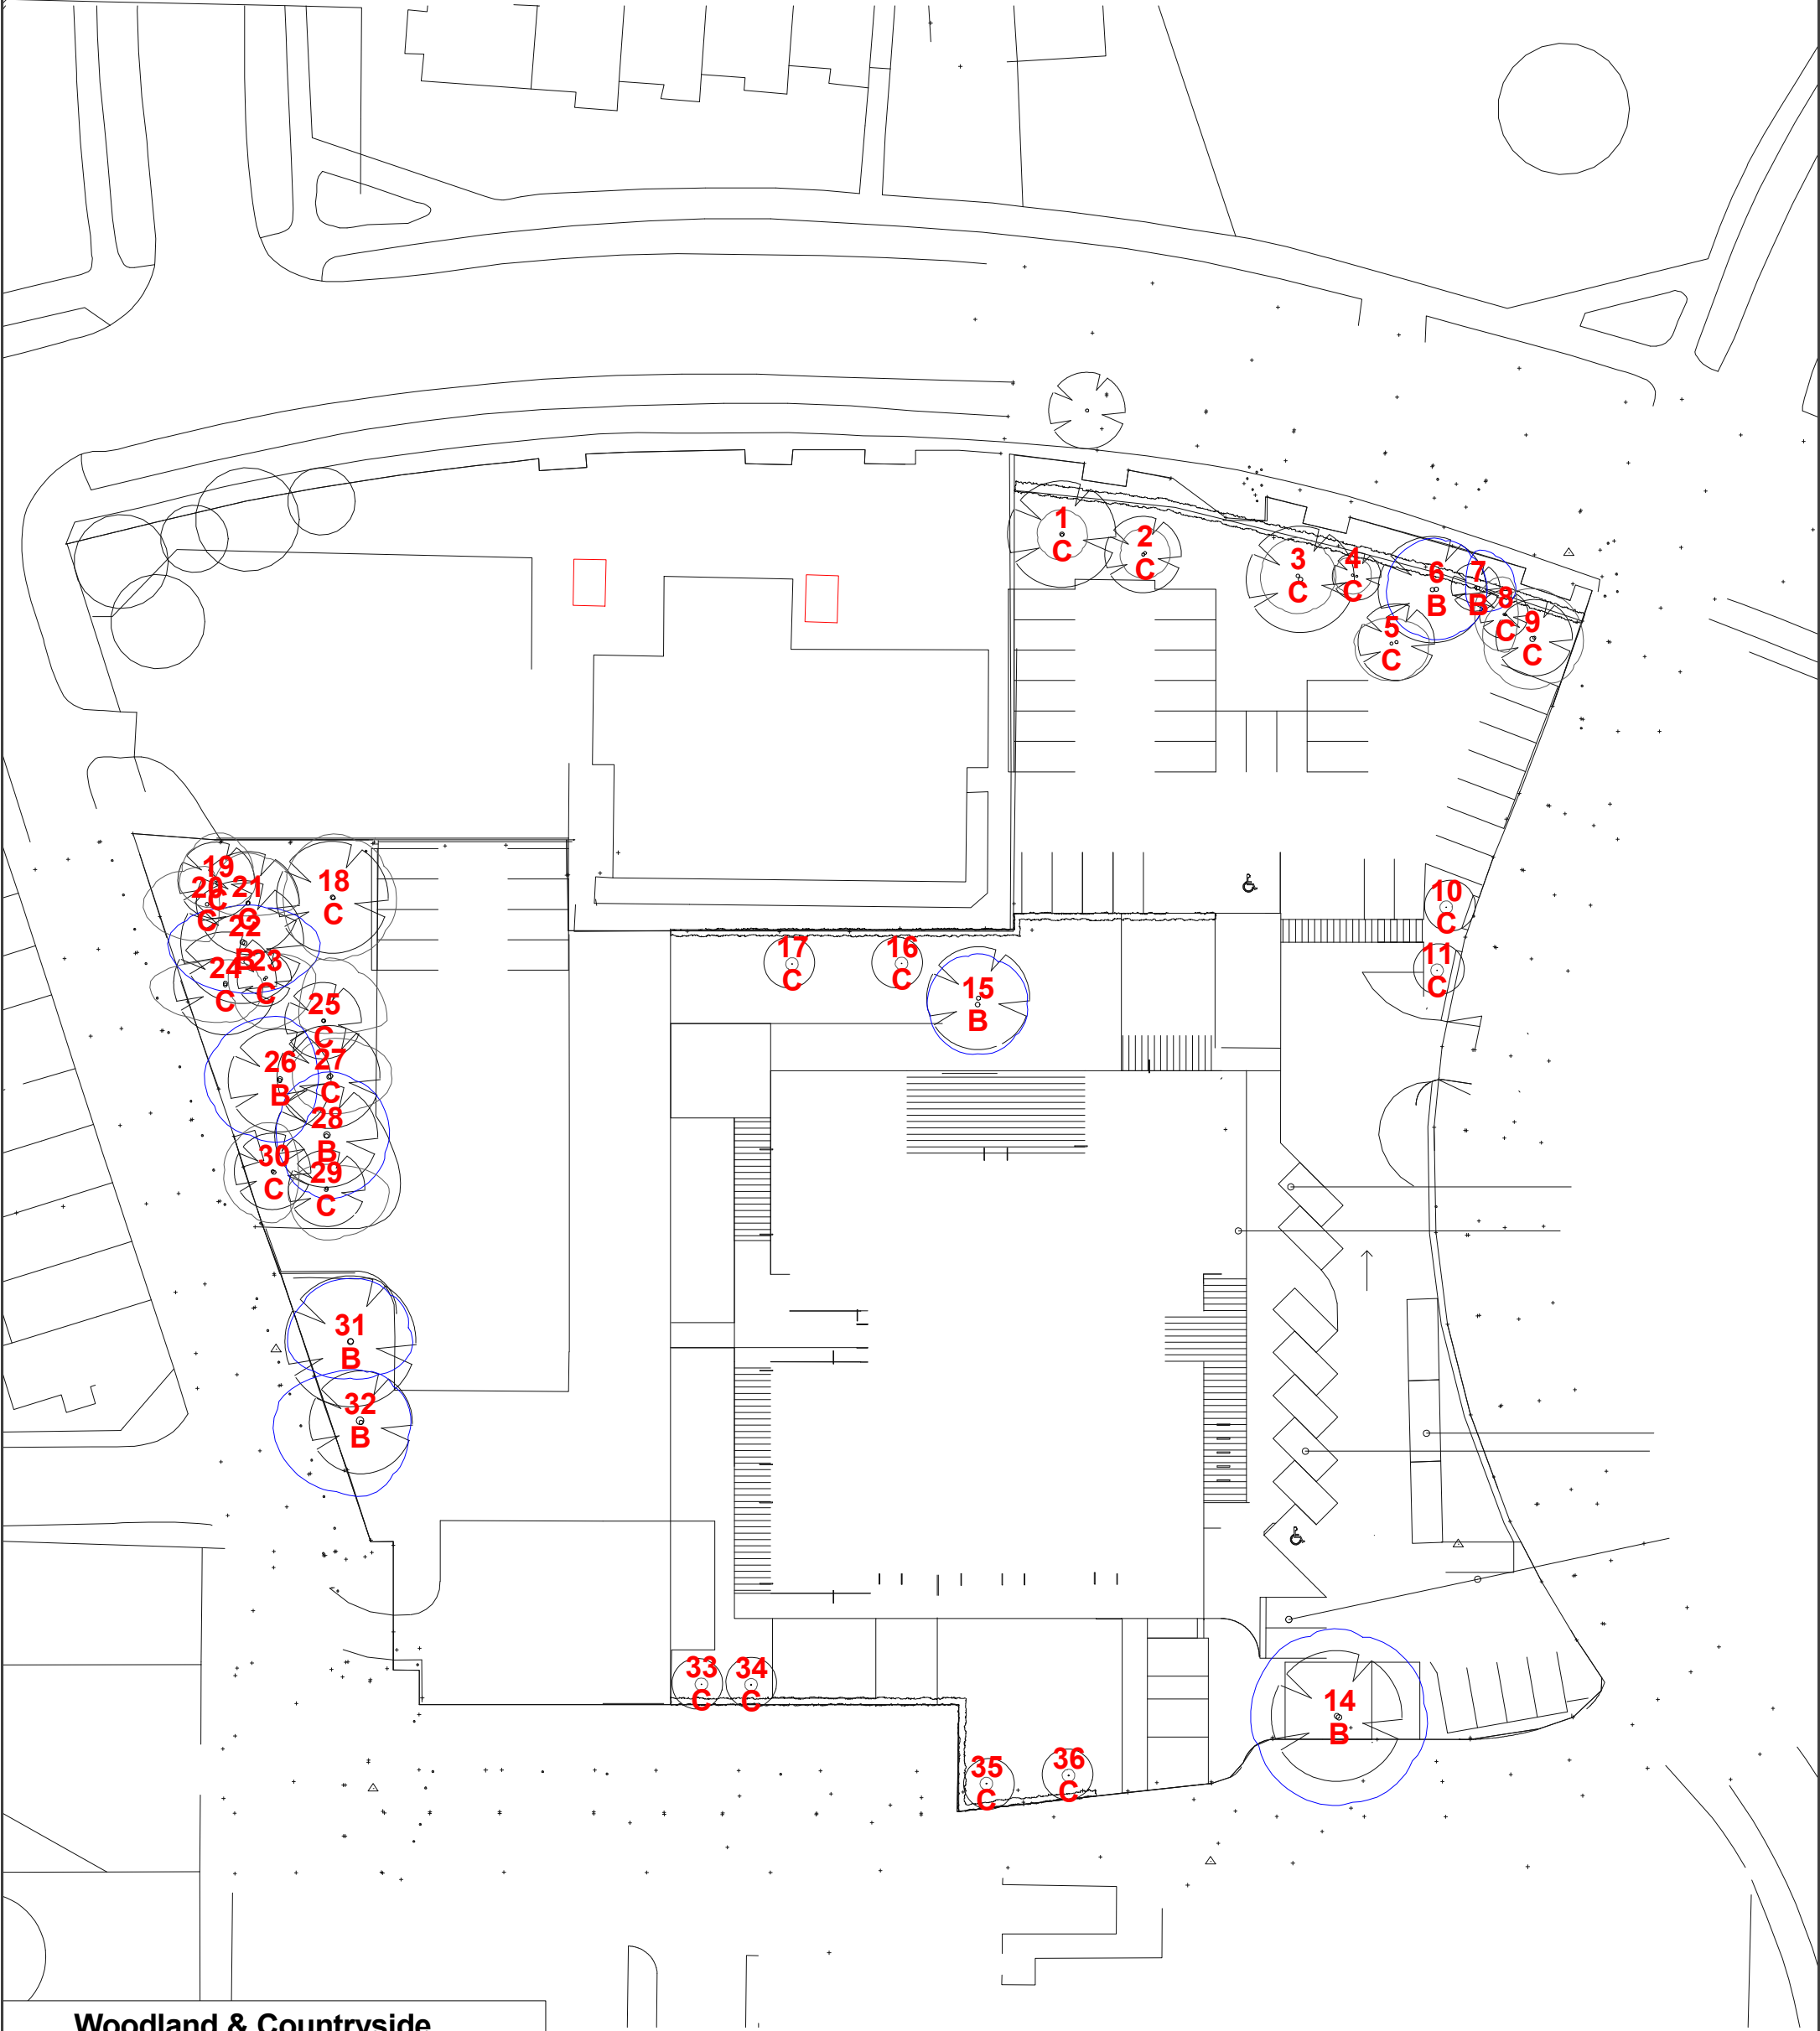
PLAN TITLE: RETAINED TREE  
PLAN REF: WCM/SSR/DS/SC/TVS/RTP/1

Any development should be made based on the primary assumption that there is no disturbance within the RPA's of the retained trees, particularly those of categories A and B. 36 trees were identified, 8 being category B and the remaining 28 being Category C. The majority of the trees are plantings associated with the earlier development of the site with trees around 30 years old. To enable the increased parking associated with the proposal two trees will need to be removed, these are as follows:

Tree 12, Common Hornbeam, *Carpinus betulus*, Young/Recently planted, in good condition.  
Tree 13, Holm Oak, *Quercus ilex*, Young/Recently planted, in good condition.

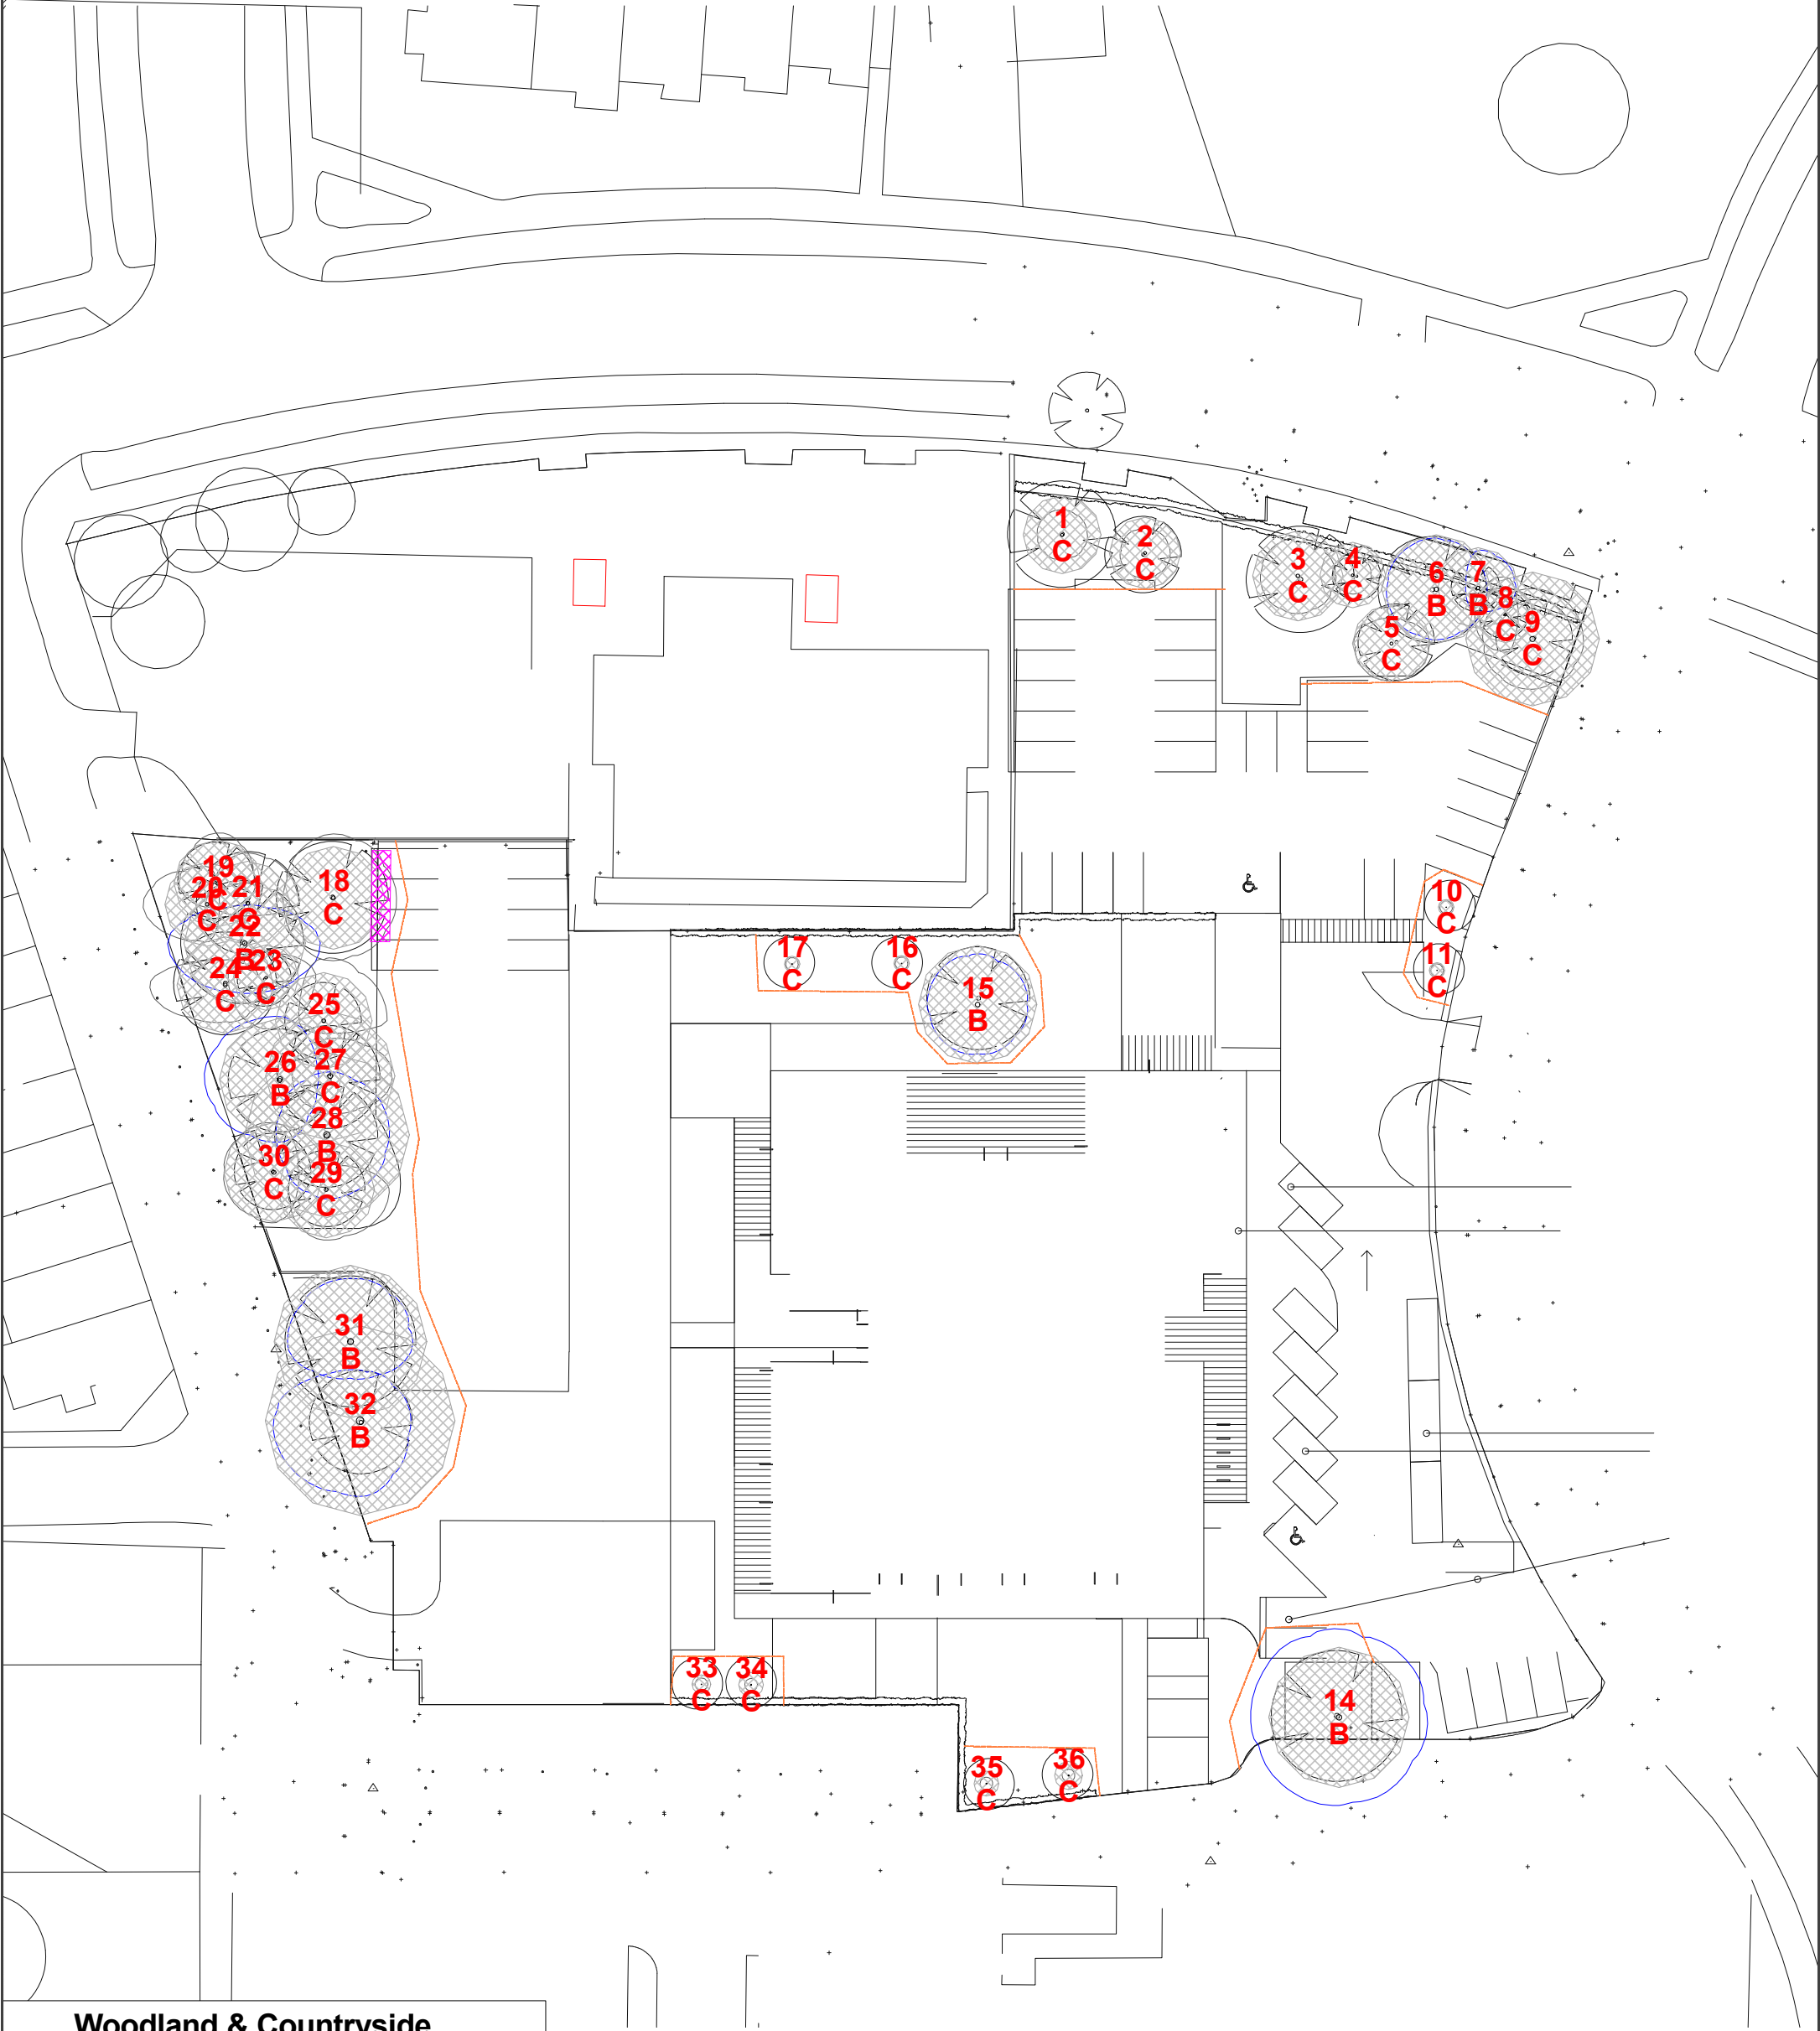
PLAN TITLE: TREE PROTECTION  
PLAN REF: WCM/SSR/DS/SC/TVS/TP/1

The proposed development in the most part has no impact on the RPA's of the retained trees. Where the parking bays impact on RPA of tree 18, the construction will be designed and constructed to have the minimum impact on the retained trees and will require a 'non dig' solution. This will be in line with BS5837 2012 Section 7.4 and guided by Arboricultural Practice Note No 12 'Through the Trees to Development'. Construction to protect the RPA

will be of a proprietary cellular confinement system that will allow water and gas movement, will provide load spreading to avoid compaction and will require no excavation to the existing surface e.g. the Cellweb TRP® Cellular Confinement System. Effective edge retention will be custom designed to avoid any significant excavation into existing soil levels being pre-formed edging secured by metal pins. Final details of the construction will be supplied by the selected system engineer. The area impacted is indicated on the Tree Protection Plan (Appendix 8).

Due to the location of the retained trees and the phase one proposals, it is unlikely that the majority of trees will be impacted or affected in any way, however Protection fencing has been proposed to ensure all trees are protected. The siting of protection fencing has been designed to provide maximum protection during the main development. The tree protection fencing is to be erected prior to the start of any on-site works, this will be retained and maintained for the full duration of the construction works, but will need to be moved away to enable the final construction of a number of parking bays which will be carried out as the final works.

BS5837 (2012) states that where protective barriers are used these should be fit for purpose, BS5837 (2012) section 6.2.2 sets out the default position, however it also states in 6.2.2.3 that 'where the site circumstances and associated risk do not necessitate the default position, an alternative specification should be prepared and agreed by the local planning authority'. Due to the nature of the site and the limited amount of fencing required, it is proposed that an above ground stabilising system of protective fence with stabilisers in block trays as per Figure 3b of BS5837 (2012) will be used (Appendix 7). The protective fencing will be erected as per the Tree Protection Plan (Appendix 8), and where meeting the boundary of the site will link to the existing boundary features to create a fully enclosed protection area.
