# Heritage / Design and Access Statement – 68 Broad Street, Reading, RG1 7QE

## I.0 Assessment of Heritage Significance

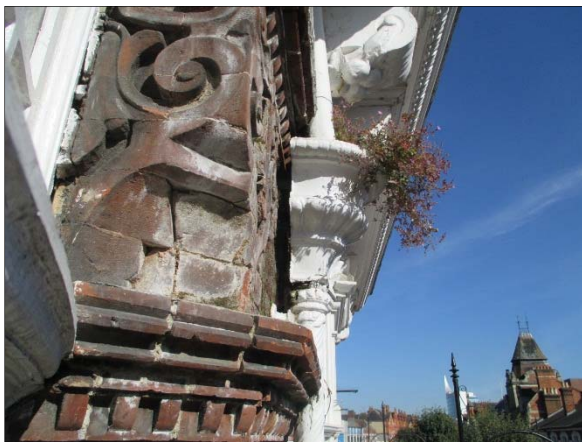
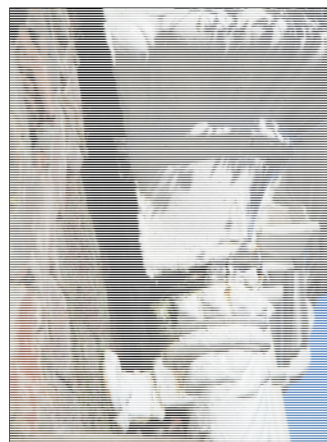
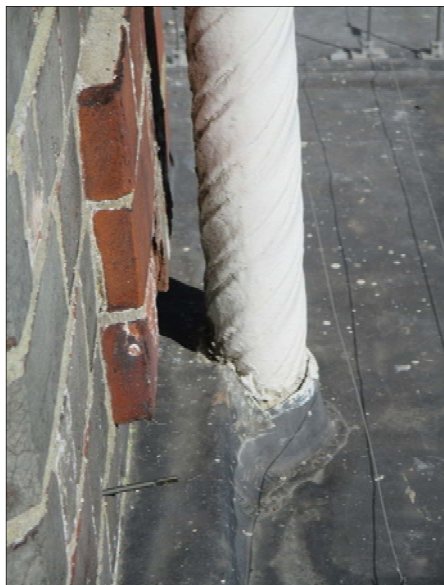
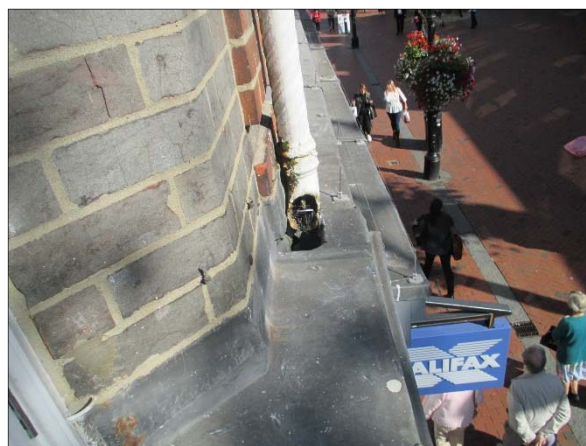
- Repair works to rainwater goods.
  - o It is intended that the cast iron sections of downpipe and the hopper to the front elevation are removed for inspection, cleaning and repair. It is unknown at this stage if the sections are in suitable condition to re-fix to the building or if replacement will be required. Should replacement be required then either salvaged or new heritage style cast down pipes will be used in conjunction with gaining approval from the conservation office for the replacement required. **IMPACT LOW**

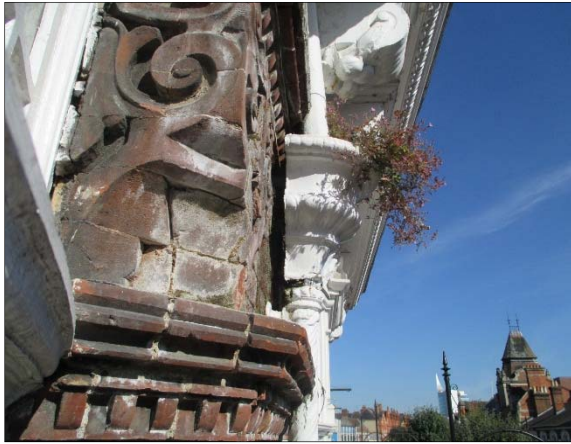
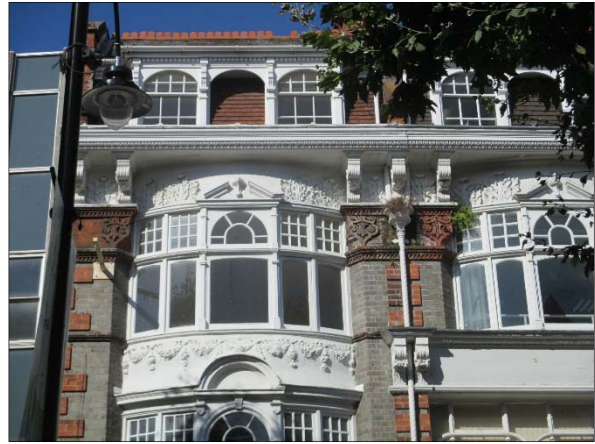
- Mortar and brickwork repairs.
  - o The mortar and brickwork to the rear of the cast iron down pipe is deteriorated in sections with some joints washed out and vegetation growth present. The repairs are to repoint the damaged mortar joints with a traditional lime mortar. With removal of the vegetation and washing down with a fungicidal wash. **IMPACT NEGLIGIBLE**
