**Design and Access Statement & Heritage/Archaeology Statement for:  
Proposed Brickwork repairs and General Maintenance**  
(To be read in conjunction with Drawings & Documentation)

**Battle Primary School, Cranbury Road, Reading, RG30 2TD**

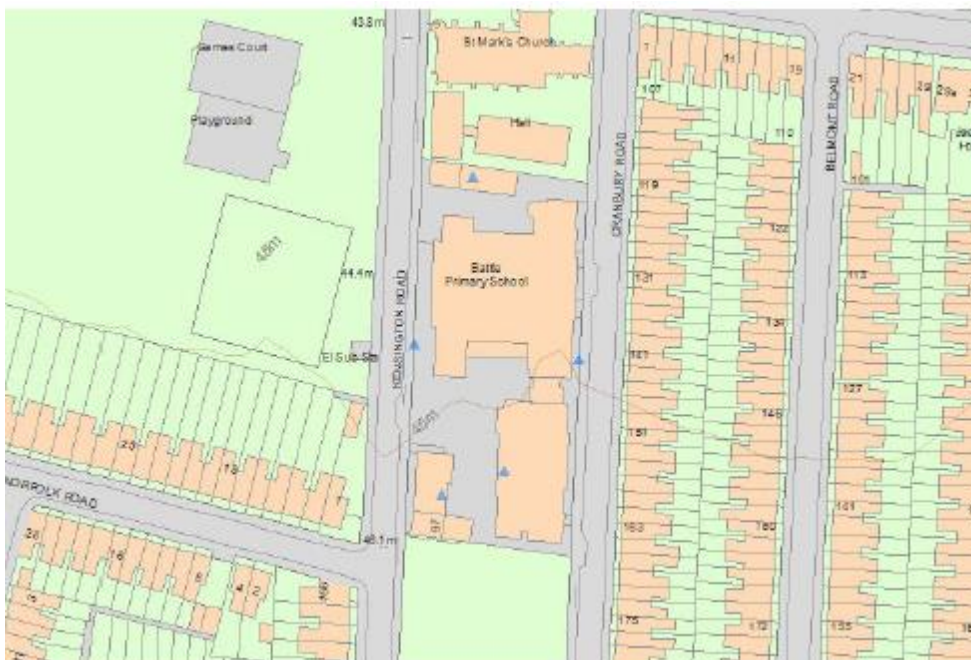
External Materials are Red Brick with clay roof tiles. Queen Anne style with much moulded brickwork, shaped gables and dormers, tall ridged and corbelled chimney stacks and multi-pane sash and casement windows of painted timber (many now replaced with modern double glazed units). The two-school unified east elevations to Cranberry road each having a tall stepped and shaped gable in centre bays, flanked by recessed outer bays with lower pedimented gables and dormers, the latter having finely-moulded brick dentil courses. Northern return elevation has curved brick plaque bearing the date 1903, adjoining a raised pedimented doorway accessed via steps with ornamental railings; behind this is a half-octagonal projecting block overlooking rear playground. Upper school's west elevation to Kensington road has three tall scrolled and shaped half dormers flanked by recessed wings with triangular gables. Tall square chimney to rear of upper school, acting as exhaust and intake for 'plenum' ventilation system: three pilastered stages and octagonal louvred belfry-like top with pyramidal roof.
