**DESIGN AND ACCESS STATEMENT**

**HIGHDOWN SCHOOL & SIXTH FORM CENTRE**

**REINSTATEMENT OF PLASTER FOLLOWING EXTENSIVE TIMBER REPAIRS TO THE  
UPPER FLOOR OF THE MANOR HOUSE**

**REPLACEMENT OF TILED ROOF COVERINGS TO “T” CLASSROOM**

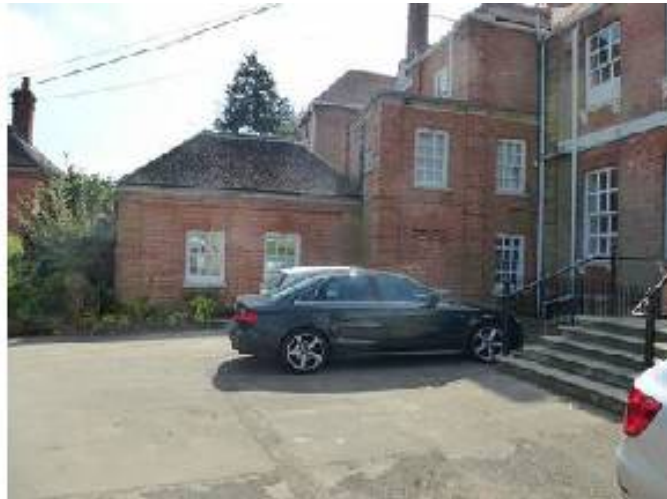
"T" CLASSROOM

At ground floor level, a single storey classroom structure to the front of the Manor House, called "T" Classroom, is of similar architectural design to the Main House having a mansard structure with tiled and pitched coverings on 4 elevations, and upper flat lead covered area with a timber monitor rooflight. The leadwork has been over-coated with a hessian membrane and bitumen application along the lines of a turnerising technique. These repairs have since broken down and the elderly lead coverings remain intact beneath, but the roof leaks are causing damage to internal finishes.

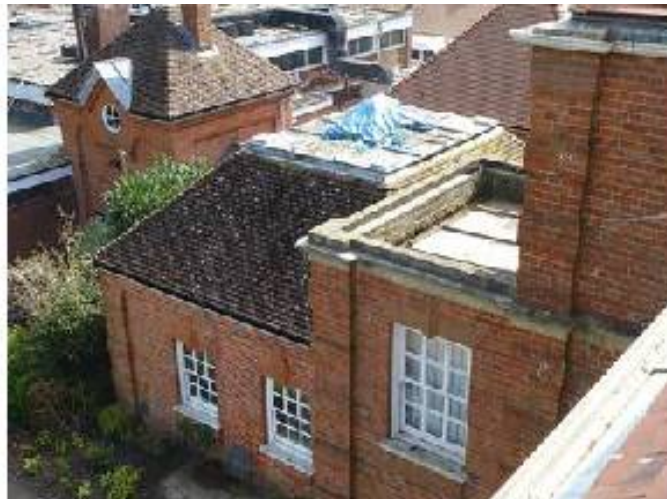
"T" CLASSROOM FOOF

The tiled roof slopes are in particularly poor condition suffering significant corrosion of nails resulting in roof tiles coming loose. This is presenting an imminent Health and Safety hazard for use of the building and adjacent pathways.

The tiled roof coverings are in very poor condition, comprising play clay peg tiles which are in excess of 100 years old. There are numerous slipped and cracked tiles, which is an ongoing maintenance issue for the School. Evidence gained during recent major roof renovation works on the Main House revealed that tiles are not salvageable due to majority being beyond further use. Tiles were found to be cracked due to rusting of the nail fixings and battens are too slender to adequately carry weight. We propose, therefore, to strip roof coverings and replace these with a similar new play clay tile to that used on the main roof comprising a Phalempin Vintage plain clay nib roofing tile.

The roof coverings are in a poor condition as experienced from works on the main roof and replace roof tiles on a similar basis with new breathable felt and battens.

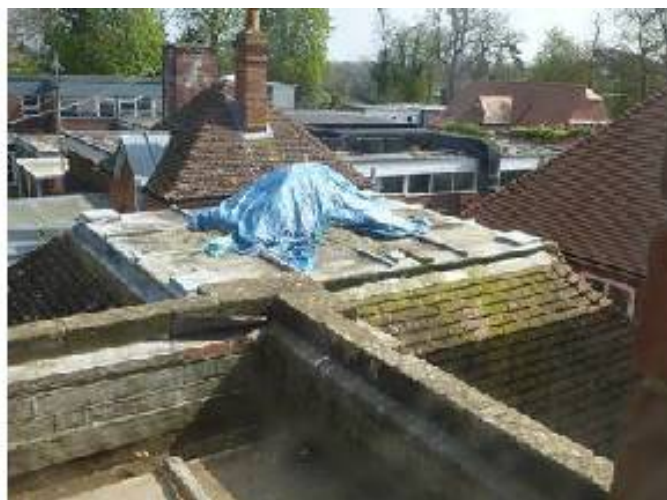
"T" CLASSROOM FLAT ROOF

The timber monitor rooflight has been covered over with tarpaulin and the true condition of this cannot be assessed at the time until access is made available. There are significant leaks occurring, and evidence of timber decay to the main glazing bars visible from the underside.

The timber monitor rooflight is badly decayed and has been covered over with tarpaulin for a number of years as a temporary repair to stop leaking. The full extent of the problem cannot be determined at this time until access is made available to roof level. Reports received from the Caretakers lead us to believe that the roof is possibly beyond economic repair. The rooflight serves no function for the room in use, and it is the wish of the School that this be removed and the aperture infilled as part of the flat roof structure.

It is proposed to retain the existing lead coverings by cleaning these down back to a sound finish. Whilst they are elderly, we believe they will be in suitable condition to be over-coated with a resin membrane such as Desmopol, to maintain integrity and ensure it remains watertight.

Over-coating of the leadwork will maintain the roof structure and its integrity without adding significant weight.

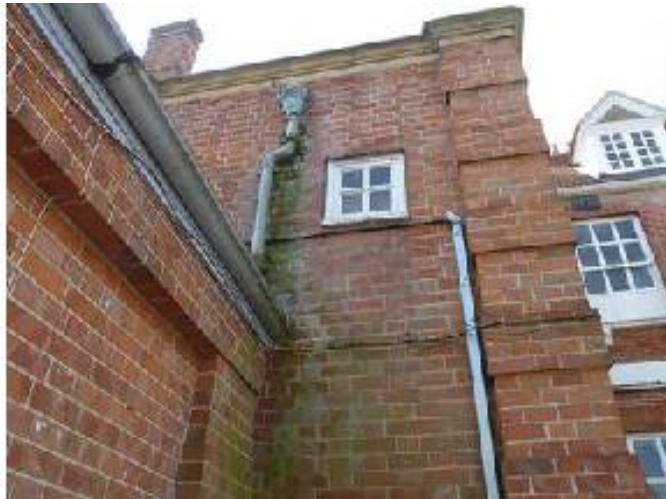
REPAIRS TO RAINWATER GOODS REQUIRED

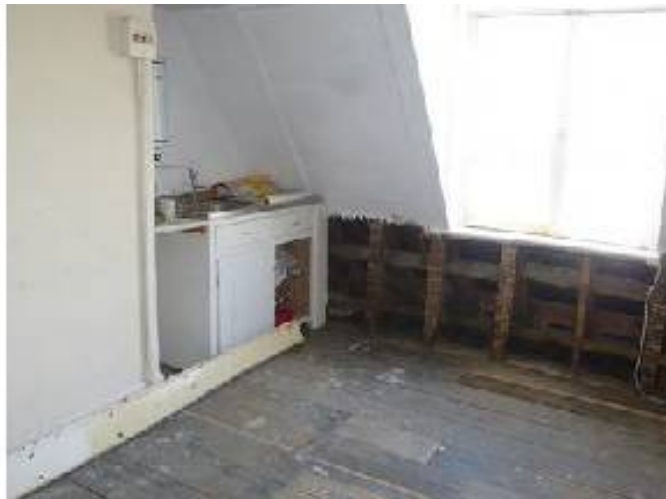
PLASTERWORK

The purpose of the Application is to reinstate finishes following the major structural repairing programme carried out in 2016 under Application 161149. Very little original lath and plasterwork was present due to previous works carried out by Reading Borough Council. Access was required to address timber repairs within the perimeter eaves requiring removal of vertical ashlar plasterwork. This largely comprised plasterboard.

We recommend approval of the work on the basis that any historic lath and plaster was removed some time ago and there is no merit to return it to its original condition. The use of plasterboard would in our mind be an acceptable finish to the upper floor areas.

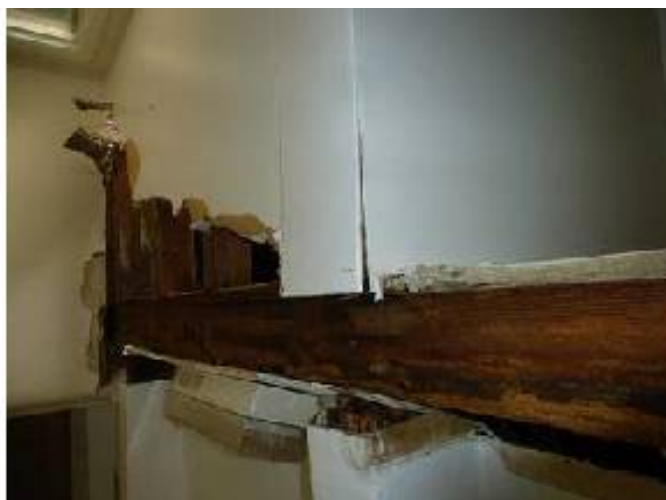
PLASTERWORK TO BEAM REQUIRED

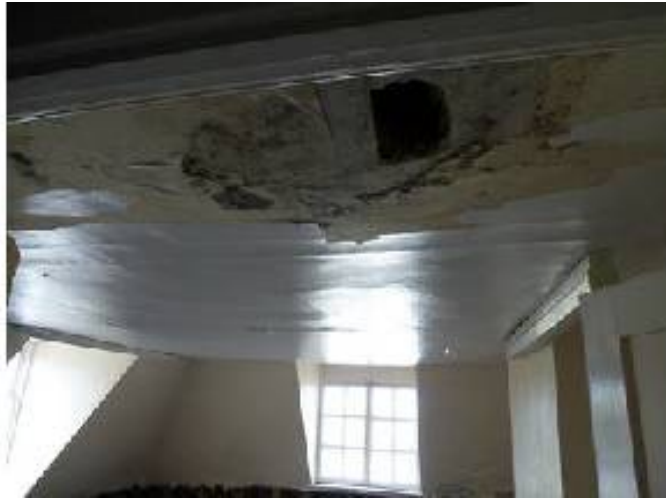
A ceiling within Classroom 01 is in poor condition, partially collapsed due to previous roof leaks and timber decay within timber laths, and requires replacement.

CEILING IN CLASSROOM 01 TO BE REPAIRED OR REPLACED
