Project title    Reading Girls School

Subject        Reading Girls School - Planning Condition 9 Review

**Bat Inspection Reference Map**

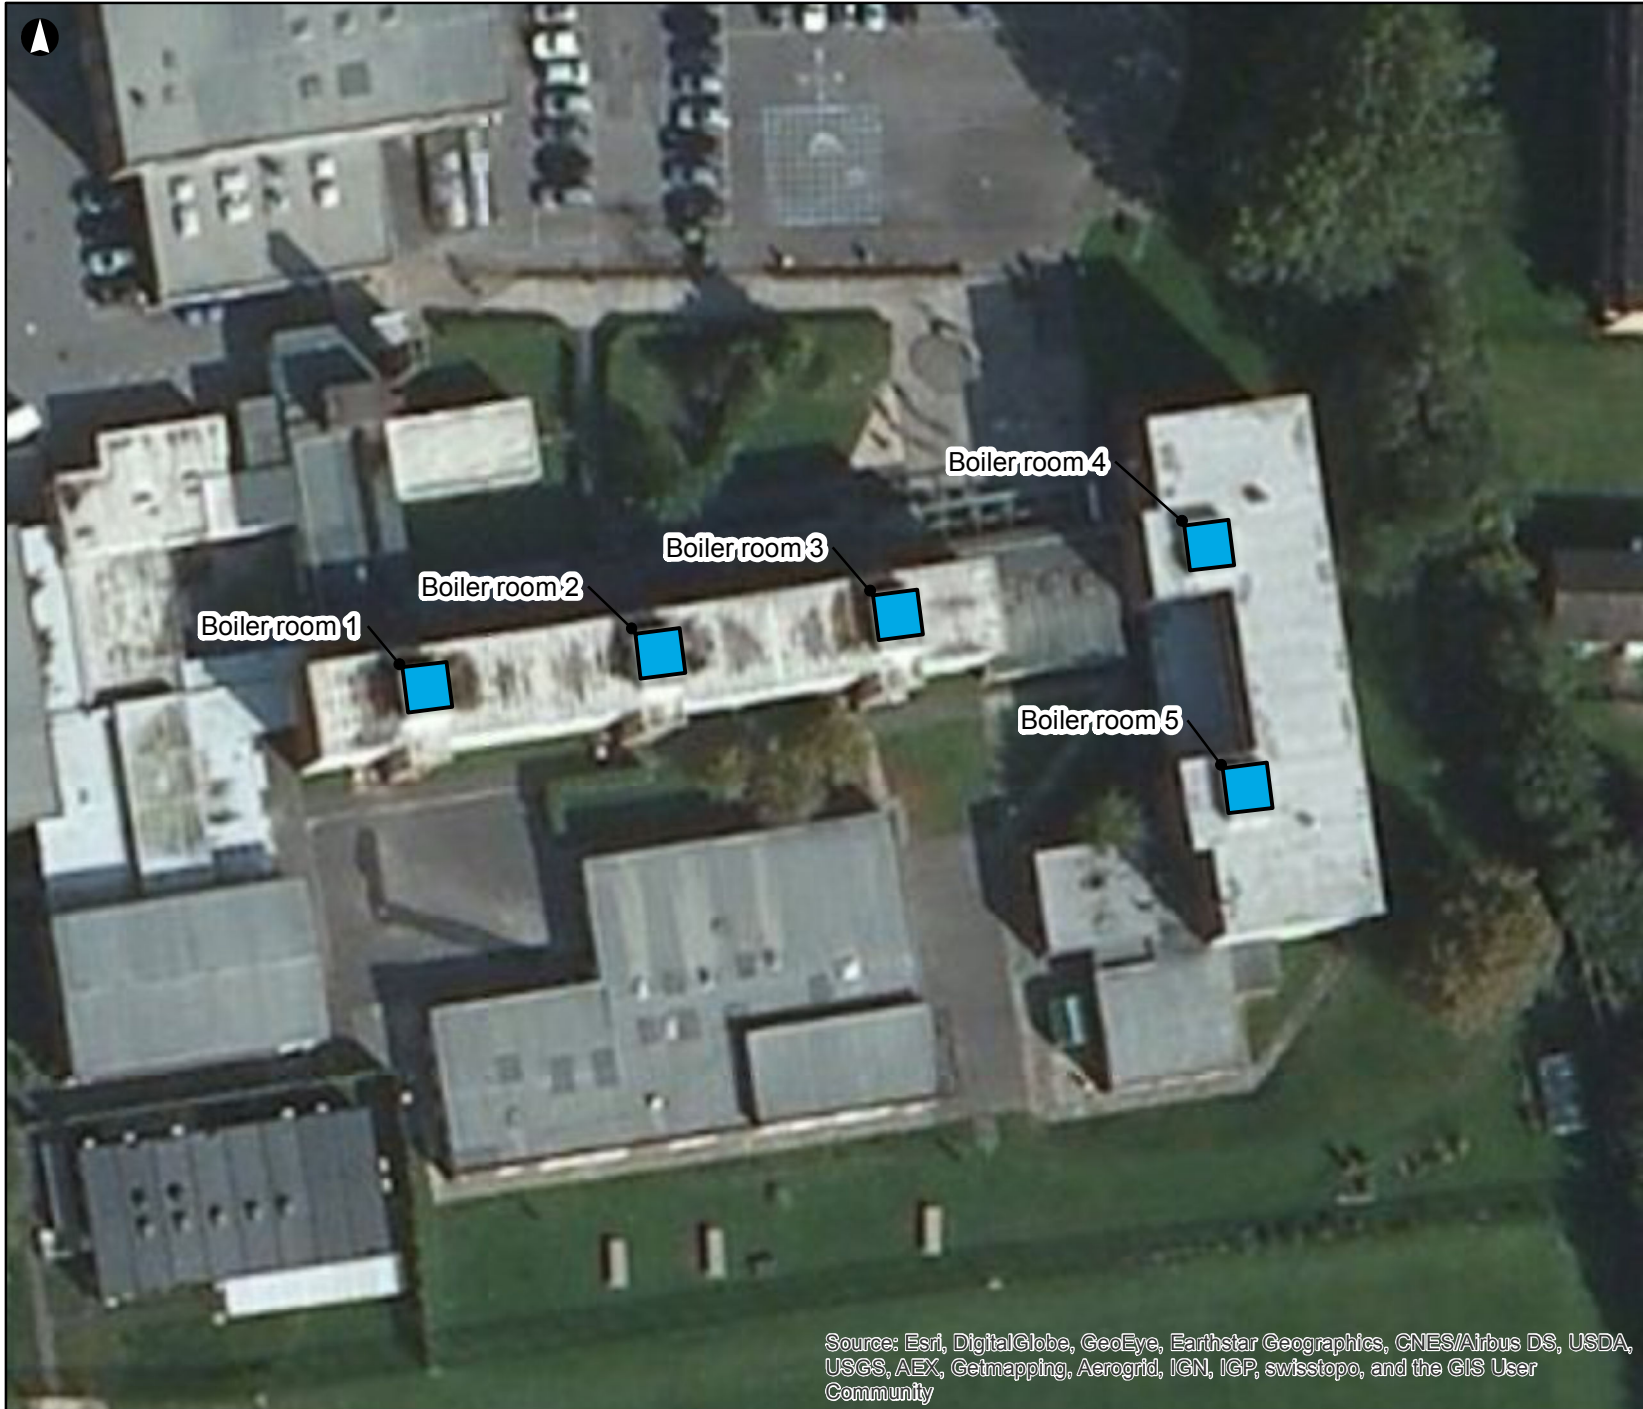
Boiler rooms 1 and 2 were well sealed, lacking any opportunity for bats to enter each room, and demonstrated no evidence of roosting bats within them. Each room also lacked features on the external façades which would be suitable for roosting bats.

A large gap in the eastern external wall of boiler room 3 was recorded, providing a suitable entrance point to the room. However, no evidence of use by roosting bats was recorded within or on the external façade of boiler room 3, with the interior lacking suitable features such as crevices or voids which could be utilised by roosting bats.

The door of boiler room 4 was missing, allowing access to the interior; however, no evidence of bat use was recorded within or on the external façade of the room.

A gap where the door of boiler room 5 had warped was identified, but this room could not be accessed on the date of the inspection, as there was no safe access to this part of the building. The room was therefore assessed from a distance using binoculars with no clear evidence of bat use recorded. In addition to this, as detailed in section 2, no bat activity was recorded in these areas during the earlier emergence and return surveys. Therefore, lack of access to the room is not thought to have significantly impacted the assessment of the building, and bats are not thought to be using this room to roost.
