Project title     HLR – Reading Girls School

2 March 2016

Subject             Reading Girls School – Bat Inspection File Note

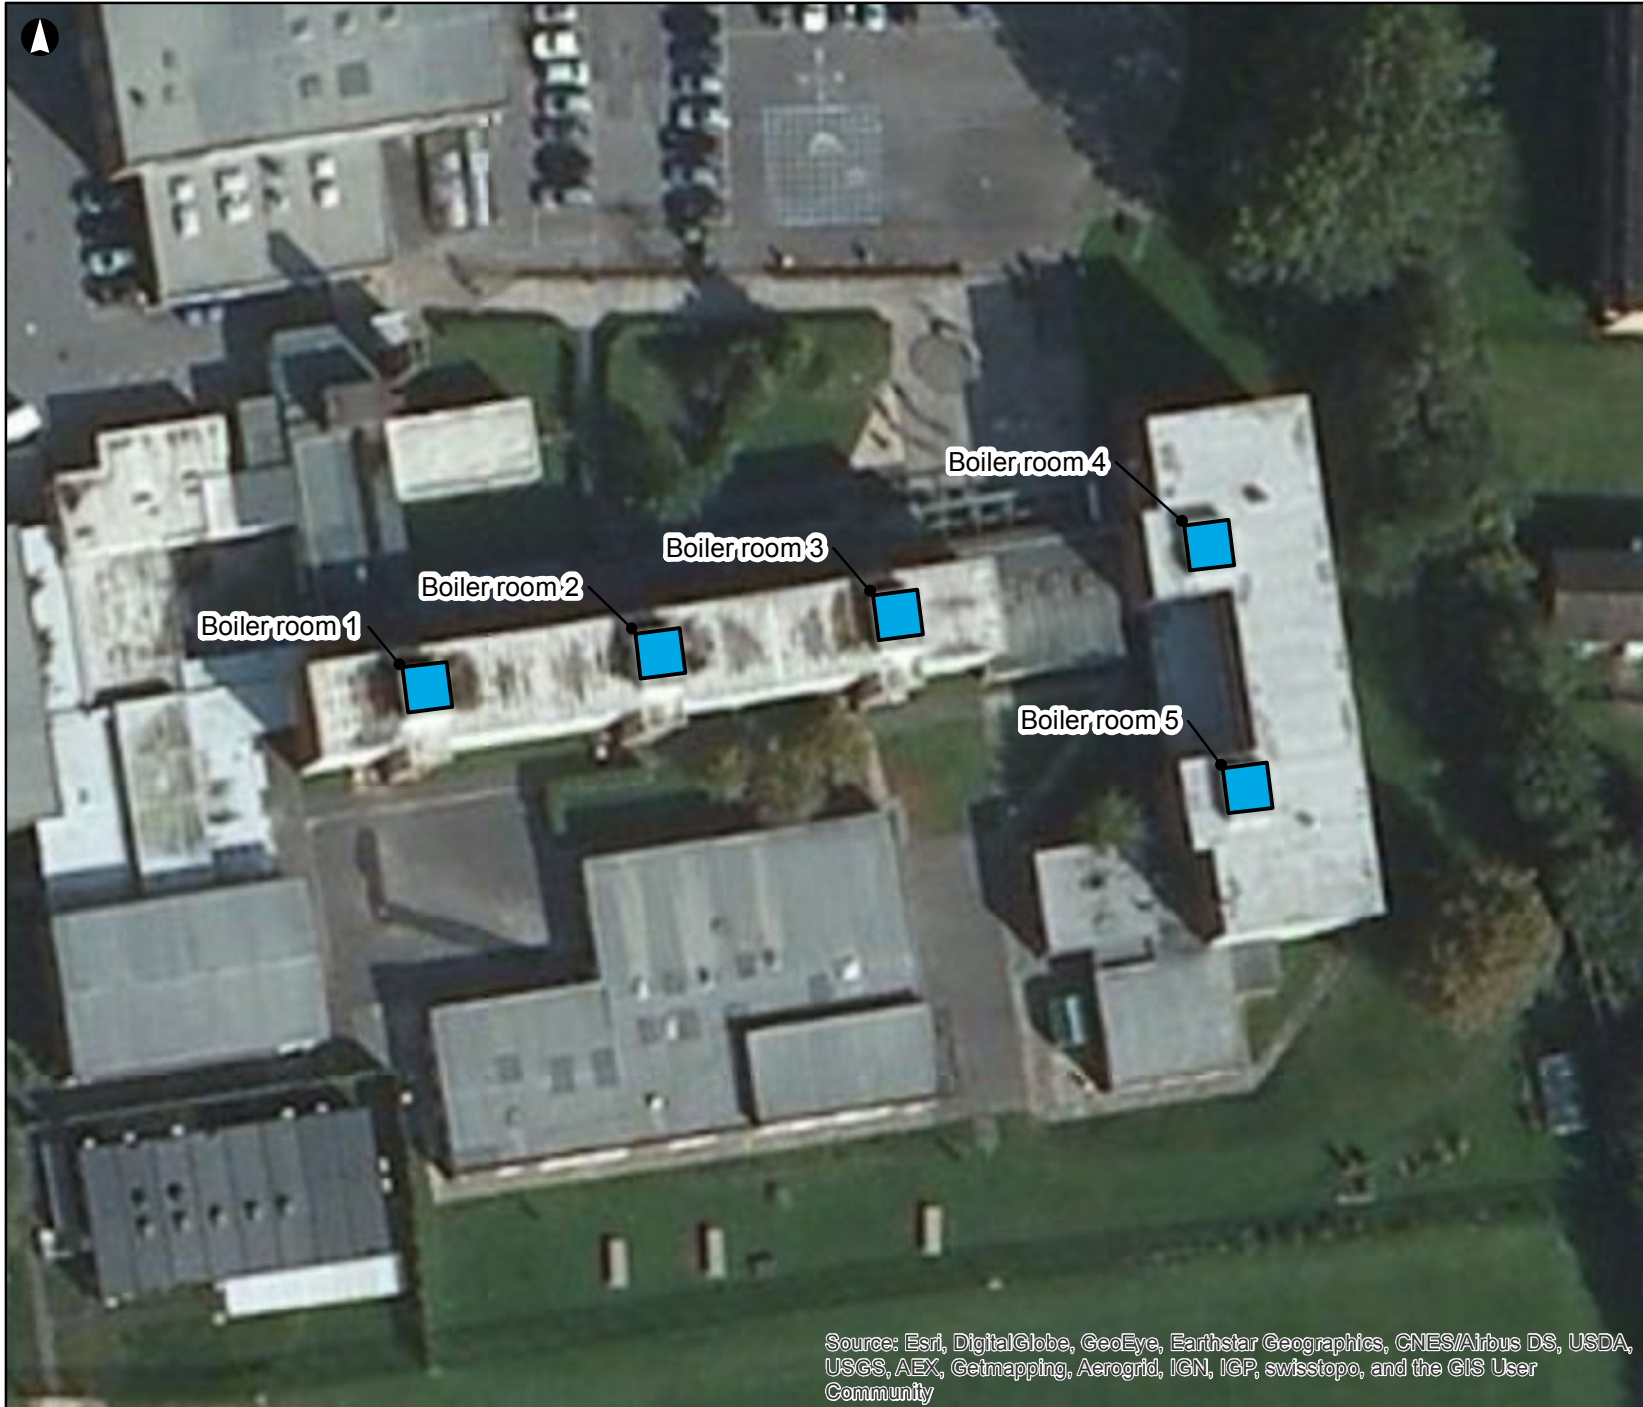
**Figure 1 - Bat Inspection Reference Map**

Boiler rooms 1 and 2 were well sealed and lacked any opportunity for bats to enter either room, with no evidence of roosting bats recorded in either room. Each room also lacked features on the external façades which would be suitable for roosting bats. A large gap in the eastern external wall of boiler room 3 resulting from a missing section of the wall was recorded, providing a suitable entrance point to the room. However, no evidence of use by roosting bats was recorded within boiler room 3.

The door of boiler room 4 was missing on the date of the inspection, allowing for a suitable point for bats to enter this room, however no evidence of bat use was recorded. A gap where the door of boiler room 5 had warped was identified, however this room could not be accessed on the date of the inspection as there was no safe access to this part of the building. In conclusion, it is unlikely that bats have been utilising the buildings to roost during the summer or to hibernate. However, the demolition of the buildings without mitigation, would result in the loss of roosting resources provided by the site.

It is recommended that the damage to boiler rooms 3, 4 and 5 is fixed as soon as possible. This will need to be undertaken before the end of February 2016 prior to bats emerging from hibernation and beginning to look for suitable summer roosts. It is also recommended that once the damage has been fixed the boiler rooms remain closed and are maintained to prevent any gaps or suitable features appearing prior to demolition (currently planned for winter 2016).
