# Bat Activity Survey

**94 Oak Tree Road**

16-002-IBA

June 2016

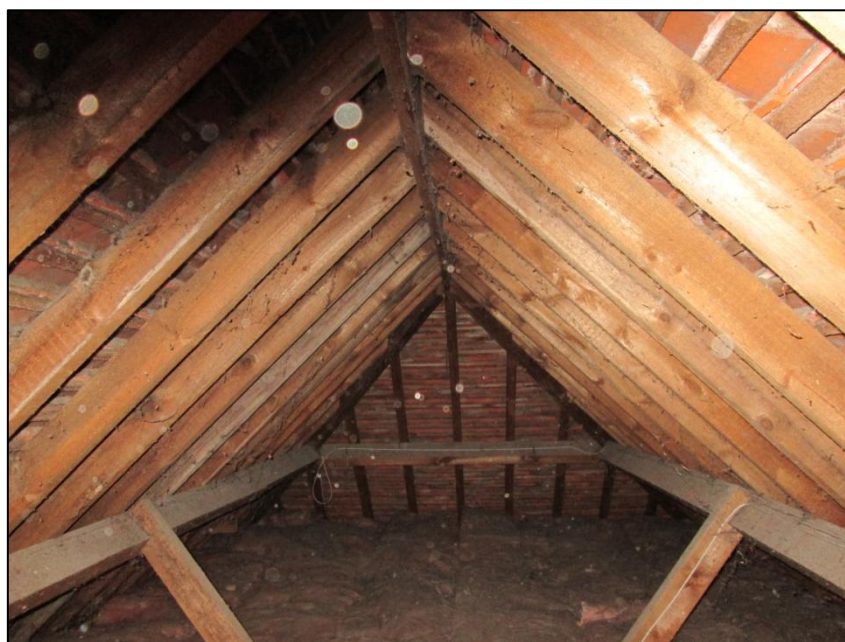
The property had a single roof void accessible through a hatch in the ceiling. The roof void was L-shaped and approx. 1.5m high (at the ridge) throughout the length of the roof. There was no underlay fitted and this resulted in the void being draughty. The roof void had a single chimney stack located towards the southern end of the building. This provided a partial barrier within the roof void behind which the microclimate appeared more stable (Figure 5). Due to the lack of underlay there were numerous access points throughout the roof void that could be utilised by bats. These included gaps in tiles, eaves gaps and access via the ridge. There was a very high level of cob-webbing along the length of the roof void; however, a small section of the ridge board (close to the chimney stack) was free of cobwebs and had staining indicative of bats roosting on it. Below this small section was a small collection of bat droppings. The droppings were in a varied state of decay, suggesting that the roof had been used for a number of years. The size and number of the droppings would suggest use by a single brown long-eared bat (*Plecotus auritus*).

Figure 4 – Roof void showing lack of underlay

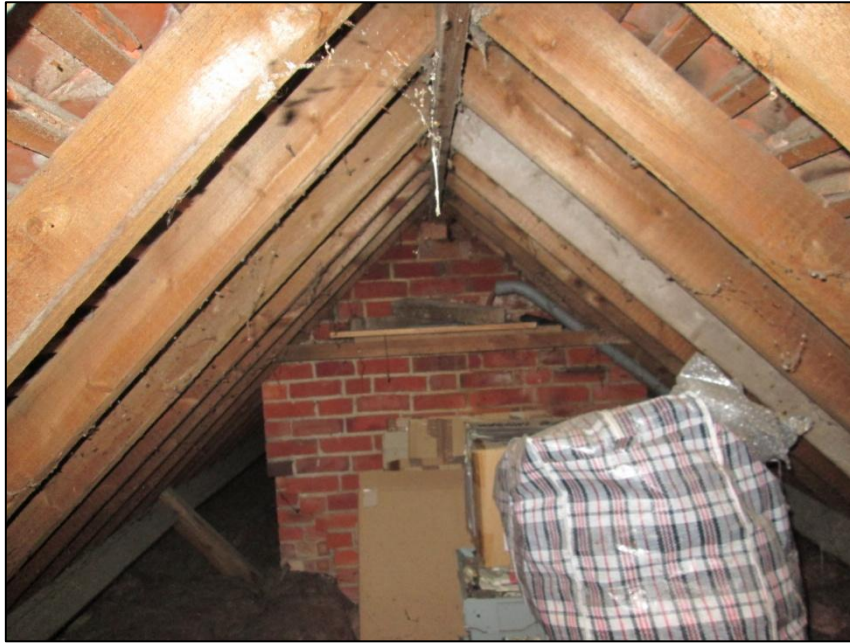
**Figure 5** – Chimney stack located towards the southern end of the property

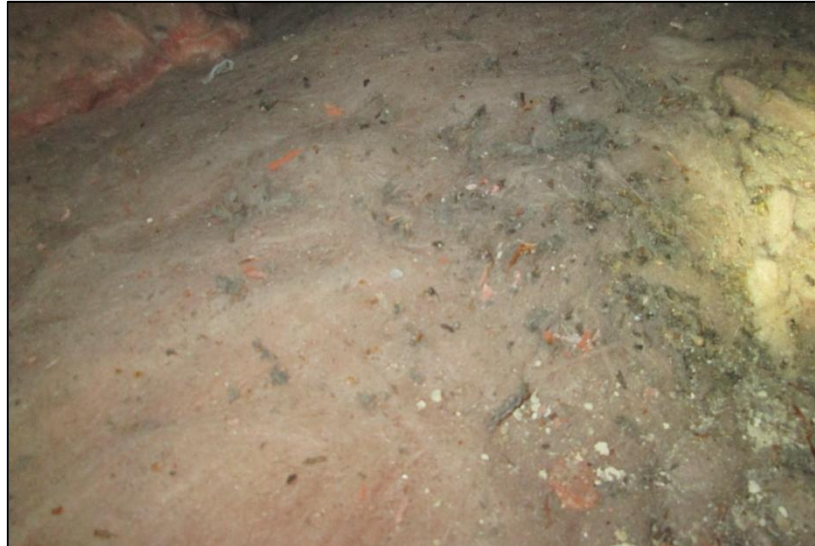
**Figure 6** – collection of bat droppings underneath the ridge board

The initial bat assessment at 94 Oak Tree Road revealed a small number of bat droppings concentrated under the ridge board (near the chimney stack) within the roof void. The location, size, shape and contents of the droppings suggested that the roof may have been used by a single brown long-eared bat (*Plecotus auritus*). Consequently, further evening emergence surveys were required to determine the status of any bat roosts within the building.

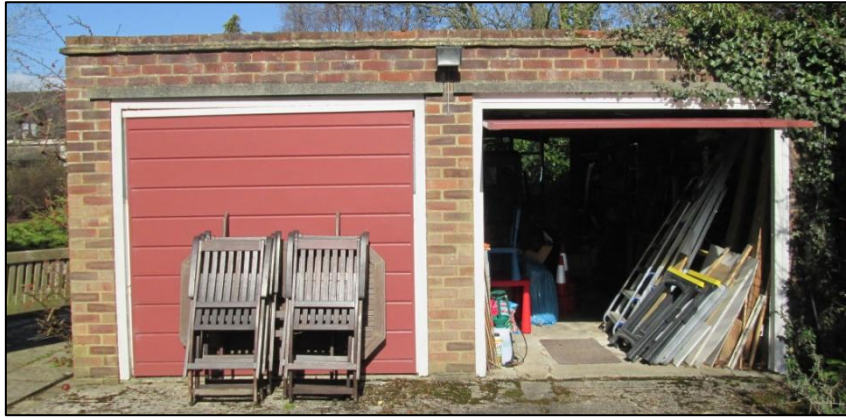
**Figure 7** – Exterior of the double garage, showing brick construction, doors and flat roof

The exterior of the garage/workshop provided no potential for bats. The brickwork was single-skinned and so even where gaps were present there was no crevice suitable for roosting. The flat roof on the garage (Figure 7) was in good condition and fixed directly to the timber cladding. Consequently there was no void to accommodate crevice dwelling bats.

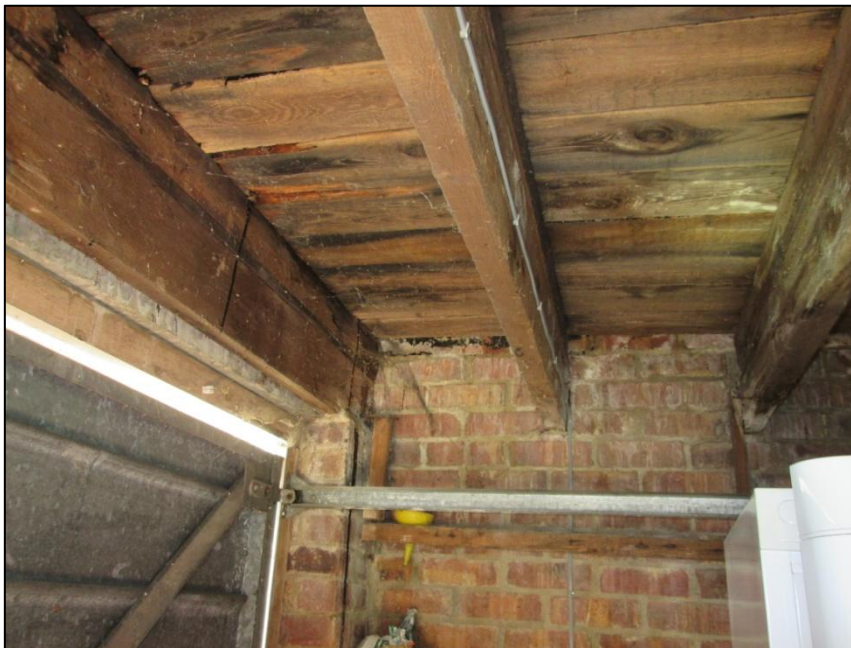
**Figure 8** – shows interior of the garage which has a boarded flat roof, areas of damp and gaps which allow draughts

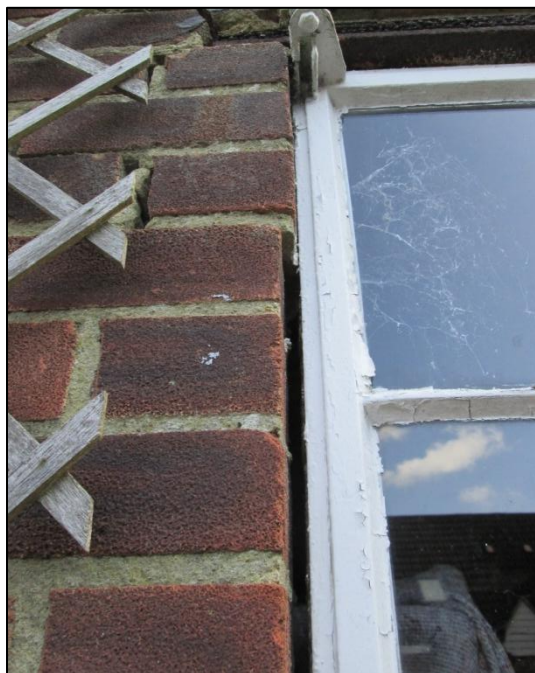
**Figure 9** – gaps around windows due to structural issues

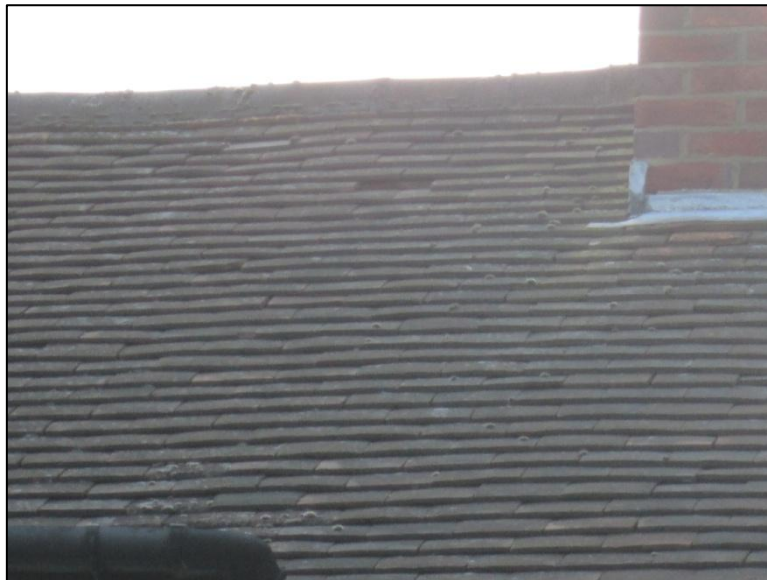
The primary roof covering consisted of both hand-made and machine-made tiles which were in relatively good condition. There were several missing and broken tiles (Figures 10&11) throughout the span of the roof, which could provide access to roosting bats. The mortar along the ridge and verges was in fair condition, although there were areas where the mortar was missing along the hips (Figure 12). Around the chimney the lead flashing was raised in areas, partially due to a missing tile (Figure 11). The eaves were sealed and the soffits in very good condition (Figure 11), this area provided no access potential.

**Figure 10** – Tile roof covering showing good condition with only a couple of lifted tiles

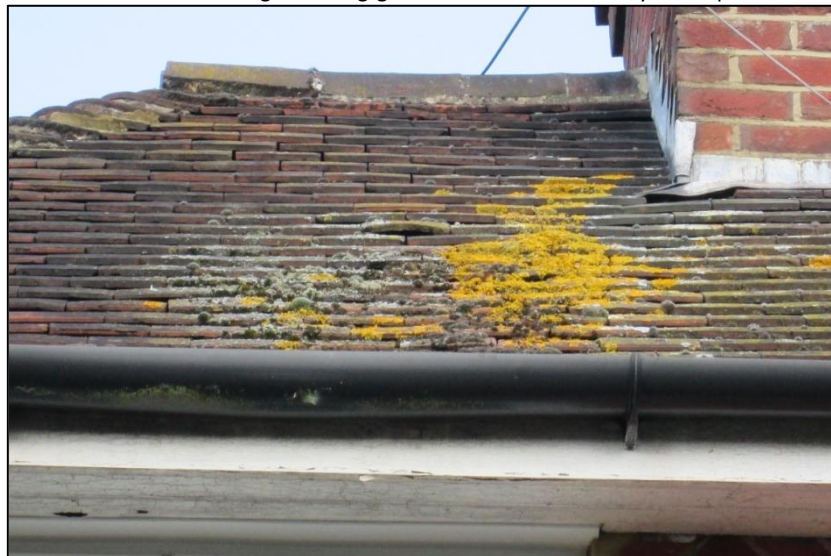
**Figure 11** – Open ended tiles close to the eaves

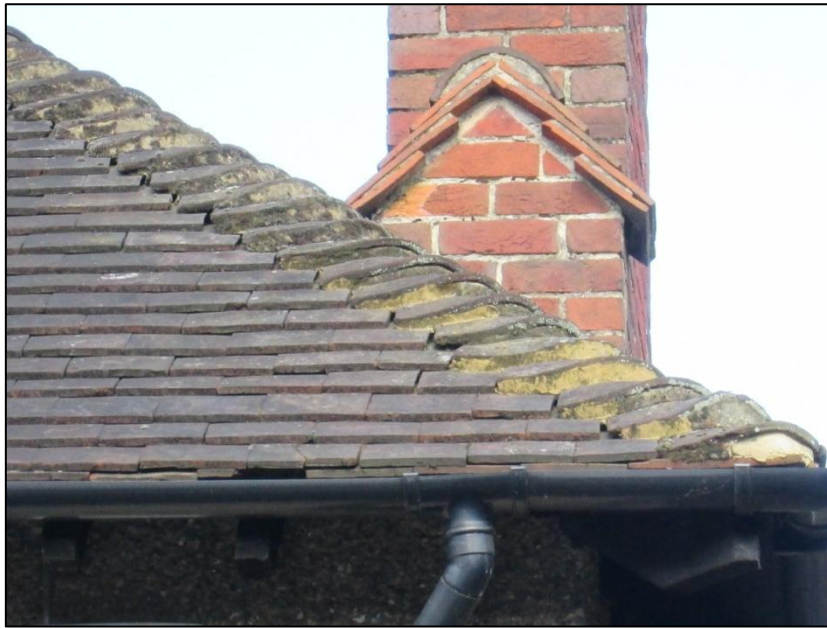
**Figure 12** – Sections of mortar missing from the hips
