**Rebuilding rear garden wall at  
69 Baker Street Reading RG1 7XY  
Listed Building Application**

Richard Bennett  
69, Baker Street  
10/04/2016

# **Re building the rear garden wall at 69 Baker Street Reading**

## **Listed Building Application**

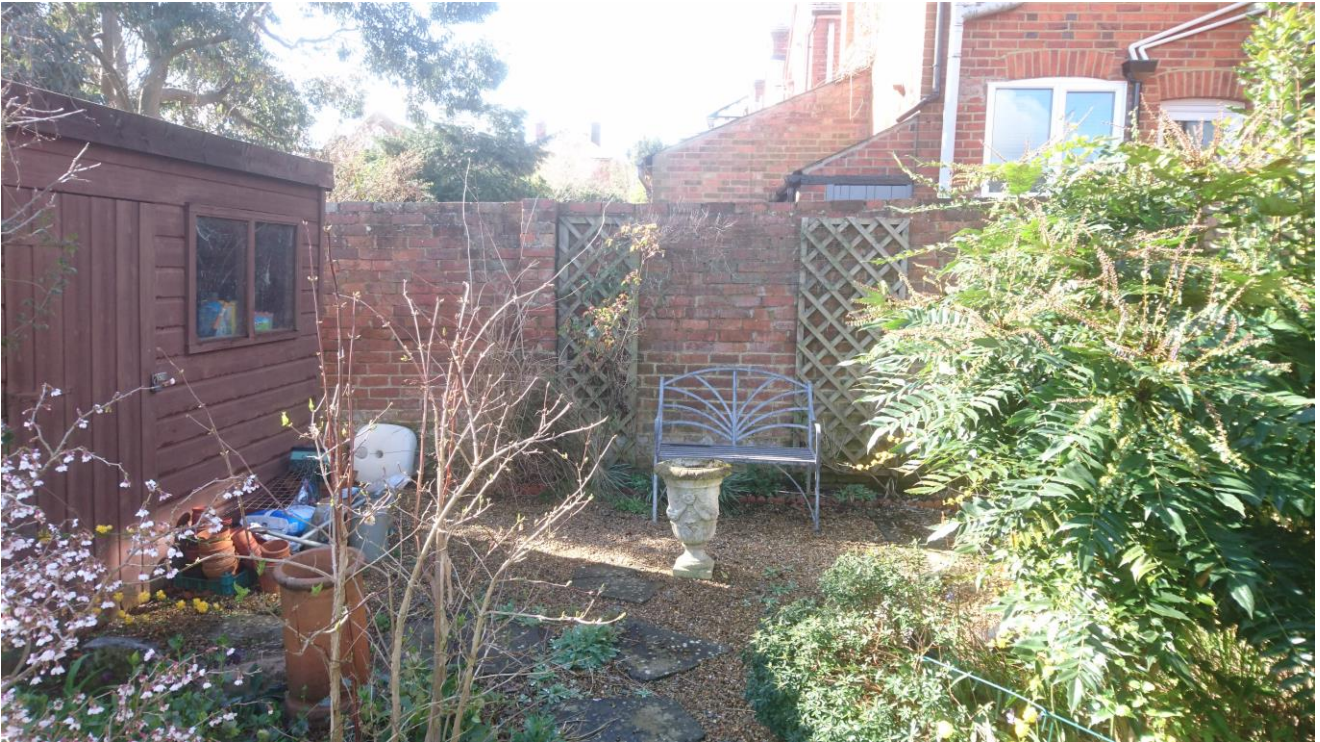
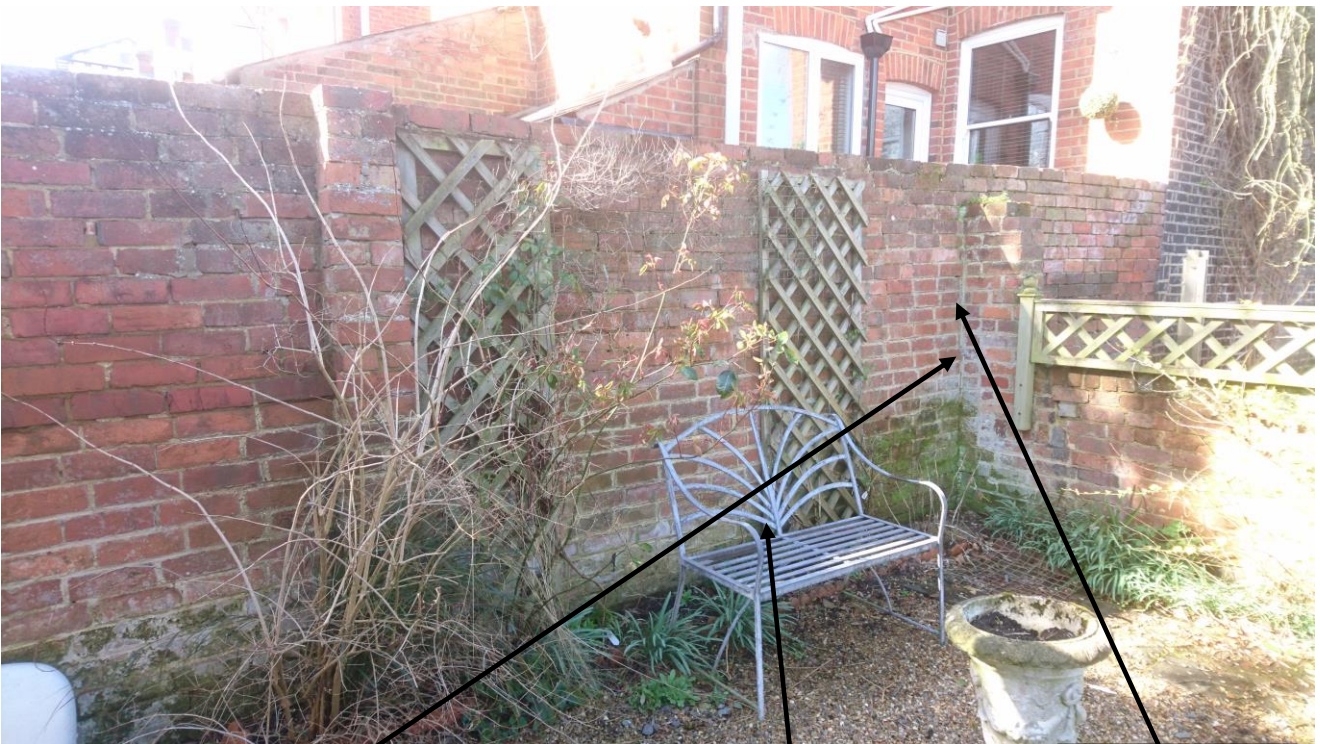
Pictures of the Wall - existing condition

- A section of the top half of the rear garden wall to the property is loose and leaning towards the neighbouring garden (20 Belle Vue Road), it is unsafe. Other parts, whilst solid at the moment, are leaning. To the base of the wall in the right hand side section it is bulging as a result of pressure from the soil in the neighbouring garden, which is at a significantly higher level. In addition as the neighbour in 20 Belle Vue Road has installed a wooden patio in part of his garden this has raised

- The top part of the wall (approx. 13 layers of bricks) appears to have been rebuilt many, many years ago and very poorly at that. The mortar used was cement which has set extremely hard. No care was given in finishing off the mortar to either side of the wall, as a result the look of the wall is very poor and patchy from half way up.

Original level  
of wall in  
1830s?

Wall bulges at low  
level. New  
buttress to be  
added

Bricks to be  
replaced to this  
level

- To address the problems and also improve the appearance of the wall it is proposed that:
  - The top 10 layers of bricks will be removed from the full width of the garden wall between 69 Baker Street and 20 Belle Vue Road. This is the wall at the rear of the garden at 69 Baker Street.
  - It is then proposed that this part of the wall be rebuilt, with an increase in height of two bricks, resulting in 27 rows of brick and an approximate height of 2.26m.
  - It is also proposed that an additional brick pillar be built halfway along the wall, on the 69 Baker Street side, to provide additional support to the wall.

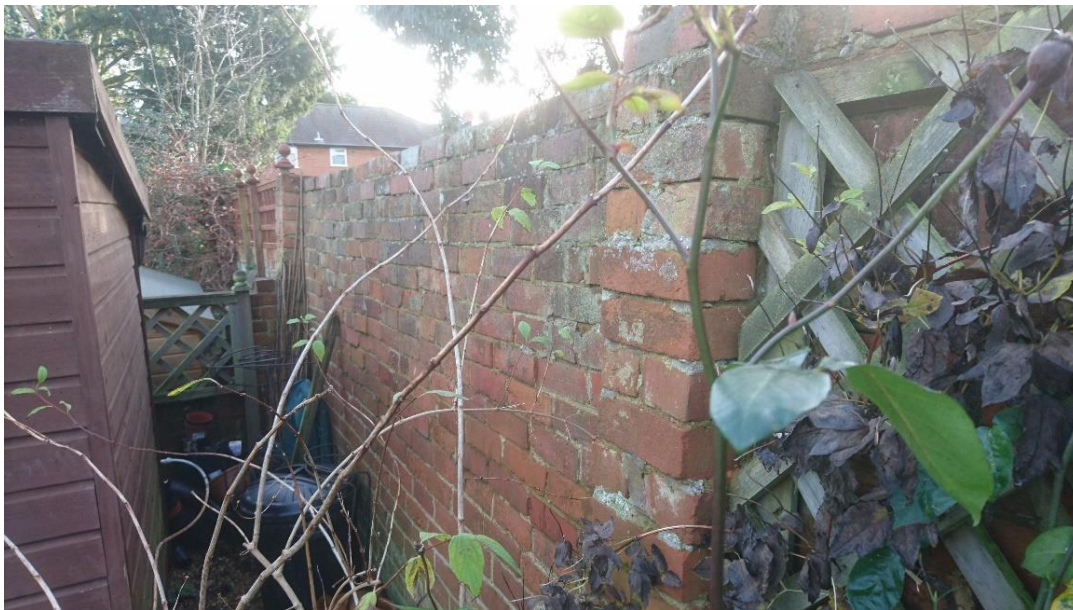
Rear Wall – to the left side.

The wall showing some of the lean. This is the worst part of the wall. 10 rows to be removed. The Pillars will be rebuilt.

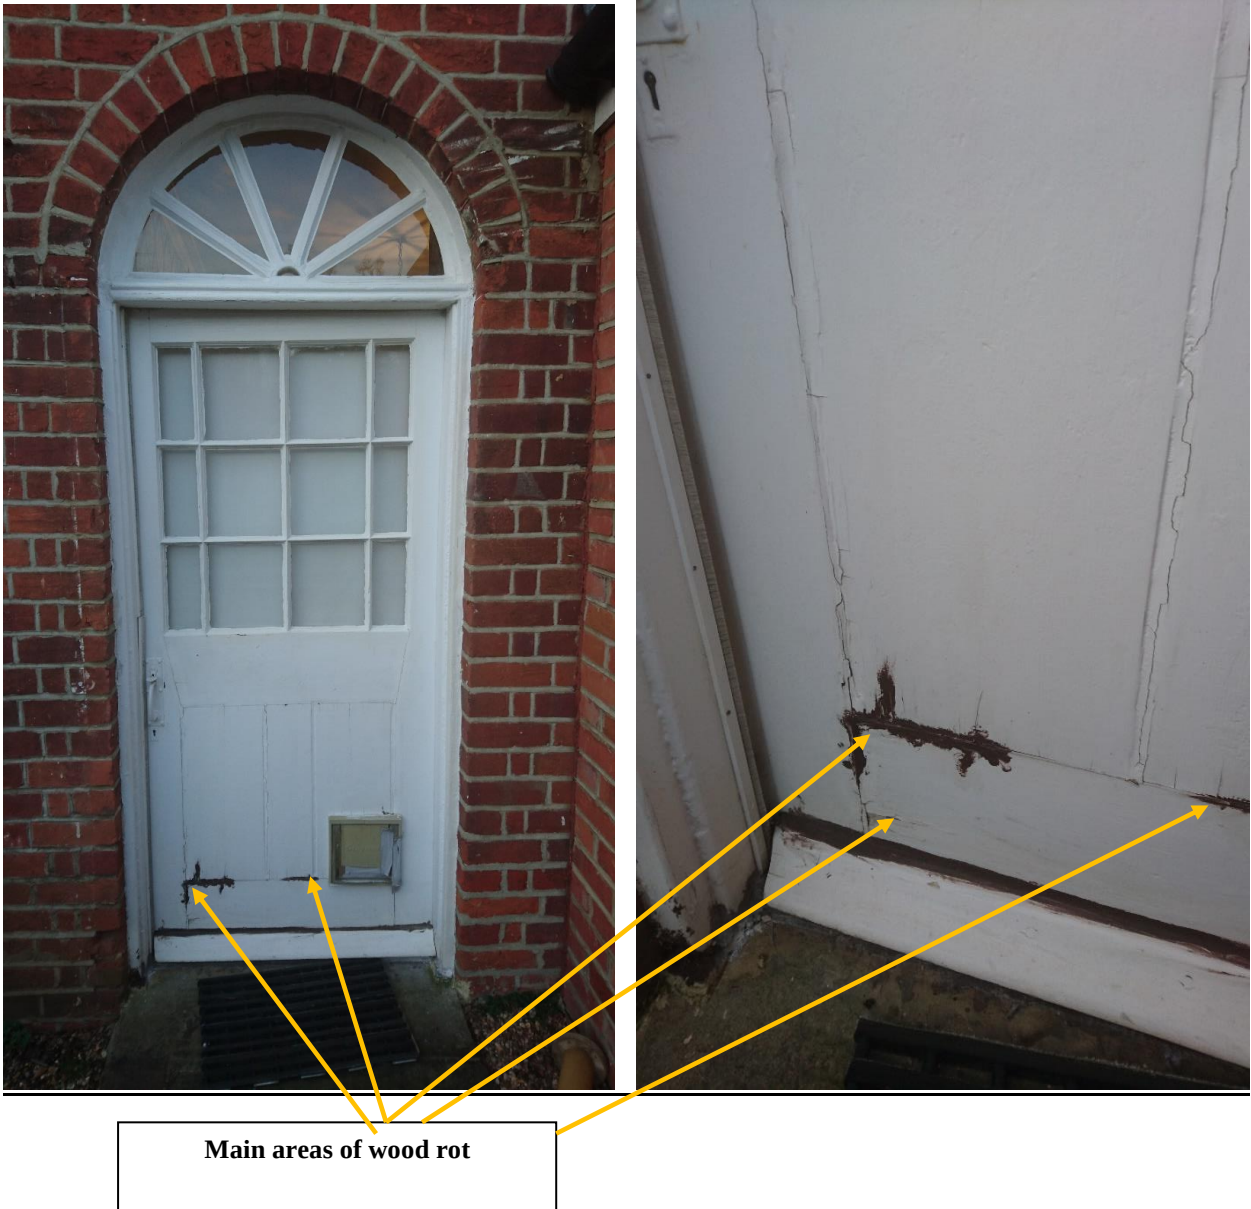
The Rear Door

- The bottom left side of the door has an area of wet rot but this seems to be more extensive. The Cat flap, installed by the previous owners in the early 1980s, also provides an area of weakness and damp ingress
- It is proposed to temporarily remove the door, cut out and replace any areas damaged by wet rot and replace with new wood shaped to replicate the original elements of the door / panels. The cat flap will be removed and full panel inserted to match the original profile.
- The source of the dampness, a tilting gutter, has been fixed.
