# FLOOD RISK ASSESSMENT

Caversham Park, Peppard Road, Caversham, Reading, RG4 8TZ

Prepared for: Beechcroft Developments Ltd  
Ref: 013\_ 8210940\_AP\_Flood\_Risk\_Assessment

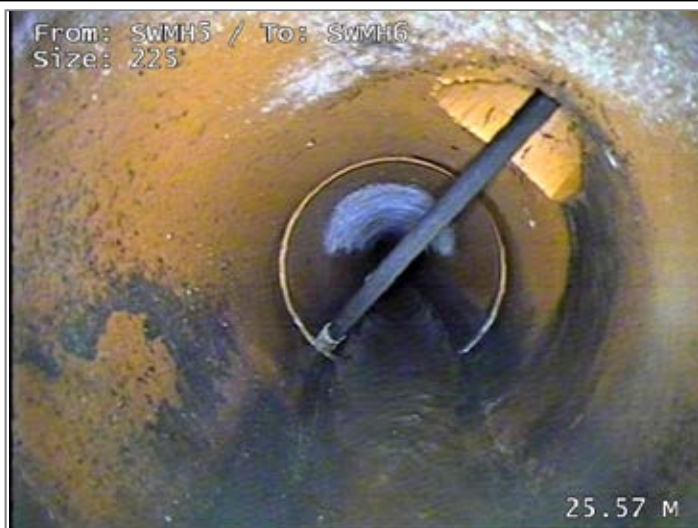
Other obstacles through connection/junction at 1 o'clock 50% cross-sectional area loss

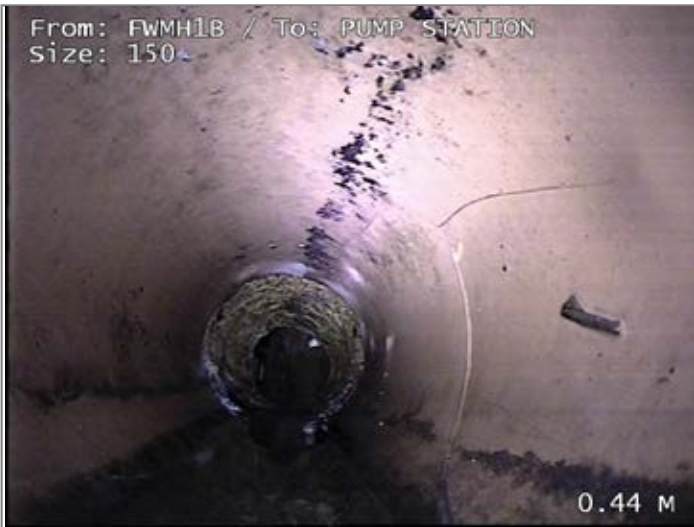
| Position | Code | Description | Photo | Type/Grade |
|---|---|---|---|---|
| 0.44 | CM | Cracks multiple from 1 to 5 o'clock | 3391031 | Structural / 3 |

Cracks multiple from 1 to 5 o'clock

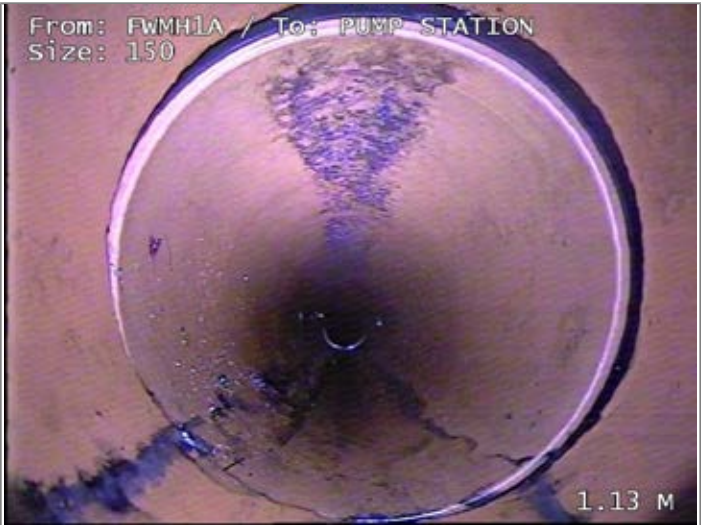
| Position | Code | Description | Photo | Type/Grade |
|---|---|---|---|---|
| 1.13 | CL (S1) | Crack longitudinal at 7 o'clock, Start | 3391094 | Structural / 2 |

| Job Number<br>780878 | Surveyed by (Operator)<br>PAUL BAYNHAM | Base Unit<br>DDFRT6A12S | Date<br>14/06/2019 |
|---|---|---|---|
| <div> <div> From: FWMH1A / To: PUMP STATION<br/>Size: 150 </div> <div>1.13 M</div> <div>Crack longitudinal at 7 o'clock, Start</div> </div> | | | |

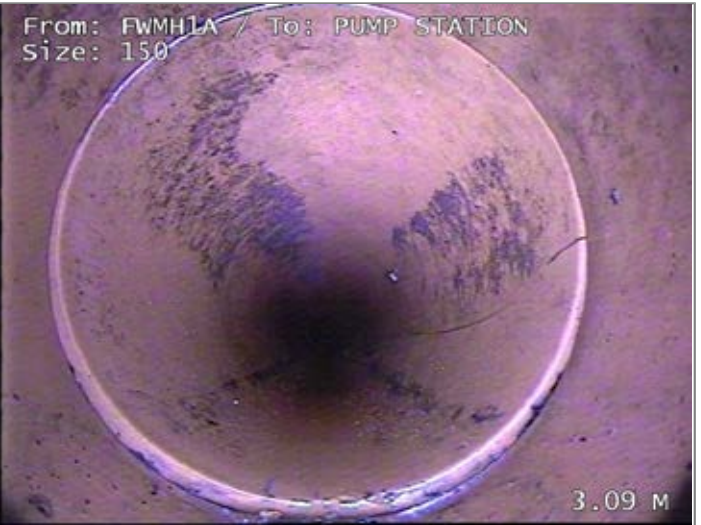
| Position | Code | Description | Photo | Type/Grade |
|---|---|---|---|---|
| 3.09 | CL (F1) | Crack longitudinal at 7 o'clock, Start, Finished | 3391095 | Structural / 2 |

| Job Number<br>780878 | Surveyed by (Operator)<br>PAUL BAYNHAM | Base Unit<br>DDFRT6A12S | Date<br>14/06/2019 |
|---|---|---|---|
| <div> <div> From: FWMH1A / To: PUMP STATION<br/>Size: 150 </div> <div>3.09 M</div> <div>Crack longitudinal at 7 o'clock, Start, Finished</div> </div> | | | |

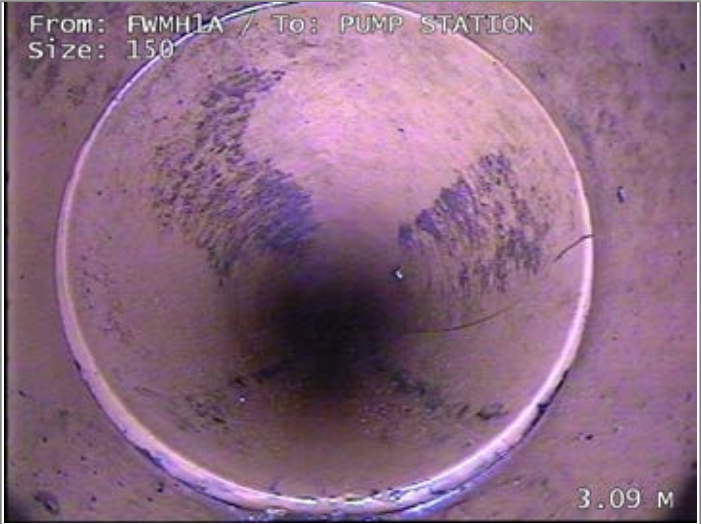
| Position | Code | Description | Photo | Type/Grade |
|---|---|---|---|---|
| 3.09 | CL (S2) | Crack longitudinal at 3 o'clock, Start | 3391096 | Structural / 2 |

| Job Number<br>780878 | Surveyed by (Operator)<br>PAUL BAYNHAM | Base Unit<br>DDFRT6A12S | Date<br>14/06/2019 |
|---|---|---|---|
| <div> <div> From: FWMH1A / To: PUMP STATION<br/>Size: 150 </div> <div>3.09 M</div> <div>Crack longitudinal at 3 o'clock, Start</div> </div> | | | |

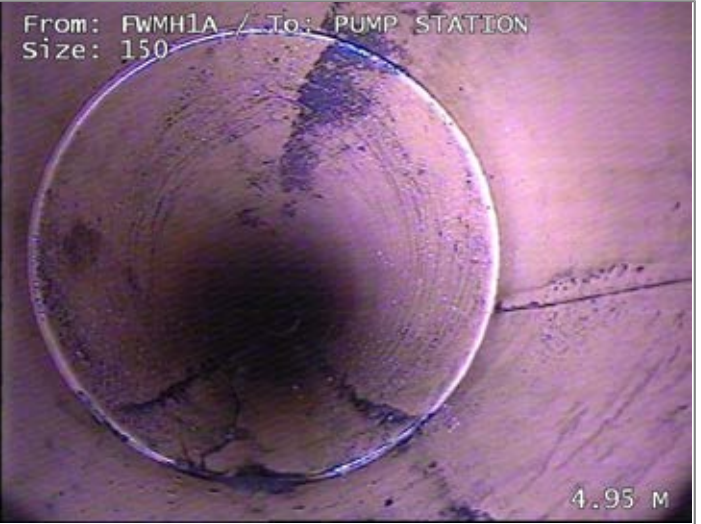
| Position | Code | Description | Photo | Type/Grade |
|---|---|---|---|---|
| 4.95 | CL (F2) | Crack longitudinal at 3 o'clock, Start, Finished | 3391098 | Structural / 2 |

| Job Number<br>780878 | Surveyed by (Operator)<br>PAUL BAYNHAM | Base Unit<br>DDFRT6A12S | Date<br>14/06/2019 |
|---|---|---|---|
| <div> <div> From: FWMH1A / To: PUMP STATION<br/>Size: 150 </div> <div>4.95 M</div> <div>Crack longitudinal at 3 o'clock, Start, Finished</div> </div> | | | |

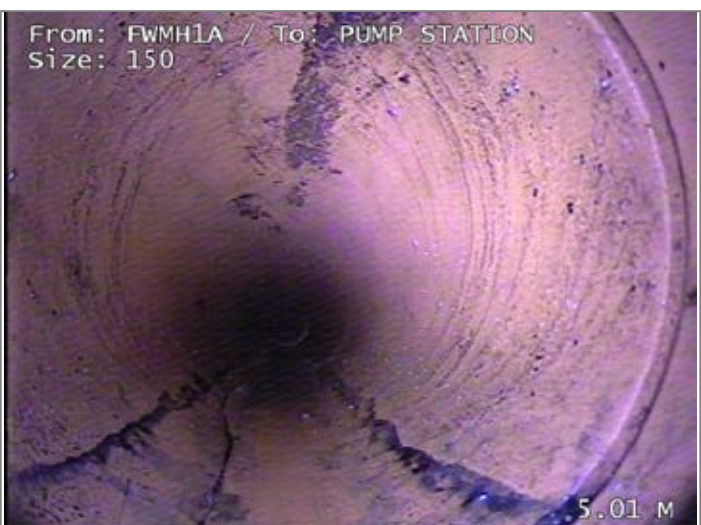
| Job Number<br>780878 | Surveyed by (Operator)<br>PAUL BAYNHAM | Base Unit<br>DDFRT6A12S | Date<br>14/06/2019 |
|---|---|---|---|
| <div> <div> From: FWMH1A / To: PUMP STATION<br/>Size: 150 </div> <div>5.01 M</div> <div>Crack longitudinal at 7 o'clock, Start</div> </div> | | | |

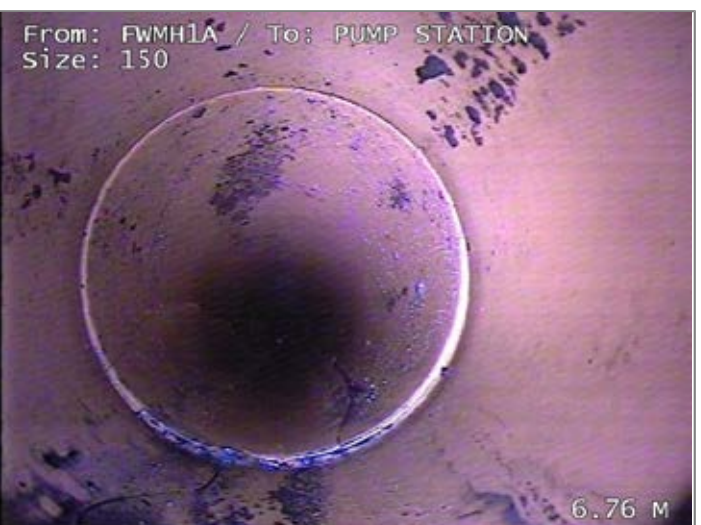
| Job Number<br>780878 | Surveyed by (Operator)<br>PAUL BAYNHAM | Base Unit<br>DDFRT6A12S | Date<br>14/06/2019 |
|---|---|---|---|
| <div> <div> From: FWMH1A / To: PUMP STATION<br/>Size: 150 </div> <div>6.76 M</div> <div>Crack longitudinal at 7 o'clock, Start, Finished</div> </div> | | | |

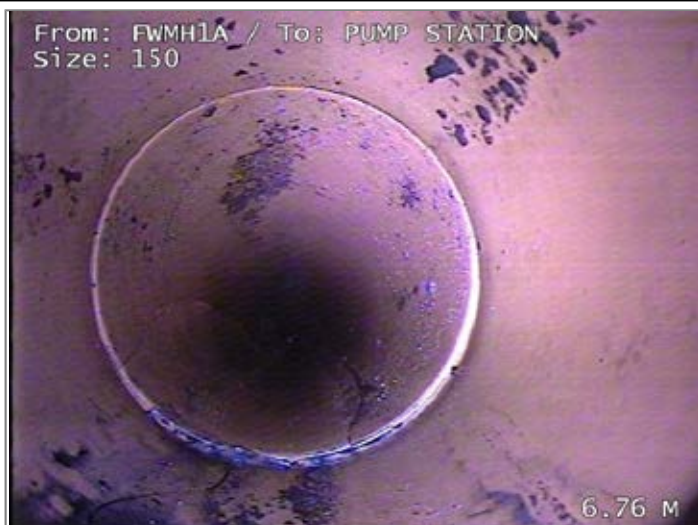
Crack longitudinal at 5 o'clock, Start

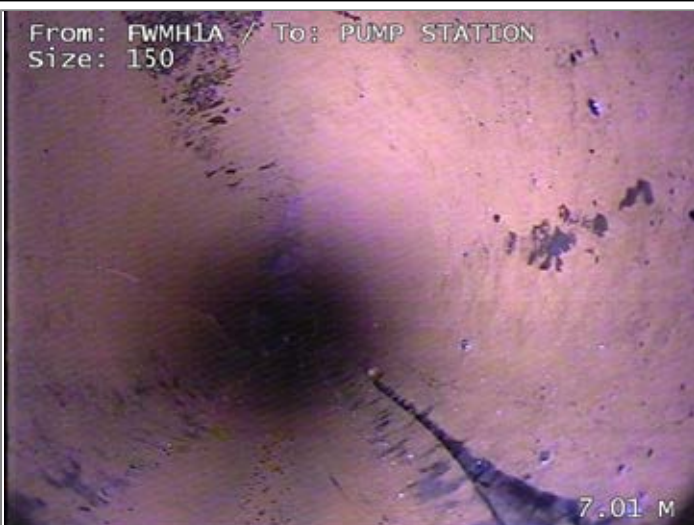
Crack longitudinal at 9 o'clock, Start

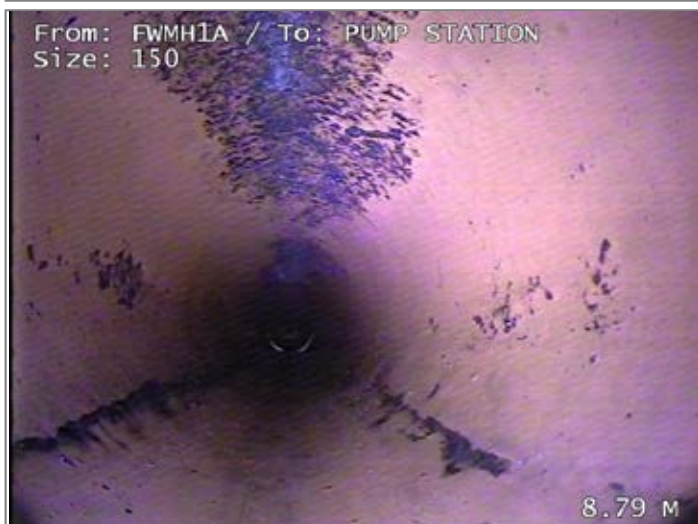
Crack longitudinal at 5 o'clock, Start, Finished

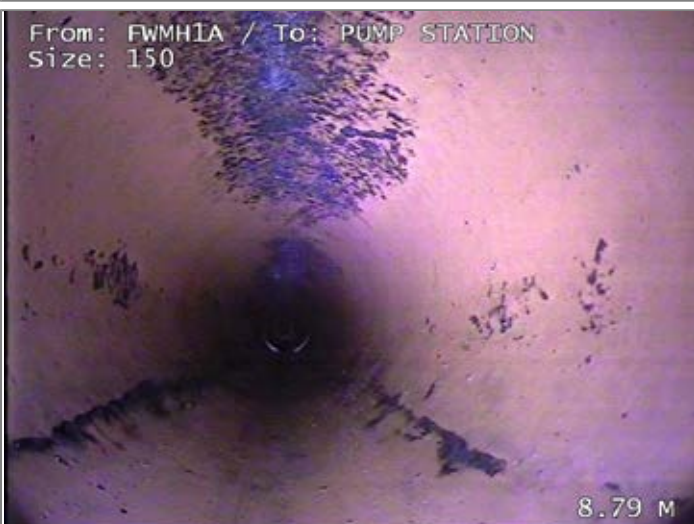
Crack longitudinal at 9 o'clock, Start, Finished

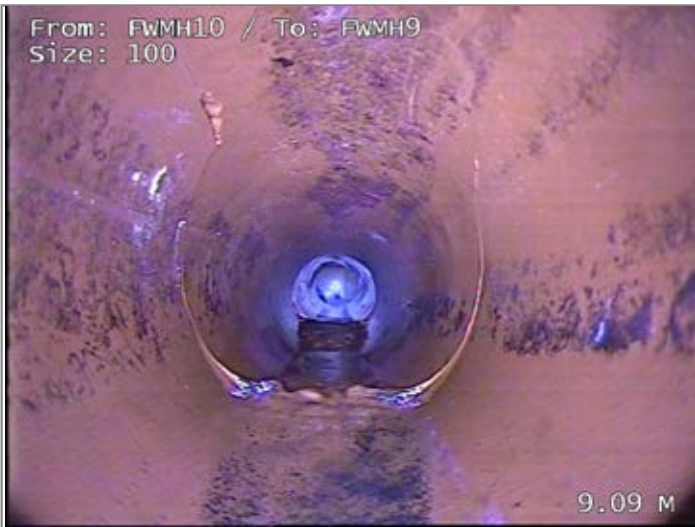
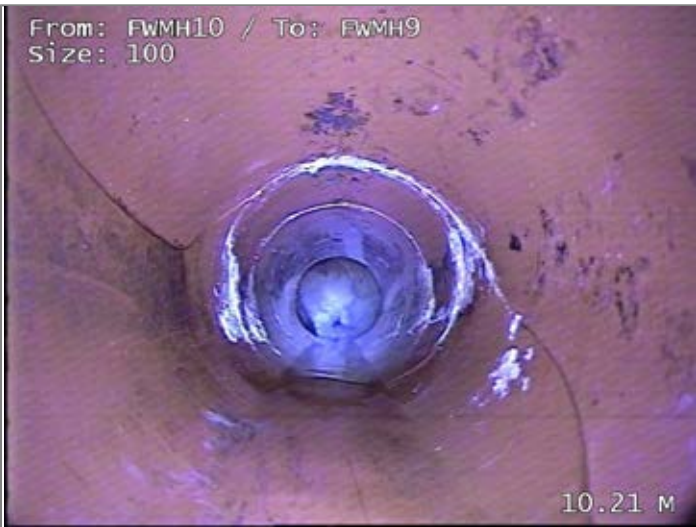
| Job Number<br><b>780878</b> | Surveyed by (Operator)<br><b>PAUL BAYNHAM</b> | Base Unit<br><b>DDFRT6A12S</b> | Date<br><b>14/06/2019</b> |
|---|---|---|---|
| <div> <div> <p>From: FWMH10 / To: FWMH9<br/>Size: 100</p> <p>9.09 M</p> <p>Crack circumferential from 1 to 11 o'clock</p> </div> <div> <p>From: FWMH10 / To: FWMH9<br/>Size: 100</p> <p>10.21 M</p> <p>Cracks multiple from 9 to 5 o'clock</p> </div> </div> | | | |

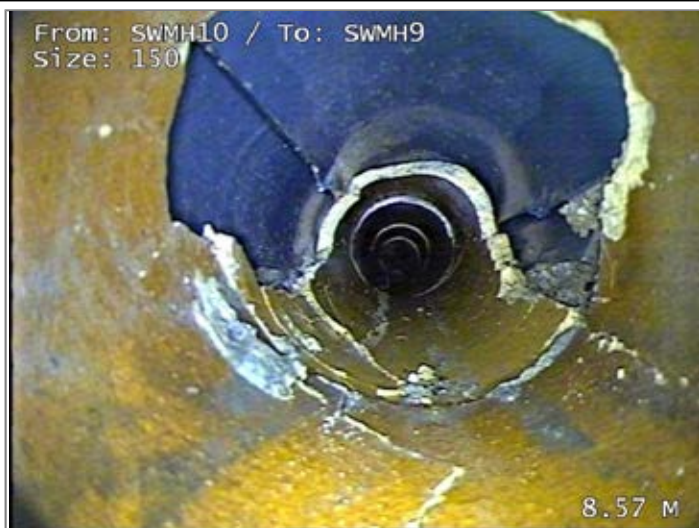
Broken pipe from 8 to 4 o'clock

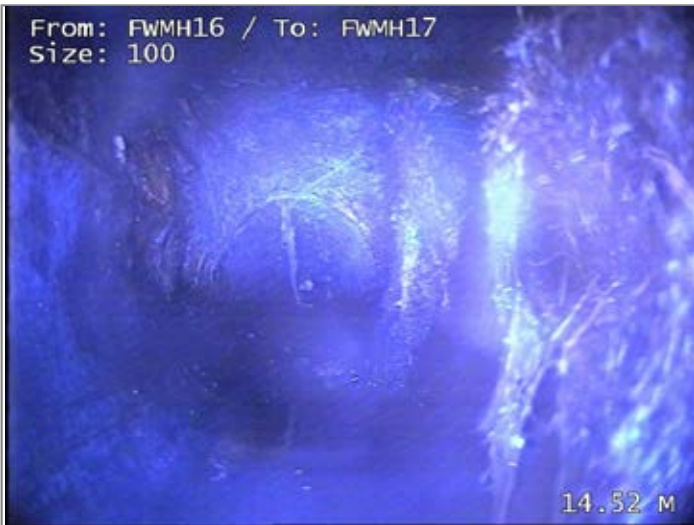
Roots mass 10% cross-sectional area loss

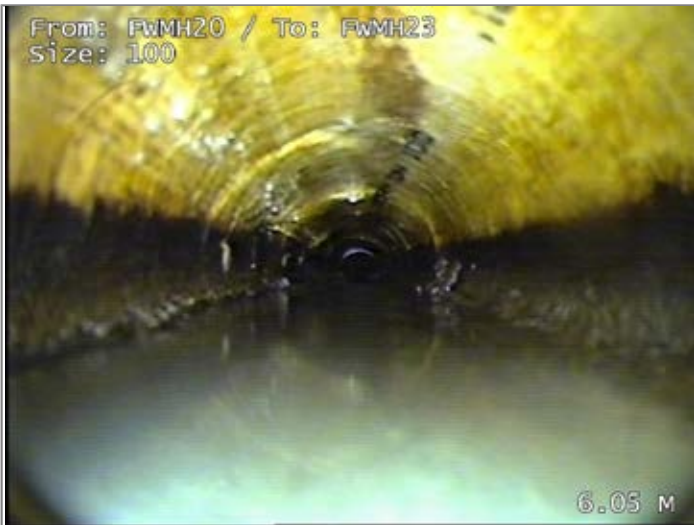
UNABLE TO GET CAMERA THROUGH LINER WITH SKID ON

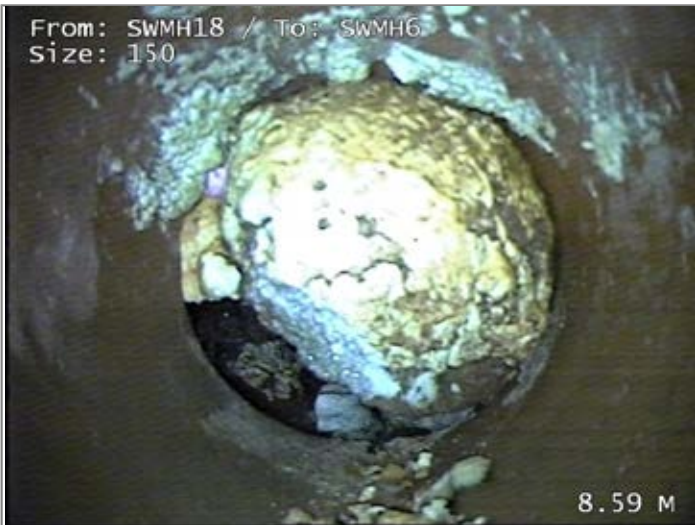
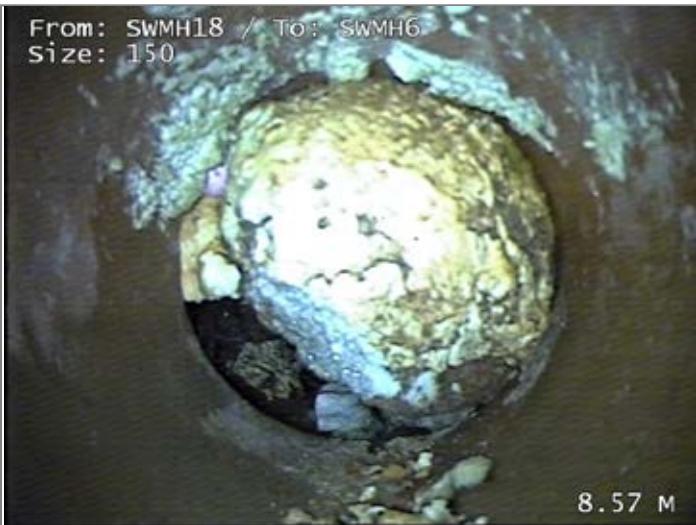
| Job Number<br>780878 | Surveyed by (Operator)<br>PAUL BAYNHAM | Base Unit<br>DDFRT6A12S | Date<br>20/06/2019 |
|---|---|---|---|
| <p>From: SWMH18 / To: SWMH6<br/>Size: 150</p> <p>8.59 M</p> <p>Collapsed drain/sewer 100%</p> | | <p>From: SWMH18 / To: SWMH6<br/>Size: 150</p> <p>8.57 M</p> <p>Survey abandoned - Remark: ABANDONED SURVEY DUE TO COLLAPSED PIPE</p> | |
