Our Ref: 240036/TPO  
Your Ref:

5 April 2024

**RE: PROPOSED FELLING OF ONE PINE TREE AT 22 COCKNEY HILL, READING - T3 OF  
TREE PRESERVATION ORDER NUMBER**

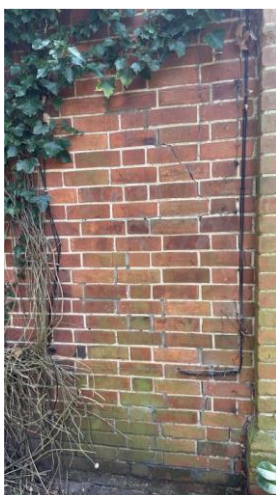
There are a potential number of causes relating to the damage throughout the property which could result in the damage recorded including, but not limited to, direct physical action from tree root / tree trunk growth against and beneath the wall. No commentary has been provided to distinguish damage relating to these potential causes and the alleged damage relating to the Pine tree.

At the location of the trial pit TP/BH1, the cracking damage has been repaired on what appears to be a number of occasions in the past. The cracking damage is predominantly vertical in nature and the pattern and location of this cracking is not consistent with tree root related clay shrinkage / heave:
