**Appendix D – CCTV Drainage Survey**

# CCTV Report

2 NORMAN PLACE,  
READING, RG1 8DA.

60390CCTV-01

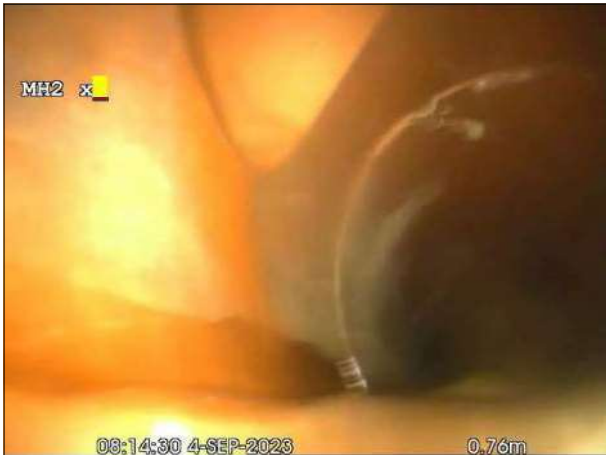
Photo: 1\_4a, 00:00:00  
0.73m, Junction at 10 o'clock, dia 100 mm

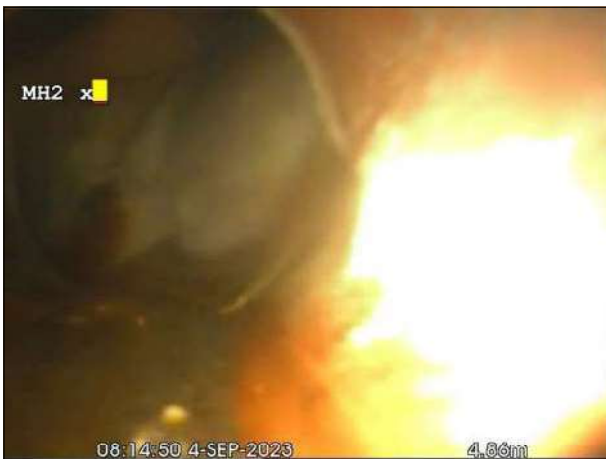
Photo: 1\_10a, 00:00:00  
5.35m, Manhole Remark: MH

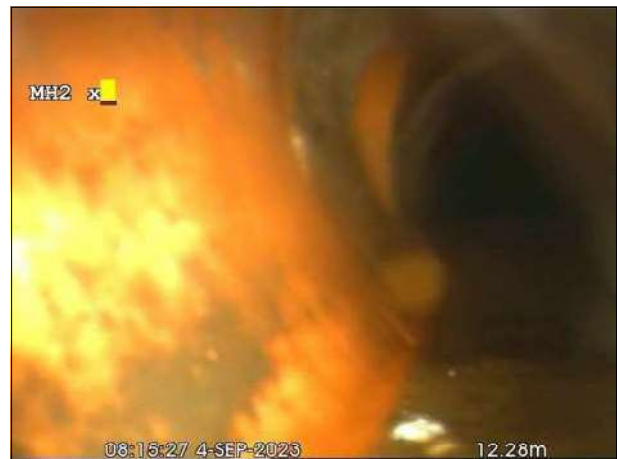
Photo: 17\_14a, 00:00:00  
12.6m, Junction at 10 o'clock, dia 100 mm

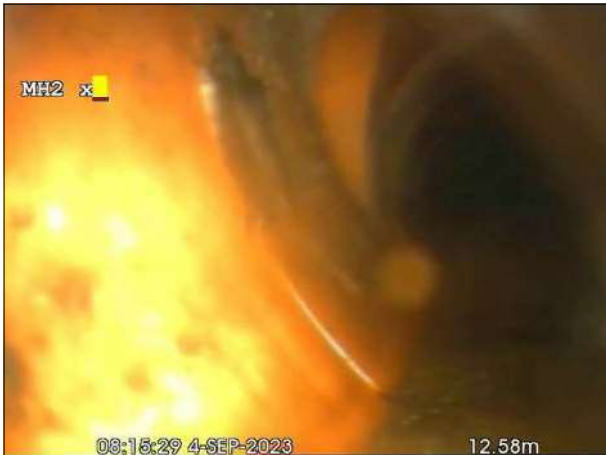
Photo: 17\_14b, 00:00:00  
12.6m, Junction at 10 o'clock, dia 100 mm

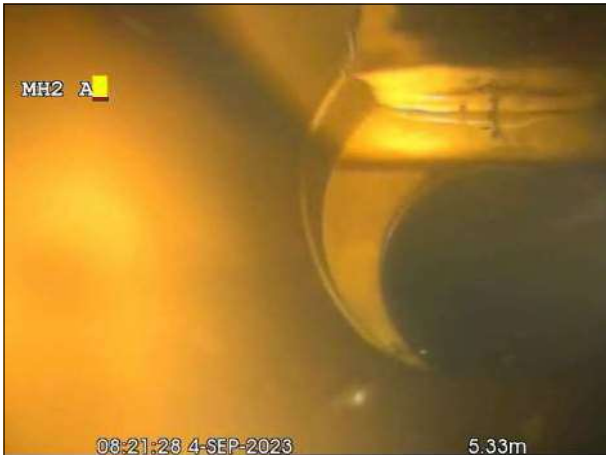
Photo: 32\_5a, 00:00:00  
 5.6m, Dimension of sewer changes, new dimension dia 100 mm

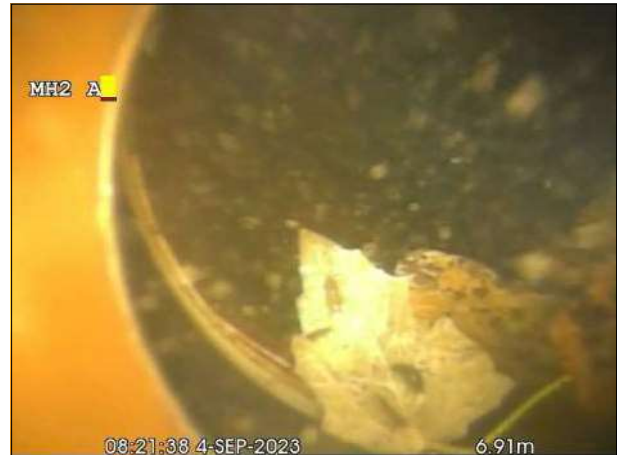
| 1:150 | position | code | observation | counter | photo | grade |
|---|---|---|---|---|---|---|
| | 7.00 | JDM | Joint displaced. Medium | 00:00:00 | 33_6a | (Struct) 1 |

Photo: 33\_6a, 00:00:00  
 7m, Joint displaced. Medium
