# **PARK LANE PRIMARY SCHOOL (INFANTS SITE)**

## **ARBORICULTURAL IMPACT ASSESSMENT**

JSL4733\_770  
Park Lane Primary School  
Arboricultural Impact  
Assessment  
V1  
July 2023

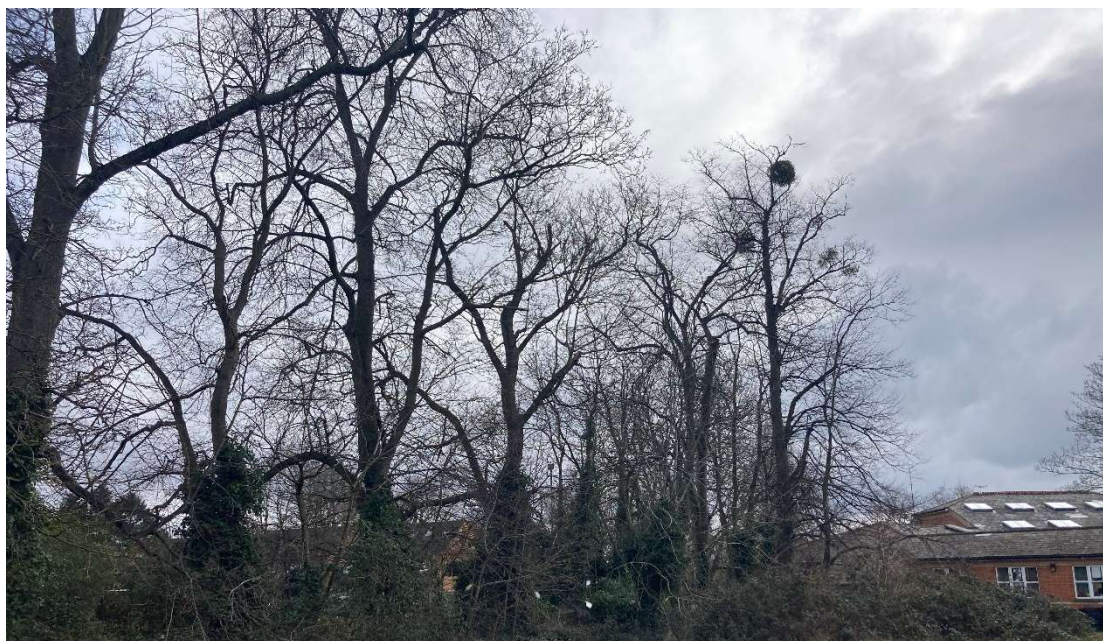
**T42-T56**

| Tree No. | Species | Diameter (mm)* | Height | Crown Spread | | | | Crown Height | First Branch Height and Direction | | Age Class | Vigour | Life Expectancy | Structural Condition/Comments | BS5837 Category |
|---|---|---|---|---|---|---|---|---|---|---|---|---|---|---|---|
| T53 | Acer platanoides (Norway Maple) | 660 | 12 | 3 | 5 | 3 | 5 | 2 | 3 | SE | M | Fair | 20+ | Unable to inspect stem due to Ivy. Previous branch failures. Minor deadwood in the crown.<br>Part of a mixed species group of mature trees in the north of the infant school site. | B2 |
| T54 | Tilia X europaea (Common Lime) | 940 | 18 | 6 | 6 | 6 | 3 | 3 | 2 | E | M | Good | 40+ | Unable to inspect stem due to Ivy. Previous branch failures. Crown distorted due to group pressure.<br>Part of a mixed species group of mature trees in the north of the infant school site. | A2 |

- Where foundations for the new modular building will encroach on the RPAs of T54 & 57, excavation is to be completed by hand or using light machinery, in a retreating manor, operating from outside of any RPAs. Any required root pruning to be in accordance with BS 3998. Pruning of roots over 25mmØ to be monitored by arboriculturalist, with ongoing monitoring of trees condition by an arboriculturalist being recommended. The minimum area where this is required is shown on the attached Tree Removal and Protection Plan (JSL4733\_710) with a blue hatch.

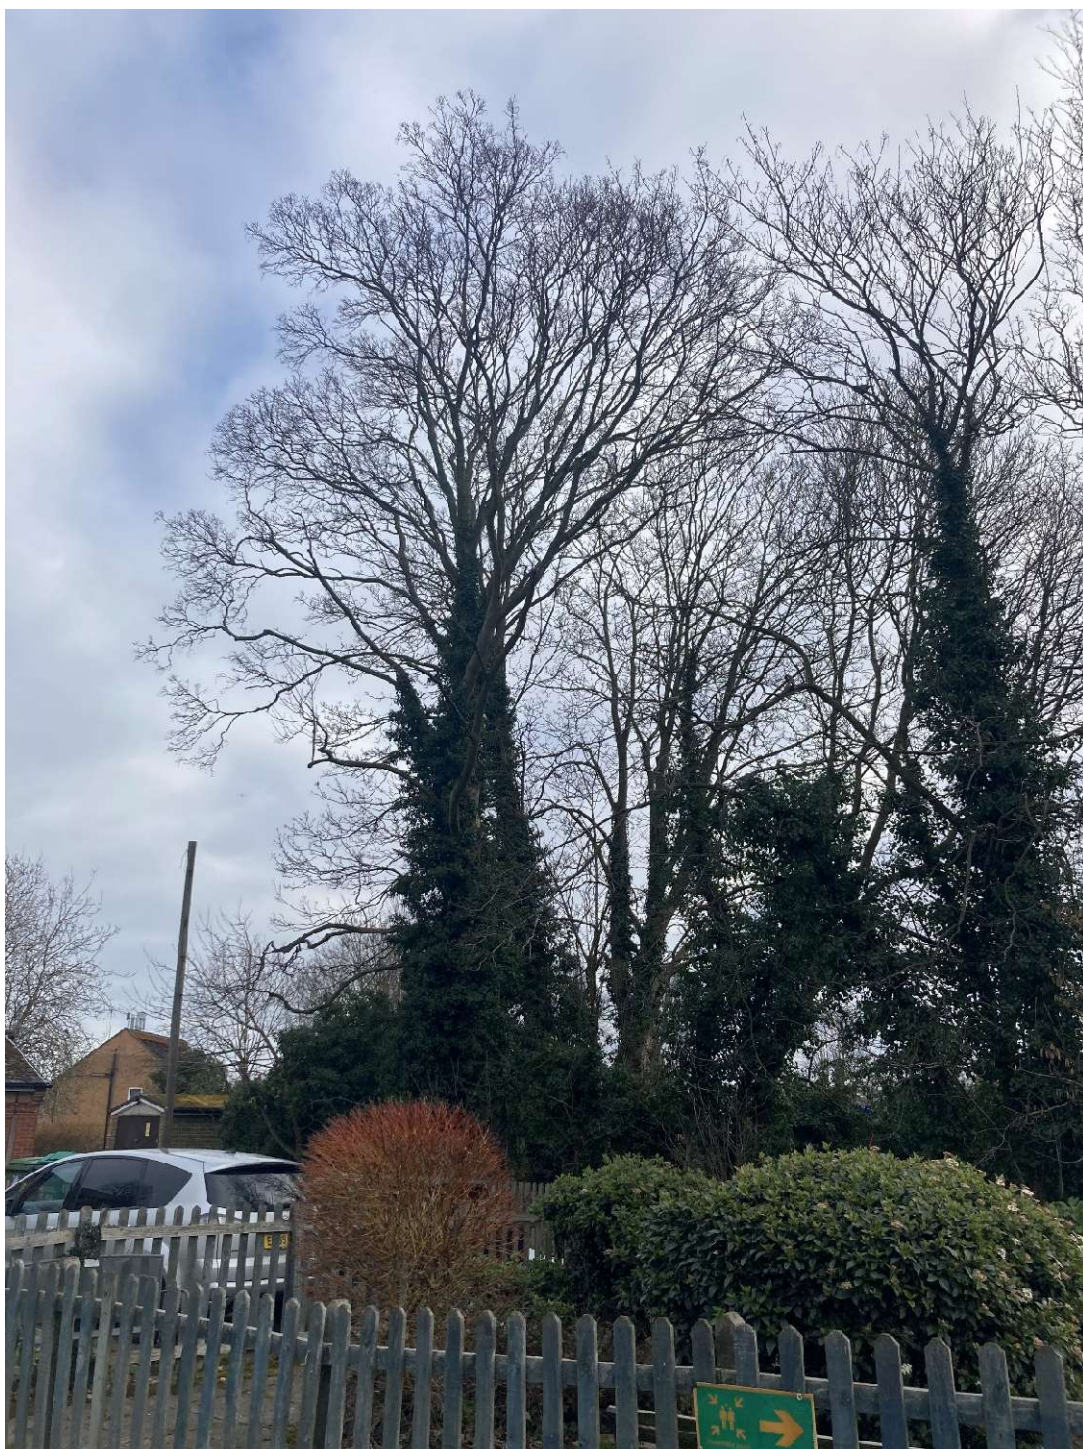
**T55-T63**

| Tree No. | Species | Diameter (mm)* | Height | Crown Spread | | | | Crown Height | First Branch Height and Direction | | Age Class | Vigour | Life Expectancy | Structural Condition/Comments | BS5837 Category |
|---|---|---|---|---|---|---|---|---|---|---|---|---|---|---|---|
| T57 | Tilia X europaea (Common Lime) | 950 | 21 | 10 | 9 | 10 | 6 | 6 | 6 | E | M | Good | 40+ | Unable to inspect stem due to Ivy. Previous branch failures. Minor deadwood in the crown. Crown distorted due to group pressure.<br>Prominent, mature lime. Part of a mixed species group of mature trees in the north of the infant school site. | A2 |
| T60 | Aesculus hippocastanum (Horse Chestnut) | 430 | 11 | 3 | 6 | 3 | 6 | 2 | 1.5 | W | EM | Good | 20+ | Stem wounds. Previous branch failures. Minor deadwood in the crown. Crown distorted due to group pressure. | B2 |

- In order to further mitigate potential root damage caused by the encroachments into the RPA of T51-T57, T59 and T60, 'No-dig' construction methodologies will be implemented in the northern-most bays of the new 14 bay car park, and for the construction of pedestrian routes/hardstanding around the northeast end of the proposed new modular building. The minimum area where this is required is shown on the attached Tree Removal and Protection Plan (JSL4733\_710) with a green hatch.
