18 Church Road, Caversham RG4 7AD

Preliminary Bat Roost Assessment

Sundance Construction Limited

**October 2024**

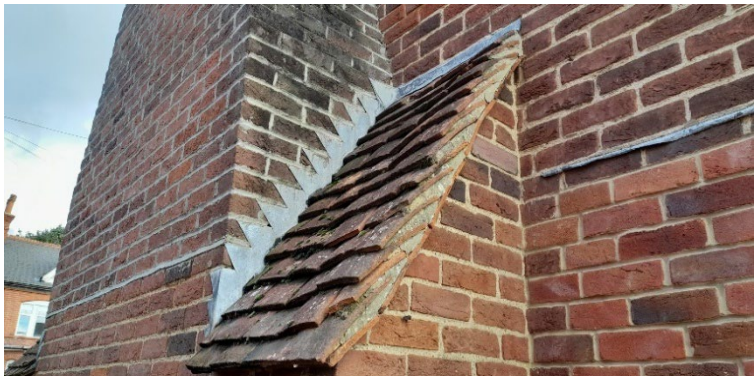
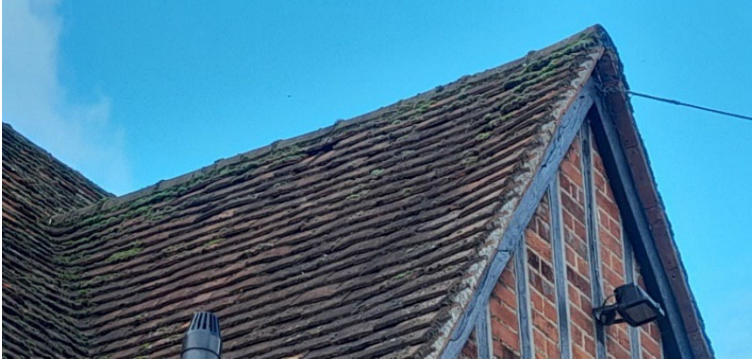
- 4.2.3 The roof has clay tiles, with gaps on all pitches. The lead flashing is in good condition with no gaps recorded.
- 4.2.4 Artificial lighting comprises a streetlight approximately 10 metres from the northwest corner of the house, and also small lights mounted to the walls on both the north and south elevations.

| Reference Number | Feature Description | Photograph | Roosting Potential |
|---|---|---|---|
| PRF 1 | Examples of gaps between clay tiles on roof | | High |

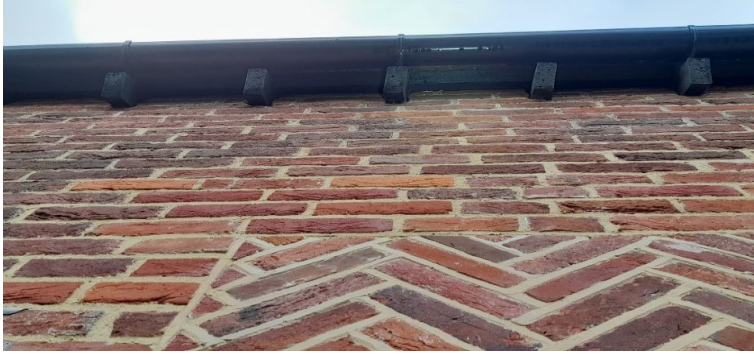
- 4.2.2 The brick work and pointing is in very good condition with no PRFs visible. The timber rafters protrude out from the wall at the eaves, and there are a few small crevices around these on both the front and rear elevations which could allow access for bats, but the majority of the rafters do not have any gaps of a suitable size.

| Reference Number | Feature Description | Photograph | Roosting Potential |
|---|---|---|---|
| PRF 2 | Gaps around protruding rafter at eaves | | Low |

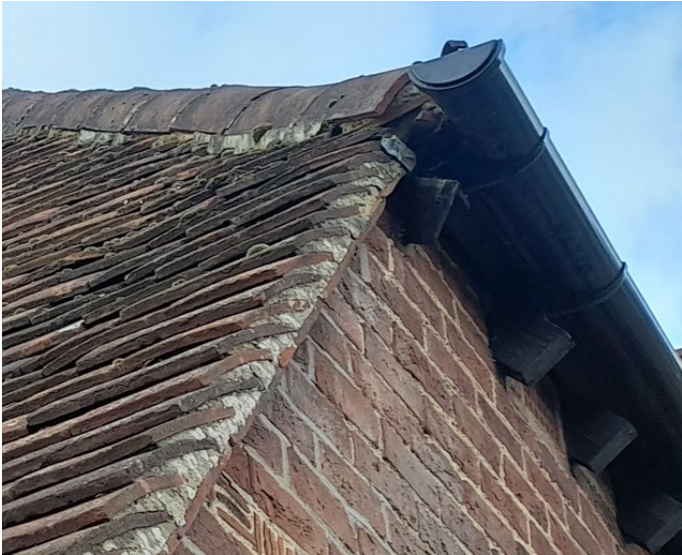
| Reference Number | Feature Description | Photograph | Roosting Potential |
|---|---|---|---|
| PRF 3 | Gap under tile | | Low |

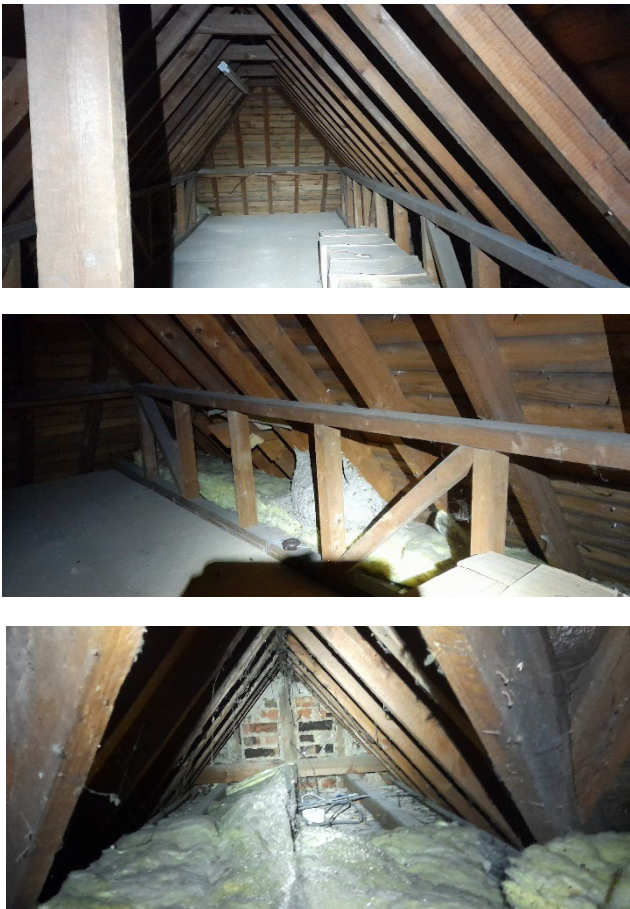
- 4.2.9 The roof has wooden sarking in good condition with very few gaps. It is not possible to determine if there is another lining such as bitumen between the sarking and the roof tiles. No bat droppings or other evidence of bats was recorded. The loft is partially used for storage and appears to receive regular human disturbance.
- 4.2.10 The cellar is underneath the extension wing and is used for storage, it appears to receive high levels of human disturbance. No access points were observed where bats could access inside. The cellar is deemed negligible for bat roost potential.
- 4.2.11 **Table 2** outlines the details of the internal inspection with photographs.

| Feature Description | Photograph of Feature |
|---|---|
| <p>Images of the loft void, which has limited suitability for bats due to a lack of outside access, and likely high levels of human disturbance.</p> | <p>The photographs show the interior of a loft void. The top photo shows a view looking up at the wooden roof structure with several beams. The middle photo shows a closer view of the wooden beams and insulation. The bottom photo shows a view looking down at the insulation and wooden beams.</p> |

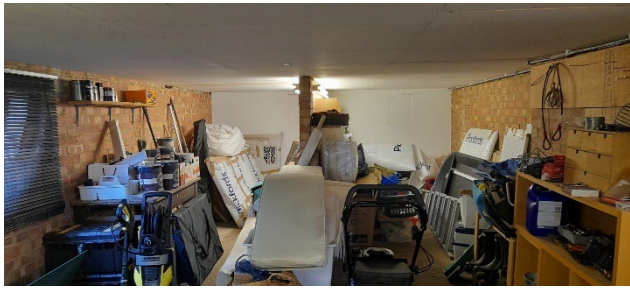
| Feature Description | Photograph of Feature |
|---|---|
| <p>The cellar, considered negligible for bat roost potential.</p> | <p>The photograph shows the interior of a cellar, which is cluttered with various items, including boxes, equipment, and storage containers. The walls are made of brick and the floor is concrete.</p> |
