# Land West of Kidmore End Road: Soakaway Testing

P25033\_R2  
March 2025

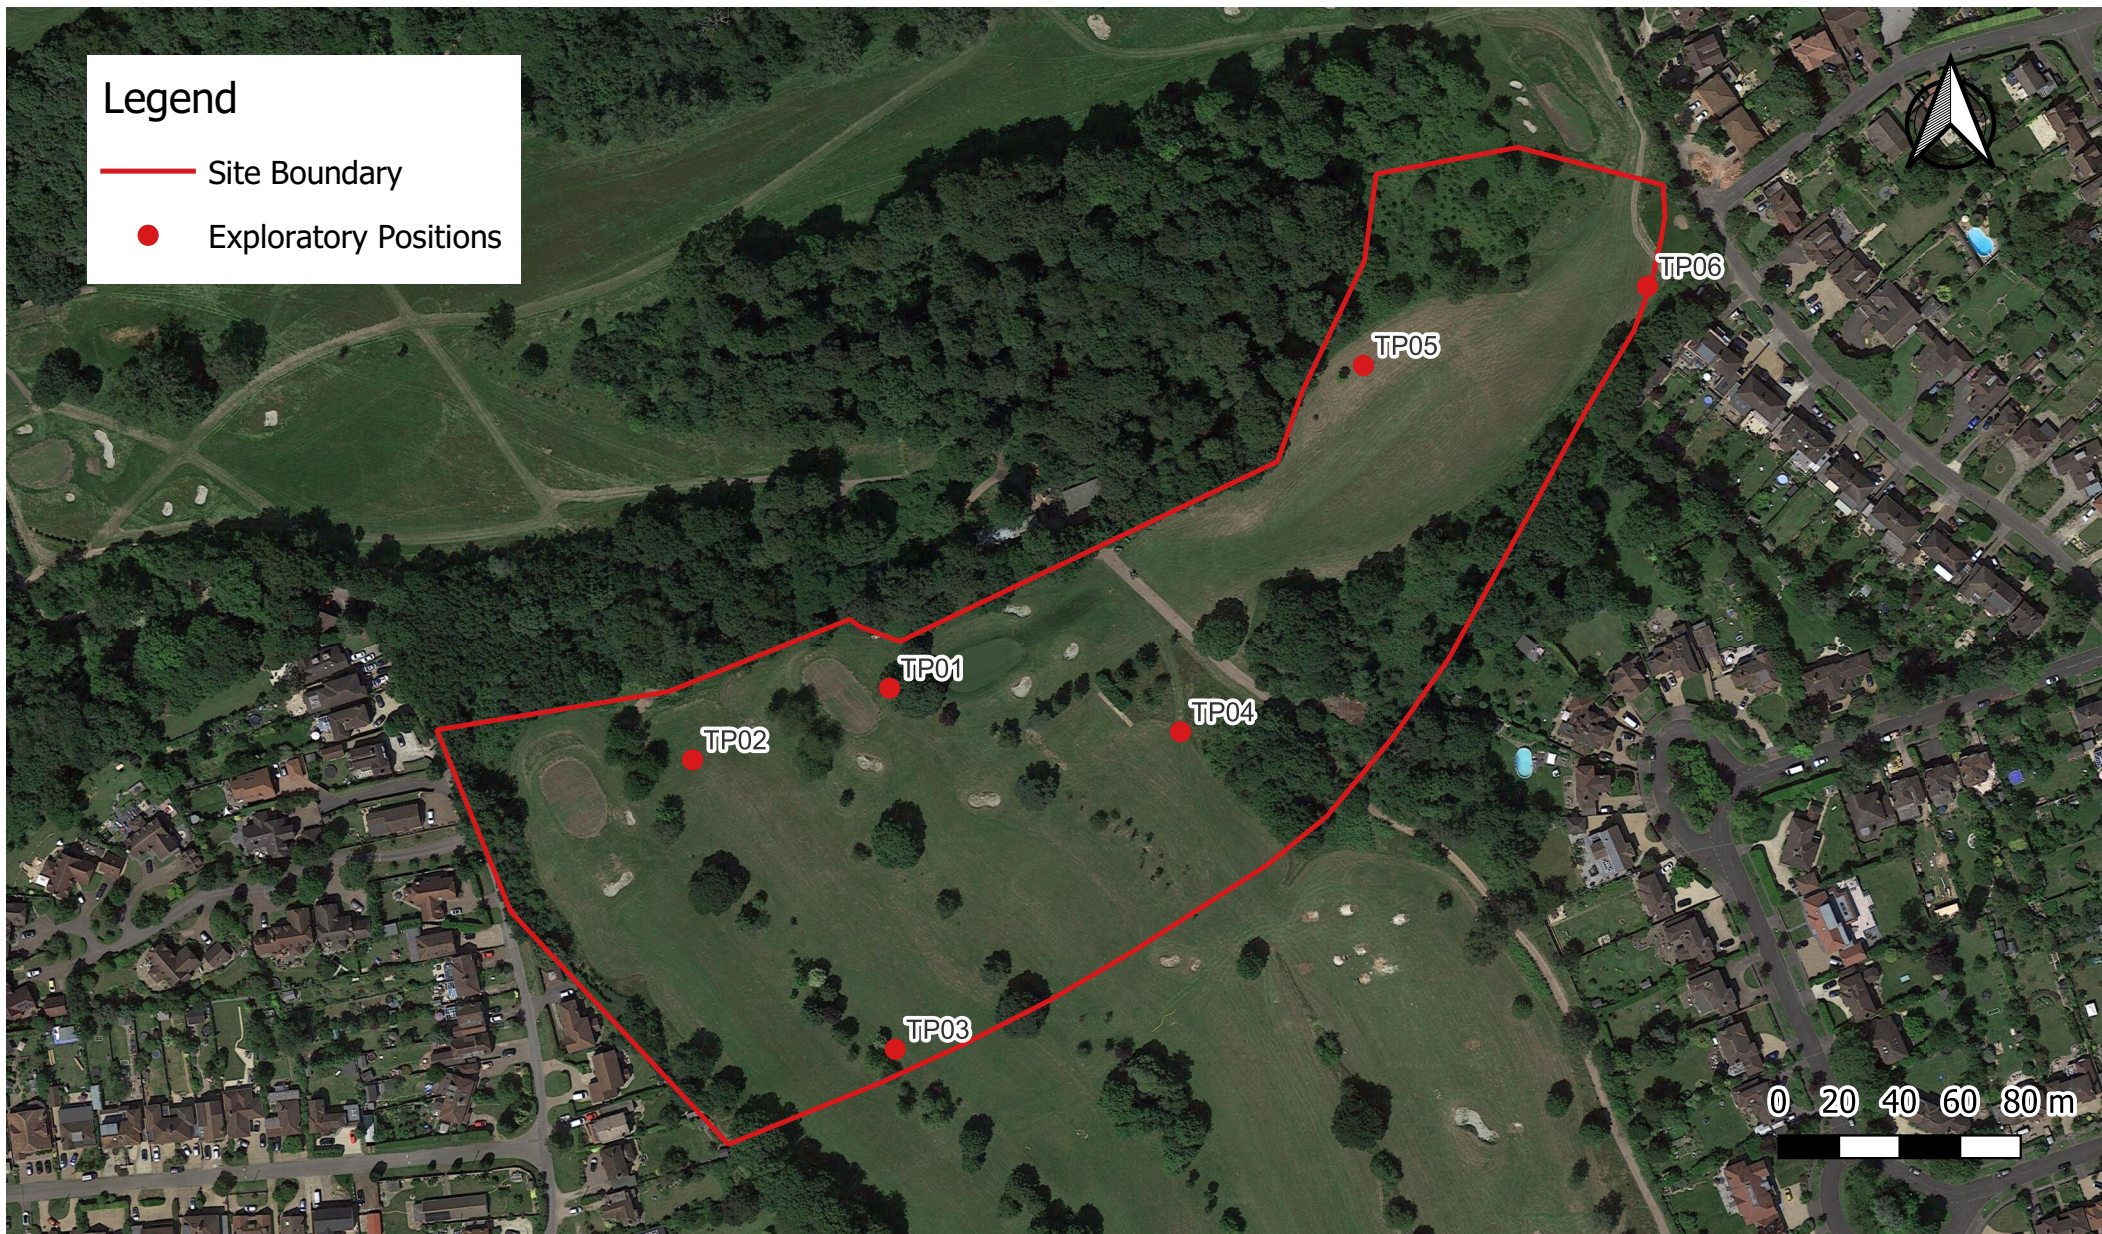
Fieldwork was undertaken over two days between the 30<sup>th</sup> August and 1<sup>st</sup> September 2022, with the location of each exploratory hole agreed with the Client and designed to minimise Site damage whilst providing suitable coverage. Drawing P25033\_R2\_D02 details the locations of the exploratory holes, and the ground conditions encountered are discussed in Section 3. The works undertaken are summarised in the following table:
