**ARBORICULTURAL IMPACT ASSESSMENT**

**VILLAGE HOTEL READING**  
**CAVERSHAM BRIDGE,**  
**RICHFIELD AVENUE,**  
**READING,**  
**RG1 8BD**

# Arboricultural Impact Assessment (AIA)

## BS 5837 'Trees in Relation to Design, Demolition and Construction' (2012)

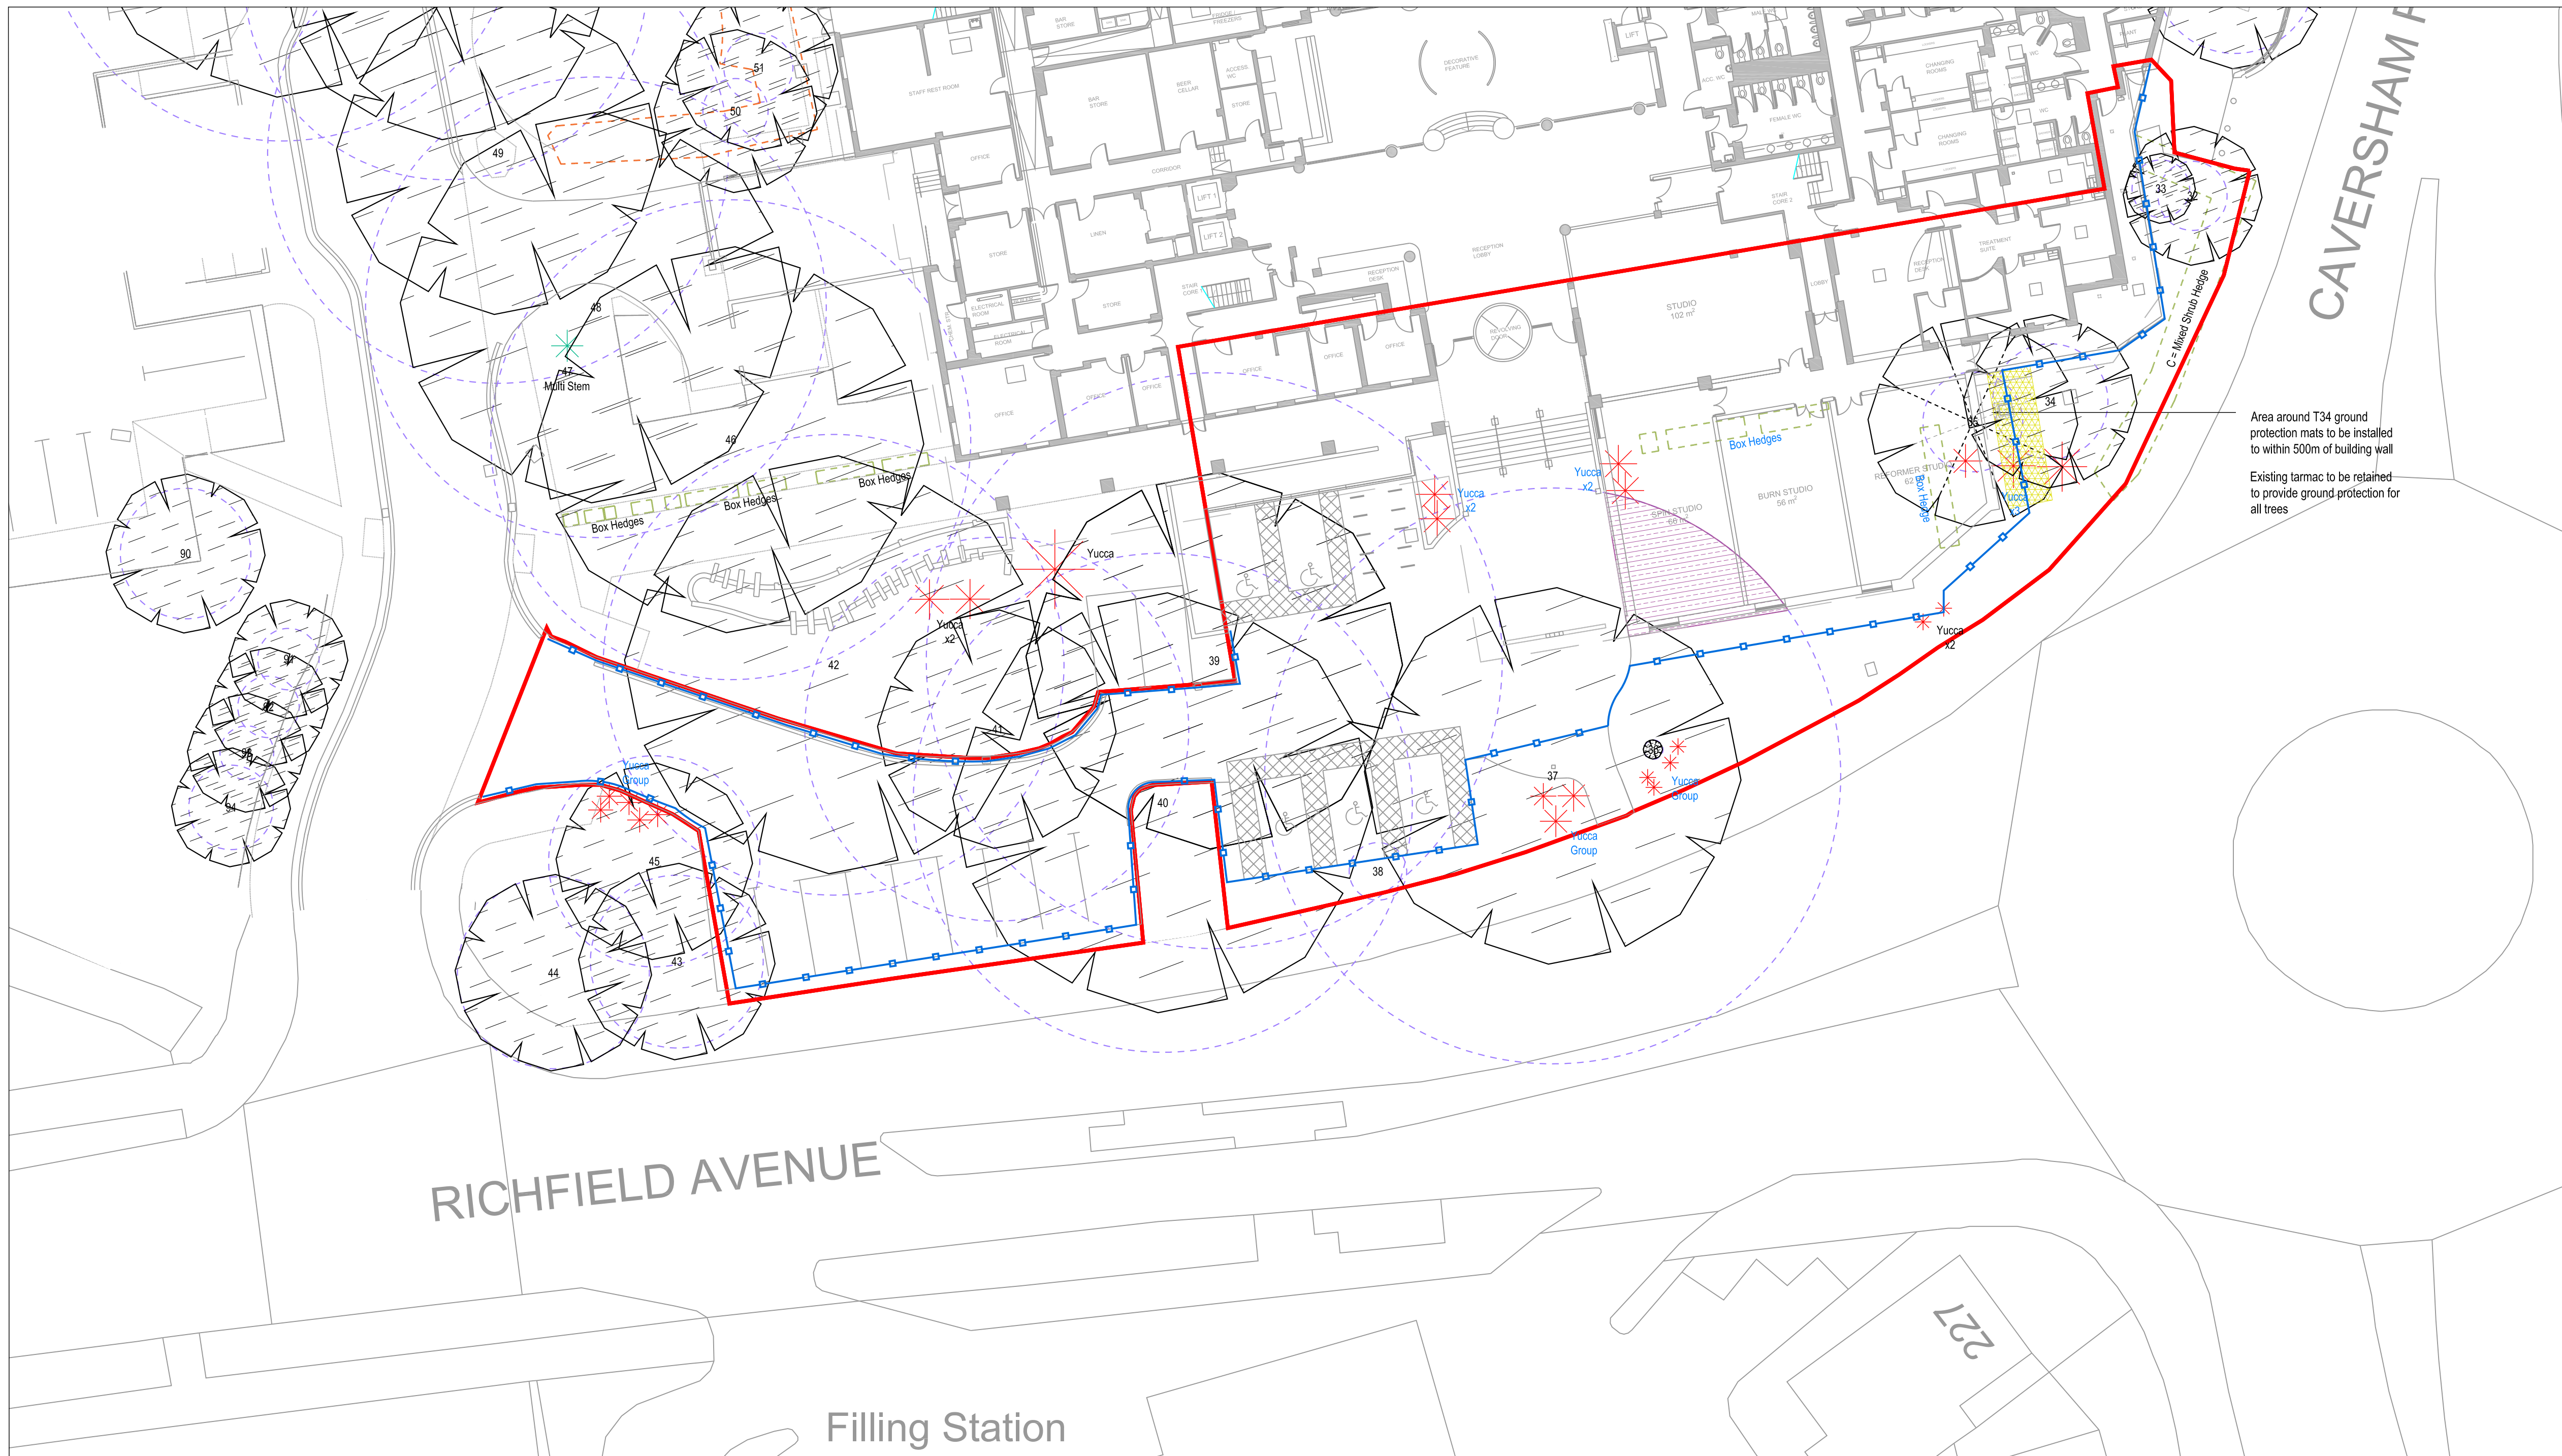
| Drawing No.<br><b>1610a-05</b> | | | Revision.<br><b>A</b> |

Working in accordance with BS5837 (2012), root spread calculation formulas have identified trees designated for retention that could potentially be at risk. Tree Nos. 34, 37 and 39 to 42 have specified 'root protection areas' (RPA) that encroach within or immediately abut the proposed new fitness suite, canopy replacement or areas proposed for existing hardstanding removal. Root encroachment that potentially placing them at risk of direct or indirect physical damage during the construction phase, and longer-term damage because of soil compaction issues.

However, whilst T34 root protection area abuts the new building, the root protection area of T37 extends beneath the design footprint of the building, and consequently it could be at direct risk of physical damage during the construction stage.

There is a proposal for replacing the existing entrance canopy. The current design appears not to enlarge the existing canopy area. However, there is a requirement for the replacement of the existing central column, and re-using the two columns behind it, closer to the building's entrance. The columns fall within part or all of Tree No 37 and 39 RPA's.

To mitigate for potential root damage, a combination of tree protection fences, ground protection, the utilisation of the existing tarmac car park areas as ground protection, and the implementation of alternative construction methodologies will need to be implemented.

To mitigate for any potential direct root damage to these two trees during the building's construction, the building of the outer walls should be constructed utilising a 'piled' foundation construction method, with accompanying linking 'ground beam'. The design of which will need to be provided by a structural engineer.

Prior to construction, essential tree fence and ground protection methods will need to be implemented around the trees, as referenced within the Tree Protection Plan, with regular monitoring implemented to ensure full adherence to the protection plan during the construction stage.

To mitigate for any construction related damage, where practical, the replacement canopy support columns should be located within the same locations as the existing columns.
