**17 Conisboro Avenue, Reading RG4 7JB**

## **Arboricultural impact assessment and tree protection measures**

**Site inspected on 5<sup>th</sup> & 9<sup>th</sup> September 2023  
by David White,  
LANTRA-approved Professional Tree Inspector  
White Knight Tree Care & Consultancy**

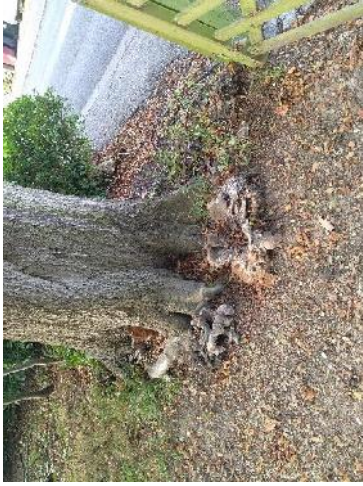
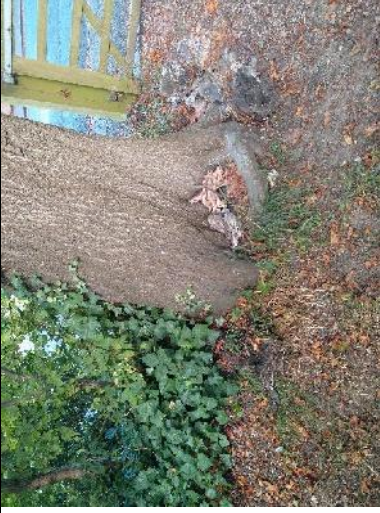
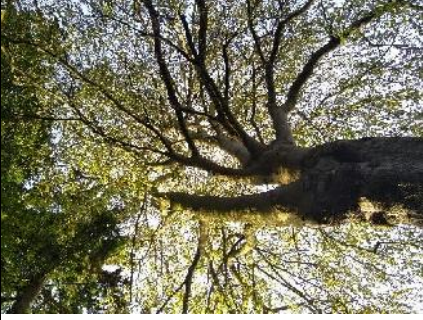
| Ref. | Species | Photo | Photo | Photo |
|---|---|---|---|---|
| T001 | Common Beech<br>( <i>Fagus sylvatica</i> ) | | | |

| Ref. | Species | Location | Structure | Num. Stems | DBH (cm) | General Observations | RPA | Recommendations | Retention category |
|---|---|---|---|---|---|---|---|---|---|
| T001 | Common Beech<br>( <i>Fagus sylvatica</i> ) | Pavement, driveway and road | Tree | 1 | 90 | <ul style="list-style-type: none"> <li>Canopy thin</li> <li><i>Meripilus giganteum</i> around majority of base</li> <li>Water main under base</li> <li>Poor vitality</li> </ul> | 10.8m radius<br>366.5m <sup>2</sup> | <ul style="list-style-type: none"> <li>Dismantle</li> </ul> Timescale: 05-Dec-2023 (3 months) | U |

T1, although it would not be directly impacted by the proposed development, is also to be removed due to the presence of *Meripilus giganteum*.

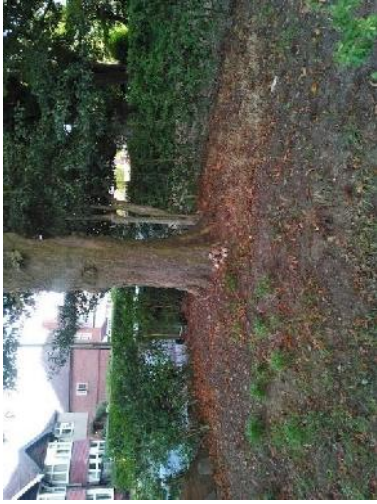
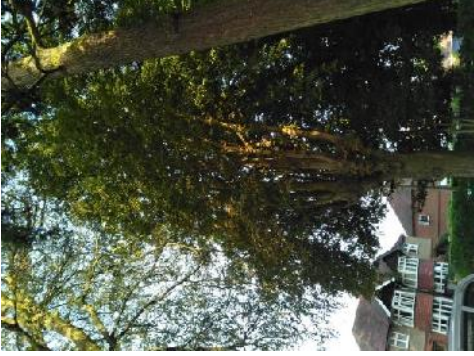
| Ref. | Species | Photo | Photo | Photo |
|---|---|---|---|---|
| T002 | Horse Chestnut<br>( <i>Aesculus hippocastanum</i> ) | | | |

| Ref. | Species | Location | Structure | Num. Stems | DBH (cm) | General Observations | RPA | Recommendations | Retention category |
|---|---|---|---|---|---|---|---|---|---|
| T002 | Horse Chestnut<br>( <i>Aesculus hippocastanum</i> ) | Road, pavement and driveway | Tree | 1 | 69 | <ul style="list-style-type: none"> <li>Good condition</li> <li>Mature</li> <li>Lapsed Pollard</li> <li>Normal vitality</li> </ul> | 8.3m radius<br>215.4m <sup>2</sup> | <ul style="list-style-type: none"> <li>Mulch</li> </ul> Timescale: 05-Sep-2024 (1 Year) | B2 |

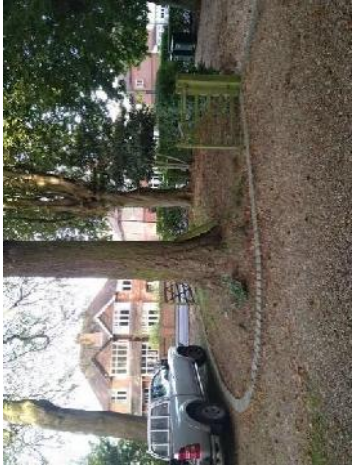
| Ref. | Species | Photo | Photo | Photo |
|---|---|---|---|---|
| T003 | Douglas Fir<br>( <i>Pseudotsuga menziesii</i> ) | | | |

| Ref. | Species | Location | Structure | Num. Stems | DBH (cm) | General Observations | RPA | Recommendations | Retention category |
|---|---|---|---|---|---|---|---|---|---|
| T003 | Douglas Fir<br>( <i>Pseudotsuga menziesii</i> ) | In driveway | Tree | 1 | 81 | <ul style="list-style-type: none"> <li>Good condition</li> <li>Mature</li> <li>7.8m from current wall</li> </ul> | 9.72m radius<br>296.9m <sup>2</sup> | <ul style="list-style-type: none"> <li>Mulch</li> </ul> Timescale: 05-Sep-2024 (1 Year) | A2 |

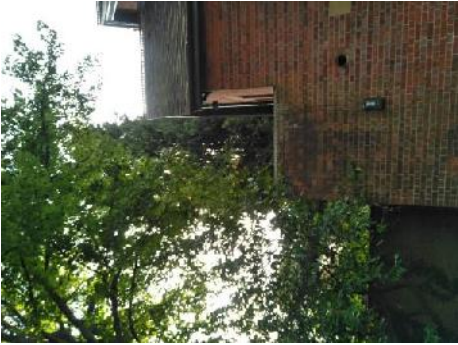
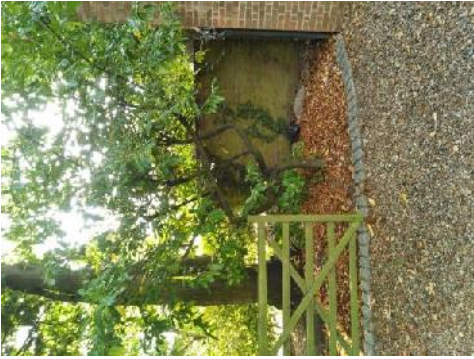
| Ref. | Species | Photo | Photo | Photo |
|---|---|---|---|---|
| T004 | Lime<br>( <i>Tilia sp.</i> ) | | | |

| Ref. | Species | Location | Structure | Num. Stems | DBH (cm) | General Observations | RPA | Recommendations | Retention category |
|---|---|---|---|---|---|---|---|---|---|
| T004 | Lime<br>( <i>Tilia sp.</i> ) | South East corner of building | Tree | 2 | 60cm below union<br><br>40cm and 37.5cm above union | <ul style="list-style-type: none"> <li>• Good condition</li> <li>• Mature</li> </ul> | 6.9m radius<br><br>149.6m <sup>2</sup> | <ul style="list-style-type: none"> <li>• Mulch</li> <li>• Some very minor pruning may be necessary to ensure clearance during construction (approx. 1m off select limbs on house side)</li> </ul> Timescale: 05-Sep-2024 (1 Year) | B1 |

The most significantly affected tree to be retained is Lime T4 which will require foundations well within its RPA. In order to minimise the impact of the foundations to T4, pile foundations will be used rather than traditional concrete filled trenches. This will allow the majority of the roots to remain undisturbed and still allow for the free flow of water and oxygen beneath the newly built structure thereby retaining the soil's viability.

A trial trench was dug along the full width of the RPA and no significant roots were found down to a depth of 220mm below ground level meaning the concrete ring beam of the foundations (as seen in drawing 2279.21B) will not sever or disturb major roots.

T4 may require a 1m reduction to selected limbs on the North-West side, depending on height of scaffolding.

Pilot holes for the piles will be hand dug/drilled to a depth of 750-1000mm below ground level to ensure there are not significant roots (greater than 25mm diameter) within the intended path of the piles. If a significant root is discovered during this process the precise pile location will be slightly adjusted to avoid the root. Once a suitable pilot hole has been dug (the position of the hole may have to change slightly depending on roots present), only then will a piling rig be used. The concrete piles will be sheathed/poured in plastic or steel pipes to minimise the risk of cement leaching into the ground water and altering pH in the vicinity of the newly cast piles.

For Lime T4 additional protective measures will be required due to the proximity of the construction activity and will be installed by a qualified arboriculturist. This will consist of a soft impact-resistant material, such as rubber or high-density foam, in contact with the stem of the tree, fixed in place with ratchet straps or similar to prevent it from sliding down/off of the stem. Around this, a hard protective barrier made from timber and plywood and gently braced against the cushioned stem to prevent any movement (e.g. rotation) of the outer barrier. This will prevent accidental mechanical damage to the tree's stem.

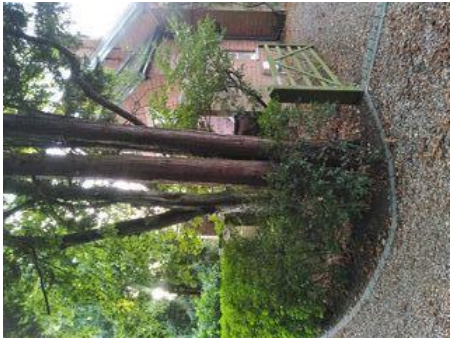
| Ref. | Species | Photo | Photo | Photo |
|---|---|---|---|---|
| T005 | Lawson<br>Cypress<br>( <i>Chamaecyparis lawsoniana</i> ) | | | |

| Ref. | Species | Location | Structure | Num. Stems | DBH (cm) | General Observations | RPA | Recommendations | Retention category |
|---|---|---|---|---|---|---|---|---|---|
| T005 | Lawson Cypress<br>( <i>Chamaecyparis lawsoniana</i> ) | Driveway | Tree | 3 | 35cm, 35cm, 15cm<br><br>0.52m combined stem diameter | <ul style="list-style-type: none"> <li>• Fair condition</li> <li>• Compression fork</li> <li>• Lowest limb over driveway quite low</li> <li>• Normal vitality</li> </ul> | 6.2m radius<br><br>120.8m <sup>2</sup> | <ul style="list-style-type: none"> <li>• Crown raise to 5m above ground level over driveway</li> </ul> Before works commence | B |

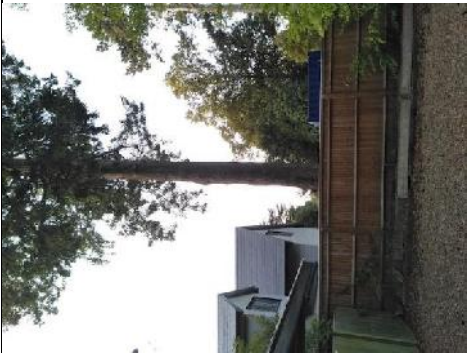
| Ref. | Species | Photo | Photo | Photo |
|---|---|---|---|---|
| T006 | Douglas Fir<br>( <i>Pseudotsuga menziesii</i> ) | | | |

| Ref. | Species | Location | Structure | Num. Stems | DBH (cm) | General Observations | RPA | Recommendations | Retention category |
|---|---|---|---|---|---|---|---|---|---|
| T006 | Douglas Fir<br>( <i>Pseudotsuga menziesii</i> ) | Neighbours | Tree | 1 | 75 | <ul style="list-style-type: none"> <li>• Good condition</li> <li>• Mature</li> <li>• Surface roots visible in drive</li> <li>• Normal vitality</li> </ul> | 9.0m radius<br><br>254.5m <sup>2</sup> | N/A | A12 |

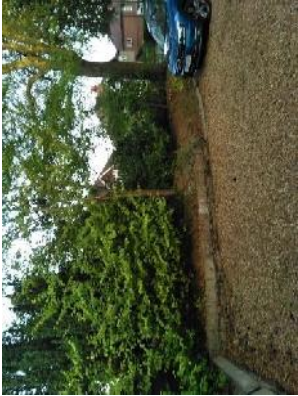
| Ref. | Species | Photo | Photo | Photo |
|---|---|---|---|---|
| T007 | Mixed species | | | |

| Ref. | Species | Location | Structure | Num. Stems | DBH (cm) | General Observations | RPA | Recommendations | Retention category |
|---|---|---|---|---|---|---|---|---|---|
| T007 | Mixed species | Roadside boundary | Group | 50 | 15 | <ul style="list-style-type: none"> <li>Mixed bed including Irish yew, cherry laurel and elm.</li> <li>Largest diameter stem is an elm at 15cm</li> </ul> | 1.8m beyond vegetation<br>10.2m <sup>2</sup> | N/A | C |

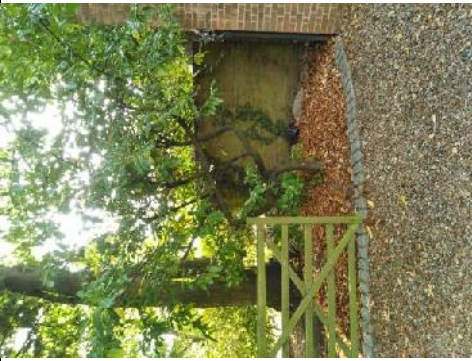
| Ref. | Species | Photo | Photo | Photo |
|---|---|---|---|---|
| T008 | Laurel Cherry<br>( <i>Prunus laurocerasus</i> ) | | | |

| Ref. | Species | Location | Structure | Num. Stems | DBH (cm) | General Observations | RPA | Recommendations | Retention category |
|---|---|---|---|---|---|---|---|---|---|
| T008 | Laurel Cherry<br>( <i>Prunus laurocerasus</i> ) | Next to house | Tree | 1 | 12cm at 1m | <ul style="list-style-type: none"> <li>Fair condition</li> <li>Small and easily replaced</li> </ul> | 1.4m radius<br>6.5m <sup>2</sup> | N/A | C |

T8, T10 and T11 are to be removed prior to work commencing, subject to approval from the Local Planning Authority. T8 is small and easily replaced; its location makes its retention untenable as it will be in the way of the proposed development. T10 is growing directly adjacent to a main wall of the property and is in the way of the proposed extension. It is small and easily replaced. T11, if retained, would be largely overhanging the new glazed extension, it has low visual amenity, low ecological value and has multiple structural defects as noted above, which would pose a risk to the new development. The removal of T11 would be advised regardless of whether or not permission is granted for the extension.

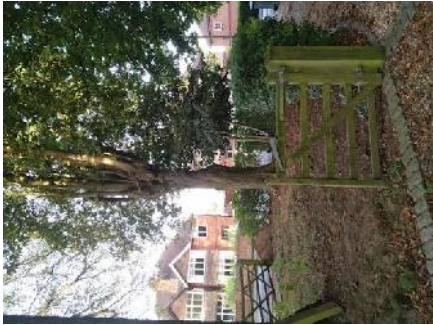
| Ref. | Species | Photo | Photo | Photo |
|---|---|---|---|---|
| T009 | Common Holly<br>( <i>Ilex aquifolium</i> ) | | | |

| Ref. | Species | Location | Structure | Num. Stems | DBH (cm) | General Observations | RPA | Recommendations | Retention category |
|---|---|---|---|---|---|---|---|---|---|
| T009 | Common Holly<br>( <i>Ilex aquifolium</i> ) | Southern boundary | Tree | 3 | Largest stem approximately 12 cm | <ul style="list-style-type: none"> <li>Small and easily replaced</li> <li>In RPA of chestnut</li> </ul> | 1.4m radius<br>6.5m <sup>2</sup> | N/A | C |

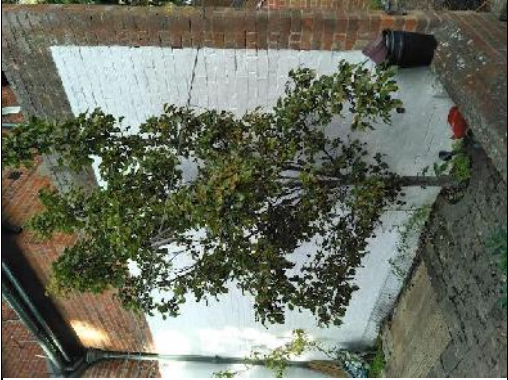
| Ref. | Species | Photo | Photo | Photo |
|---|---|---|---|---|
| T010 | Common Pear<br>( <i>Pyrus communis</i> ) | | | |

| Ref. | Species | Location | Structure | Num. Stems | DBH (cm) | General Observations | RPA | Recommendations | Retention category |
|---|---|---|---|---|---|---|---|---|---|
| T010 | Common Pear<br>( <i>Pyrus communis</i> ) | Against wall | Tree | 1 | 9 | <ul style="list-style-type: none"> <li>Semi-mature</li> <li>Small, easily replaced</li> </ul> | 1.1m radius<br>3.7m <sup>2</sup> | <ul style="list-style-type: none"> <li>Remove due to proximity to wall</li> </ul> Timescale: 05-Sep-2024 (1 Year) | U |

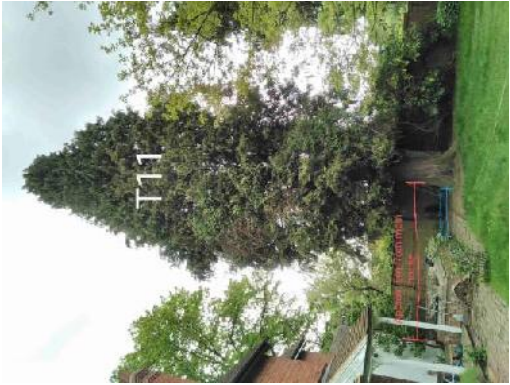
| Ref. | Species | Photo | Photo | Photo |
|---|---|---|---|---|
| T011 | Lawson<br>Cypress<br>( <i>Chamaecyparis lawsoniana</i> ) | | | |

| Ref. | Species | Location | Structure | Num. Stems | DBH (cm) | General Observations | RPA | Recommendations | Retention category |
|---|---|---|---|---|---|---|---|---|---|
| T011 | Lawson Cypress<br>( <i>Chamaecyparis lawsoniana</i> ) | Back garden | Tree | 4 | 150 | <ul style="list-style-type: none"> <li>Close proximity to main house (5m)</li> <li>Main unions are compression forks</li> <li>East of stem has a large ear protruding from union of 2 main stems</li> <li>Multiple compression forks throughout crown</li> <li>Canopy overrun with climbing roses and clematis</li> </ul> | 18m radius<br>1,017.9m <sup>2</sup> | <ul style="list-style-type: none"> <li>Dismantle to just above ground level</li> </ul> Timescale: 05-Sep-2024 (1 Year) | C |

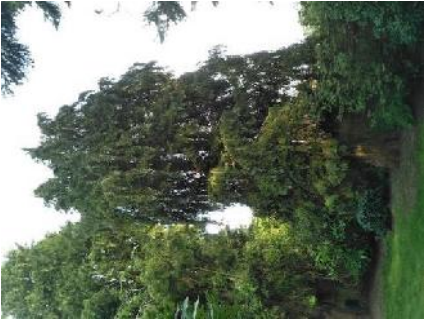
| Ref. | Species | Photo | Photo | Photo |
|---|---|---|---|---|
| T012 | Lawson<br>Cypress<br>( <i>Chamaecyparis lawsoniana</i> ) | | | |

| Ref. | Species | Location | Structure | Num. Stems | DBH (cm) | General Observations | RPA | Recommendations | Retention category |
|---|---|---|---|---|---|---|---|---|---|
| T012 | Lawson Cypress<br>( <i>Chamaecyparis lawsoniana</i> ) | Side boundary | Tree | 1 | 80 | <ul style="list-style-type: none"> <li>Mature</li> <li>Historically topped</li> </ul> | 9.6m radius<br>289.5m <sup>2</sup> | N/A | B2 |

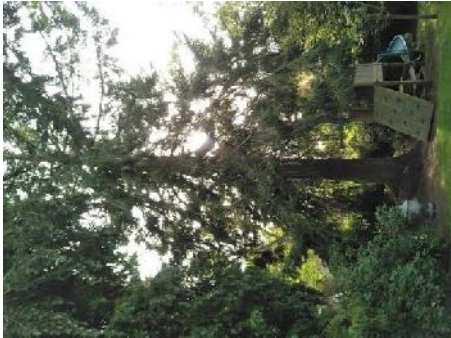
| Ref. | Species | Photo | Photo | Photo |
|---|---|---|---|---|
| T014 | Douglas Fir<br>( <i>Pseudotsuga menziesii</i> ) | | | |

| Ref. | Species | Location | Structure | Num. Stems | DBH (cm) | General Observations | RPA | Recommendations | Retention category |
|---|---|---|---|---|---|---|---|---|---|
| T014 | Douglas Fir<br>( <i>Pseudotsuga menziesii</i> ) | Back corner of garden | Tree | 1 | 85 | <ul style="list-style-type: none"> <li>Good condition</li> </ul> | 10.2m radius<br>326.9m <sup>2</sup> | <ul style="list-style-type: none"> <li>Mulch</li> </ul> Timescale: 05-Sep-2024 (1 Year) | A2 |

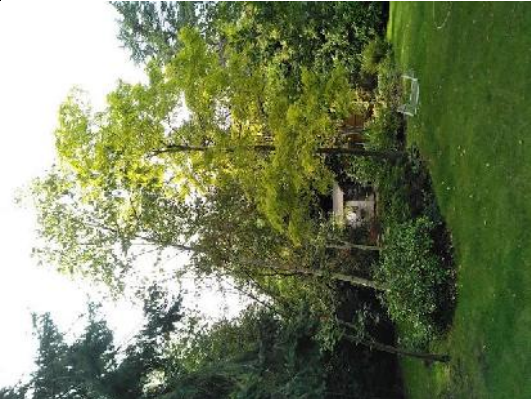
| Ref. | Species | Photo | Photo | Photo |
|---|---|---|---|---|
| T015 | Mixed species | | | |

| Ref. | Species | Location | Structure | Num. Stems | DBH (cm) | General Observations | RPA | Recommendations | Retention category |
|---|---|---|---|---|---|---|---|---|---|
| T015 | Mixed species | Near West boundary | Group | 1 | 15 | <ul style="list-style-type: none"> <li>Group of relatively small young trees</li> </ul> | 1.8m radius<br>10.2m <sup>2</sup> | N/A | B2 |

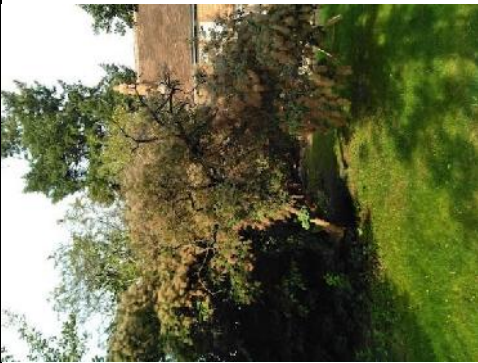
| Ref. | Species | Photo | Photo | Photo |
|---|---|---|---|---|
| T016 | Smoke bush<br>( <i>Cotinus</i><br><i>Coggygia</i> ) | | | |

| Ref. | Species | Location | Structure | Num. Stems | DBH (cm) | General Observations | RPA | Recommendations | Retention category |
|---|---|---|---|---|---|---|---|---|---|
| T016 | Smoke bush<br>( <i>Cotinus Coggygria</i> ) | North boundary | Tree | 1 | 16 | <ul style="list-style-type: none"> <li>Historically fallen and self-corrected</li> </ul> | 1.9m radius<br>11.6m <sup>2</sup> | N/A | C2 |

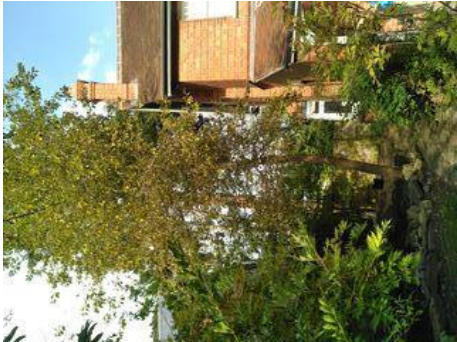
| Ref. | Species | Photo | Photo | Photo |
|---|---|---|---|---|
| T018 | Goat Willow<br>( <i>Salix caprea</i> ) | | | |

| Ref. | Species | Location | Structure | Num. Stems | DBH (cm) | General Observations | RPA | Recommendations | Retention category |
|---|---|---|---|---|---|---|---|---|---|
| T018 | Goat Willow<br>( <i>Salix caprea</i> ) | North boundary | Tree | 1 | 20 | <ul style="list-style-type: none"> <li>Fair condition</li> </ul> | 2.4m radius<br>18.1m <sup>2</sup> | N/A | C |

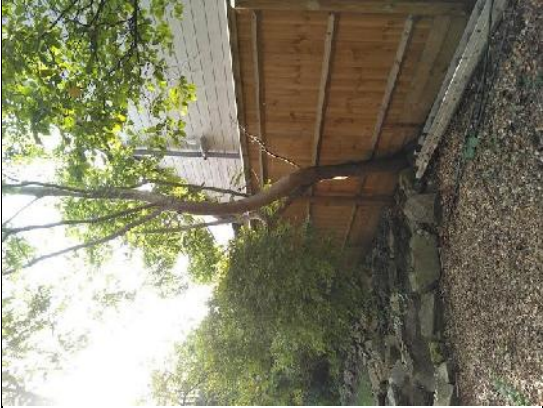
| Ref. | Species | Photo | Photo | Photo |
|---|---|---|---|---|
| T019 | Ash<br>( <i>Fraxinus</i> sp.) | | | |

| Ref. | Species | Location | Structure | Num. Stems | DBH (cm) | General Observations | RPA | Recommendations | Retention category |
|---|---|---|---|---|---|---|---|---|---|
| T019 | Ash<br>( <i>Fraxinus sp.</i> ) | North boundary | Tree | 1 | 20 | <ul style="list-style-type: none"> <li>Next to fence</li> <li>Fair condition</li> </ul> | 2.4m radius<br>18.1m <sup>2</sup> | N/A | C |
