THE FERNERY AT THE ACACIAS,  
LONDON ROAD, READING  
DESIGN AND ACCESS STATEMENT  
ISSUE 01: JULY 2025

# THE FERNERY AT THE ACACIAS: DESIGN AND ACCESS STATEMENT

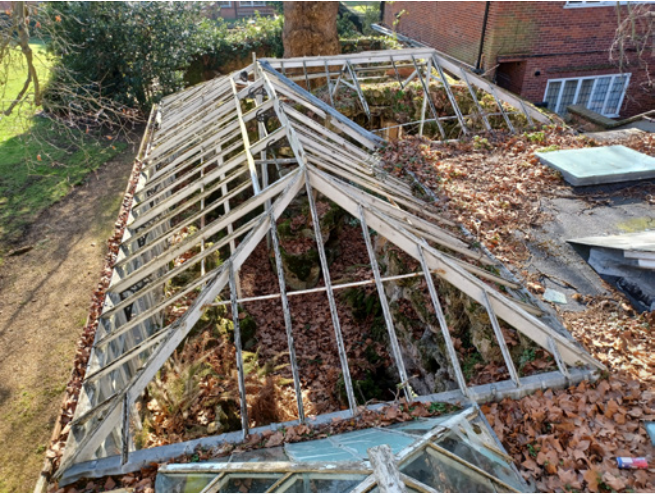
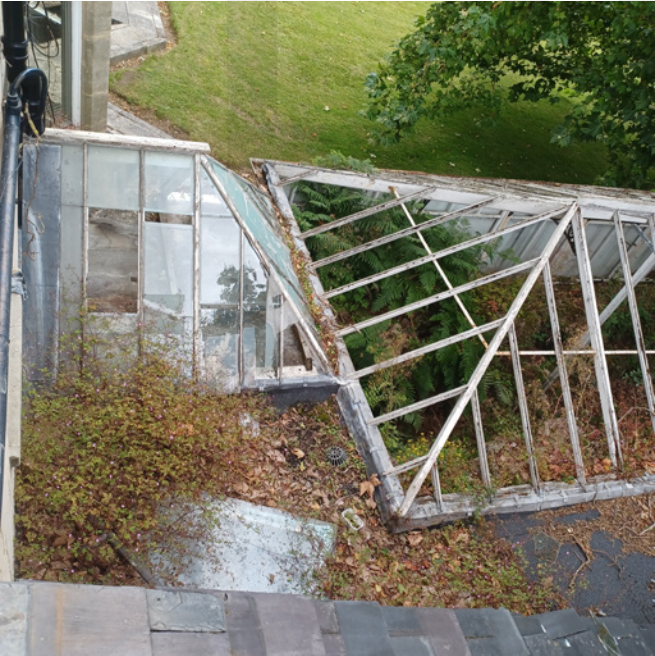
Roof seen from rear of the Acacias

- Decayed timbers of existing hipped roof removed and replaced with a new roof matching the existing layout, pitch, joinery profiles and metal brackets, but raised by about 150mm in relation to the existing roof height and incorporating opening lights; leadwork flashings to be incorporated to ridge, hips and eaves;

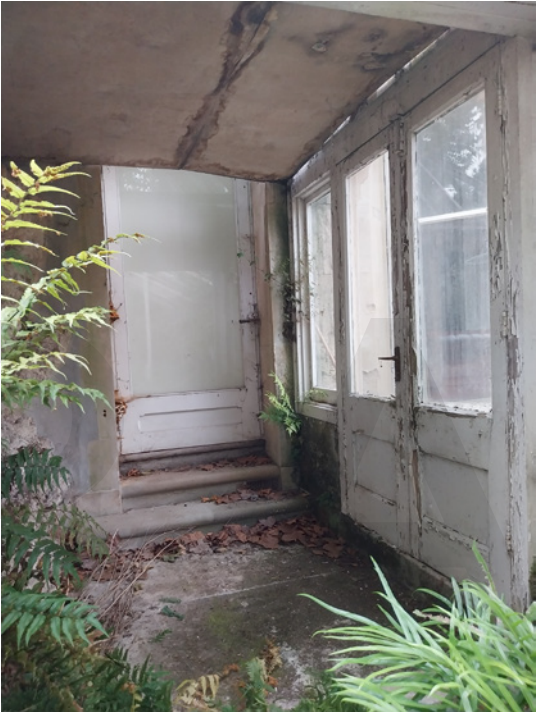
Entrance porch

| Proposed Alteration | Impact | Justification |
|---|---|---|
| Existing porch roof between the Fernery and the Acacias to be re-designed to allow improved drainage and access to adjacent flat roof | The existing porch roof is not original and is unsafe due to the risk of falling glass. Its replacement with a slightly shorter glazed roof will allow a lead-lined gutter to be introduced between the two roofs. | Apart from its awkward appearance, the current glazed roof has some practical disadvantages. The existing narrow gutter between the Porch roof and the Fernery roof is not discharging rainwater effectively. This has led to extensive timber decay in the structure below. Furthermore, the Porch roof prevents access to maintain the adjacent flat roof. A slightly shorter glazed roof of the same pitch and height as the existing roof will have minimal visual impact. |

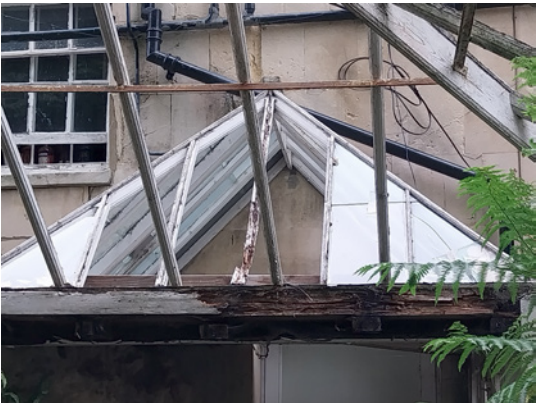
Junction of Fernery roof with porch roof

- New lead-lined gutter to be formed between porch roof and Fernery roof, discharging to a new cast-iron hopper and downpipe;
- New masonry upstand at junction of Fernery and flat roofs to prevent future decay to wall plate by provision of lead flashings chased into masonry and dressed onto the adjacent flat roof.

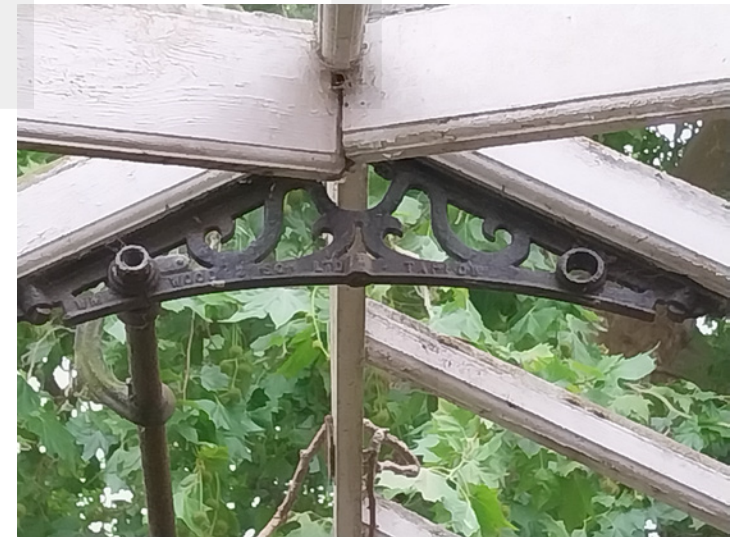
*Cast iron bracket below the ridge*

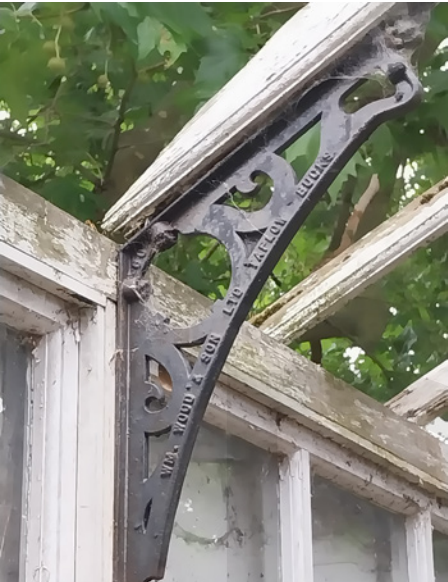
Cast iron bracket at eaves level

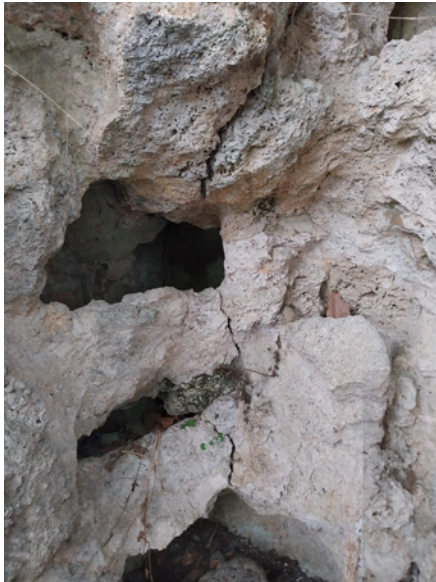
Crack in Pulhamite at south end of Fernery

The Fernery was inspected again on 2nd July 2025, including an inspection of the interior. There had been no significant changes to the condition observed in July 2023, however some cracking in the Pulhamite was observed at the south end of the Fernery. Given the dangerous condition of the roof, permission has been obtained from the Conservation Officer to carefully dismantle the decayed timber roof structure, retaining any salvageable elements, including cast-iron brackets and other iron fittings.

| Proposed Alteration | Impact | Justification |
|---|---|---|
| The Pulhamite rockwork in the Fernery will remain as existing. | The preliminary condition survey did not identify any significant defects in the rockwork and it appears to be stable, although some cracks are evident towards the south end of the Fernery. Temporary protection will be necessary to ensure that no damage occurs during the proposed works. If any conservation works are found to be necessary in the course of works, these will follow the guidance in the English Heritage publication <i>Durability Guaranteed: Pulhamite rockwork – Its conservation and repair</i> (2008). | No impact. |

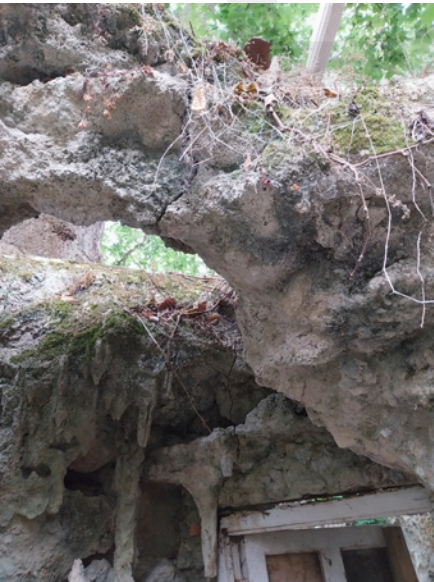
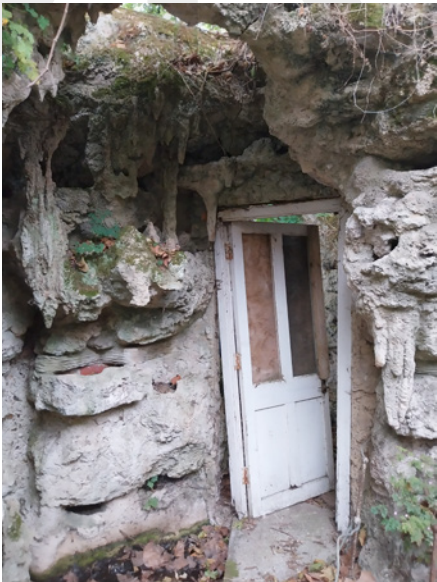
Pulhamite rockwork at south end of Fernery
