# RF19

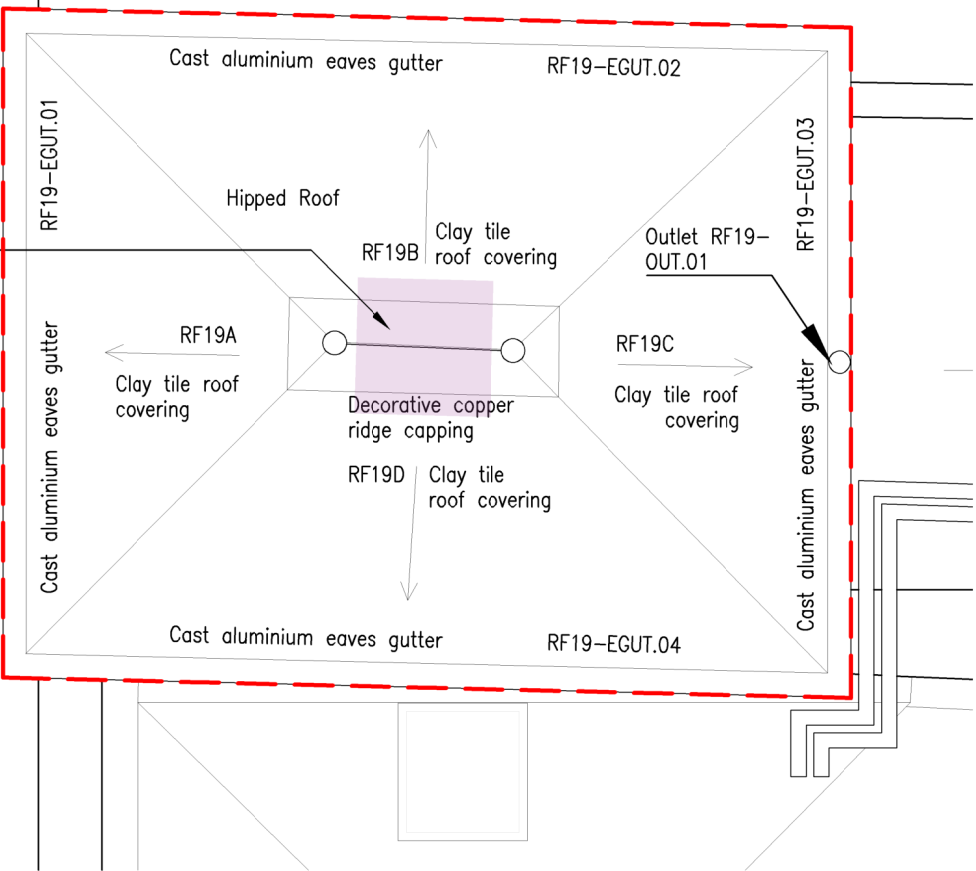
Remove 900mm x 900mm area of previously damaged lath and plaster ceiling finish above level 3 to inspect roof structure above. Trim existing timber joists to form new opening. New loft hatch to be installed to provide permanent access into roof space above. Inspect copper ridge capping to determine source of leak
