**BS 5837:2012 Tree Survey &  
Arboricultural Impact Assessment**

**Address: Village Hotel Car Park,  
Reading**

**Date: 5<sup>th</sup> December 2025**

**Report Prepared for McArdle Doyle**

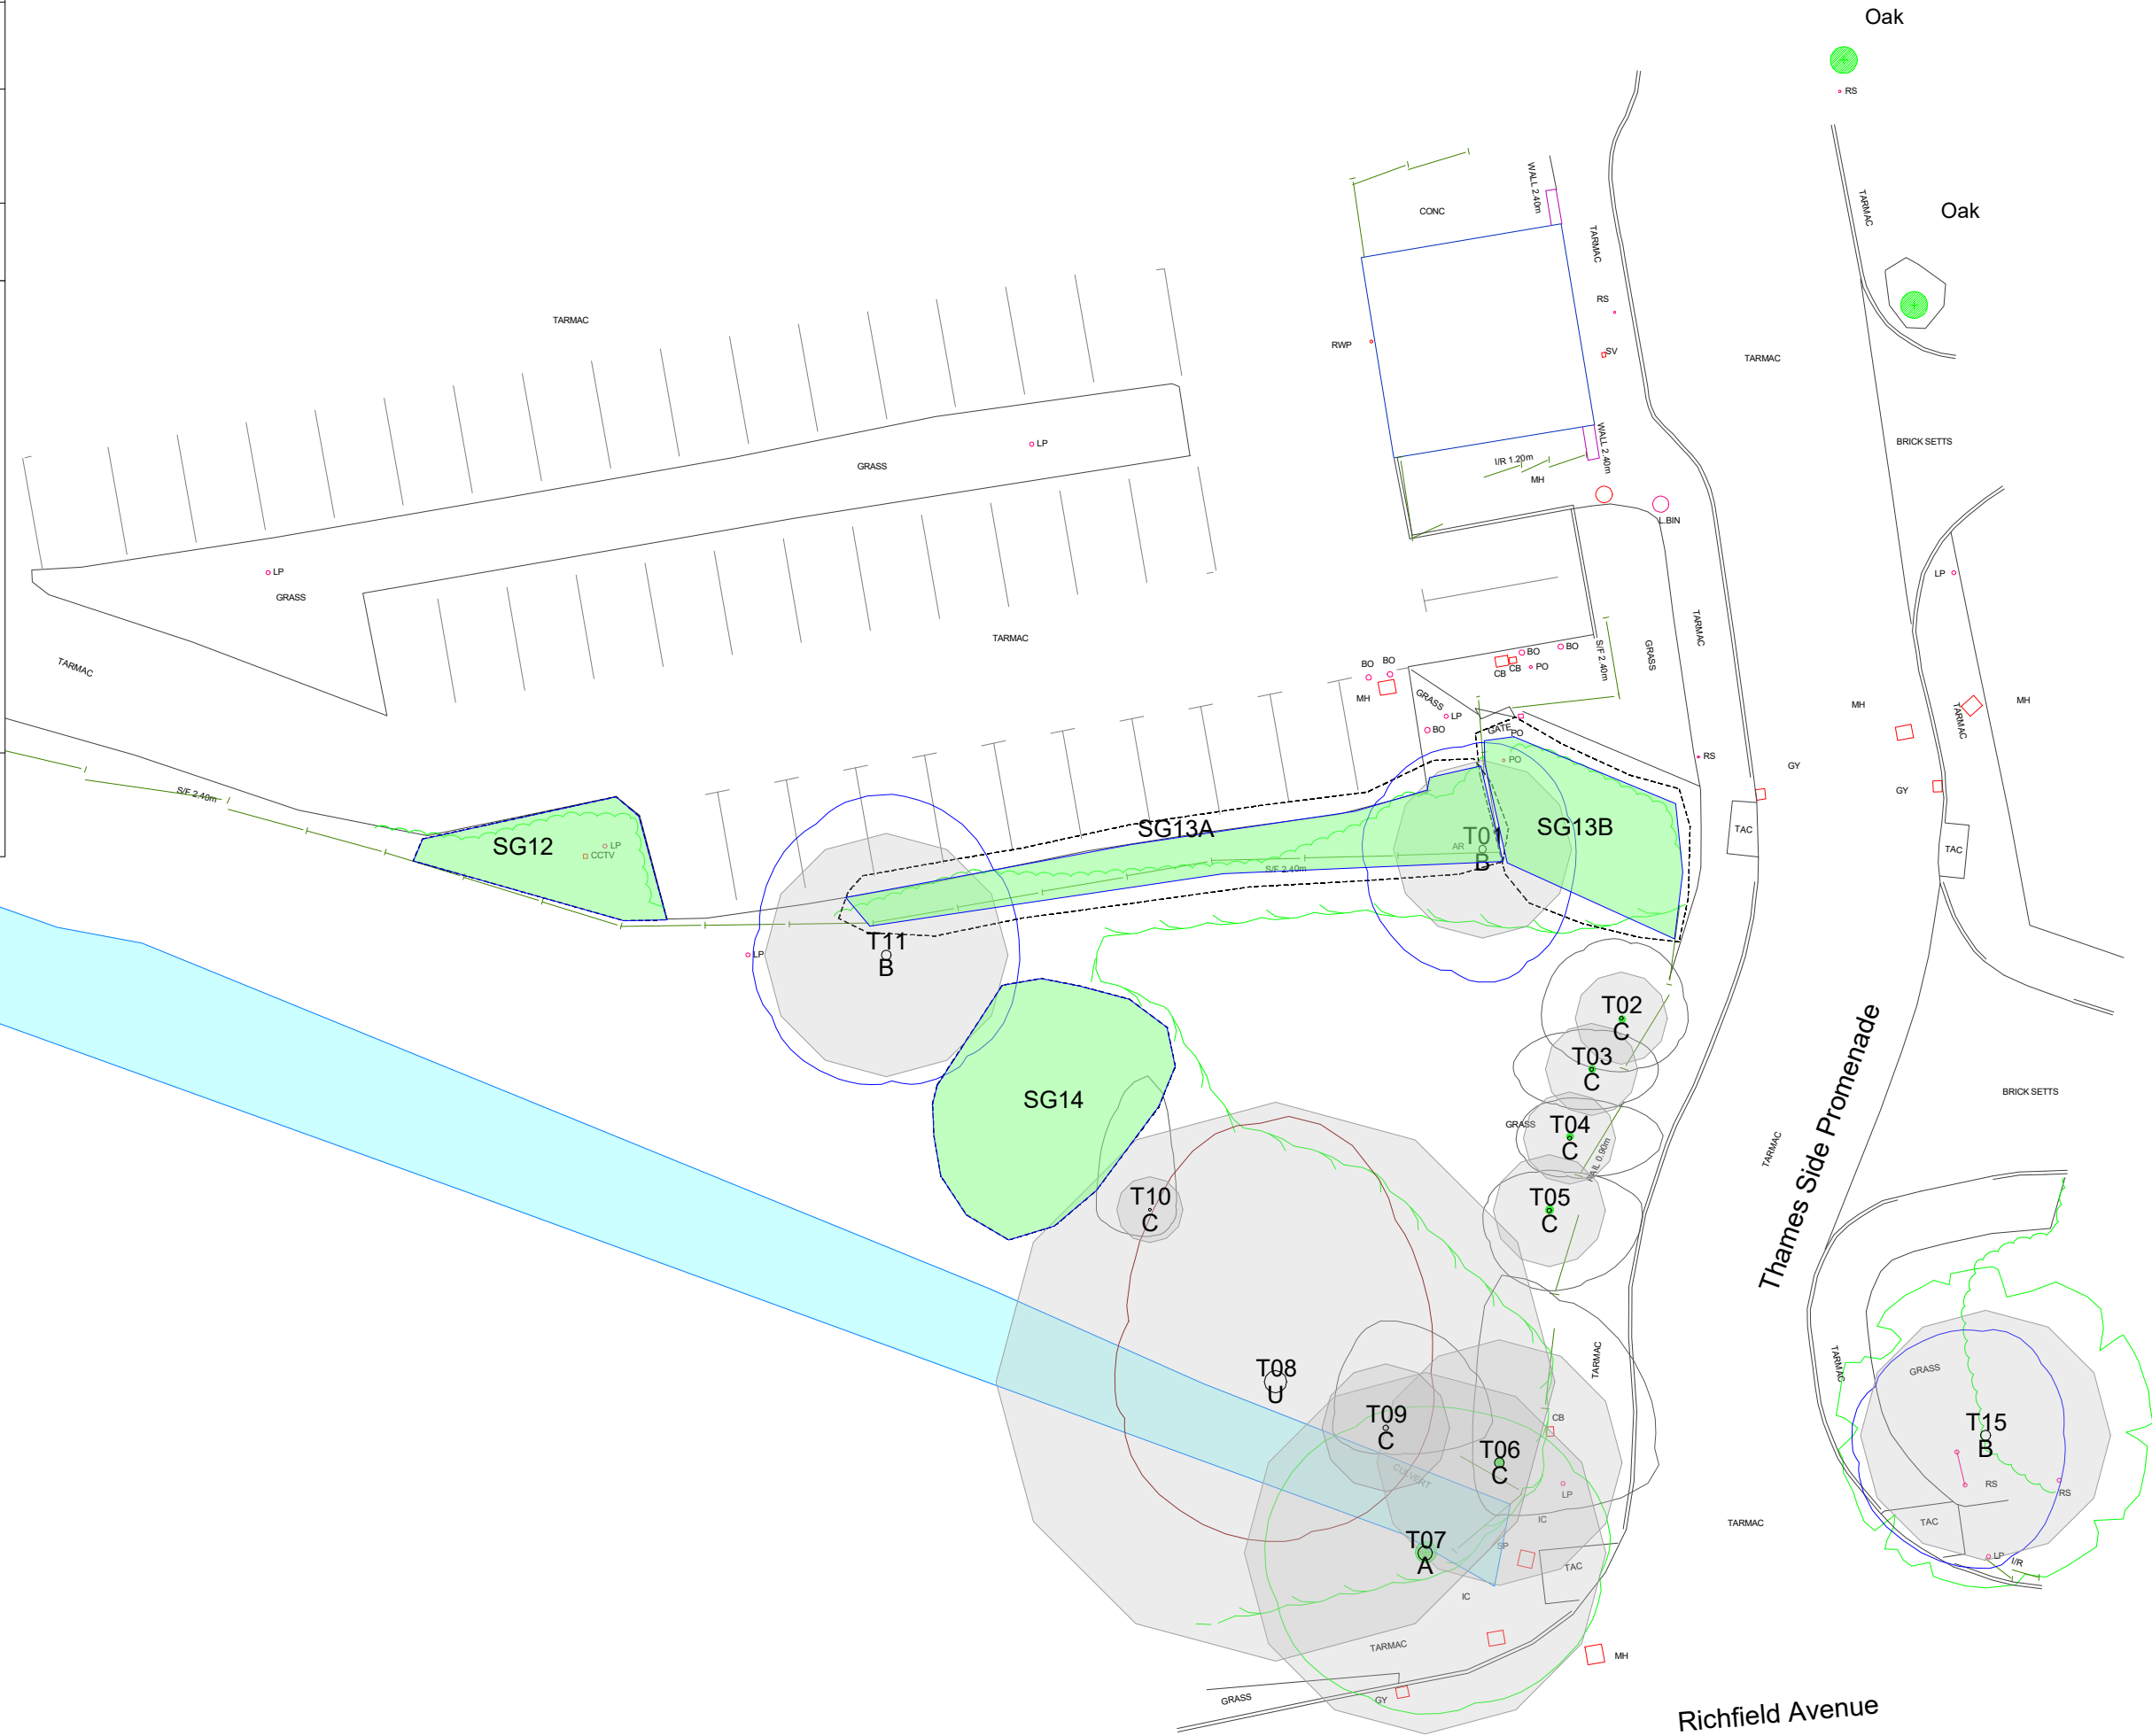
## **10. Appendix 3: Existing Site Plan with Tree Constraints**

- 6.3 Tree Constraints**
- 6.3.1 The tree constraints are plotted on the Existing Site Plan with Tree Constraints in Appendix 3 and the Proposed Site Plan with Tree Constraints in Appendix 4 and Appendix 5.

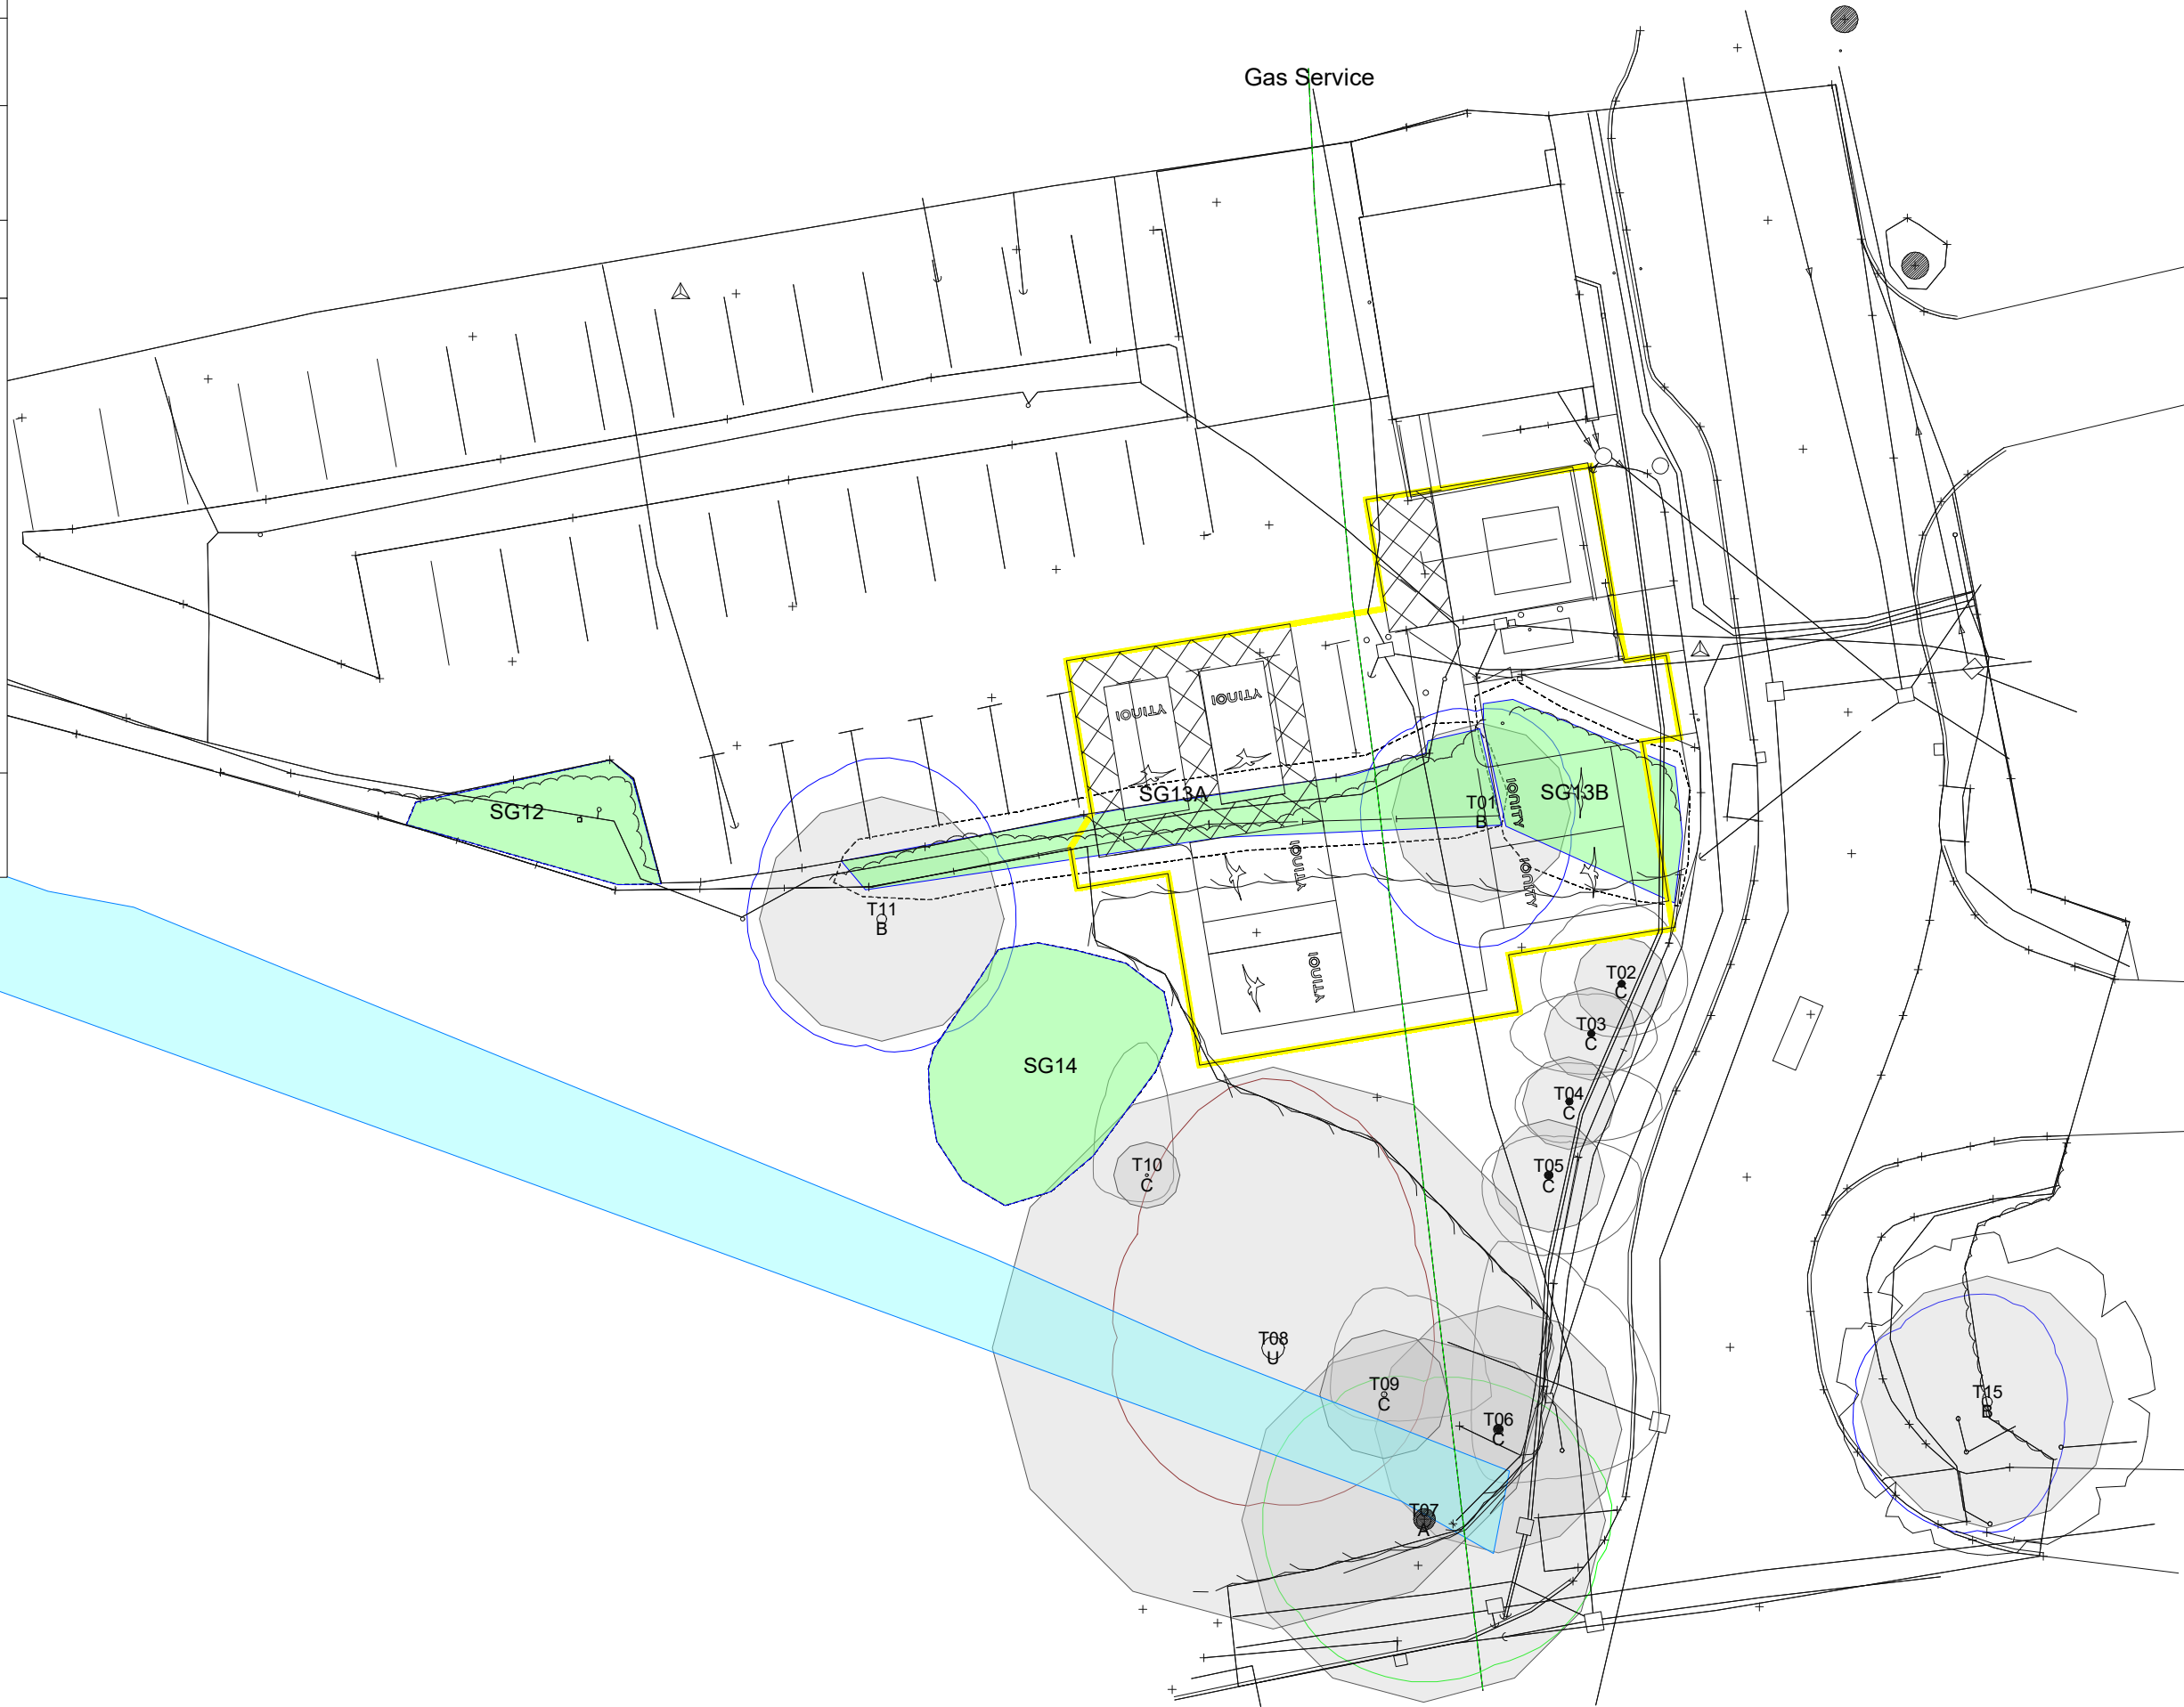
## **12. Appendix 4: Proposed Site Plan with Tree Constraints**

- 7.1 The Proposed Site Plan with Tree Constraints in Appendix 4 indicates where the proposal could affect retained trees.
- 7.2 I expect site access, materials storage, waste storage, and car parking to be within the Village Hotel car park adjacent to the north of the site.

- 7.8 The Small Leaved Lime T01 could not be retained. There is space to plant a replacement for this tree elsewhere within the car park or in the land around the perimeter of the car park if the Planning Authority demand it.

- 7.9 The group of four Mop-head Maple (T02-T05) could be retained as the impact on the circular RPAs is minimal. The crowns of one of them (T02) would need to be pruned to clear the perimeter of the site.

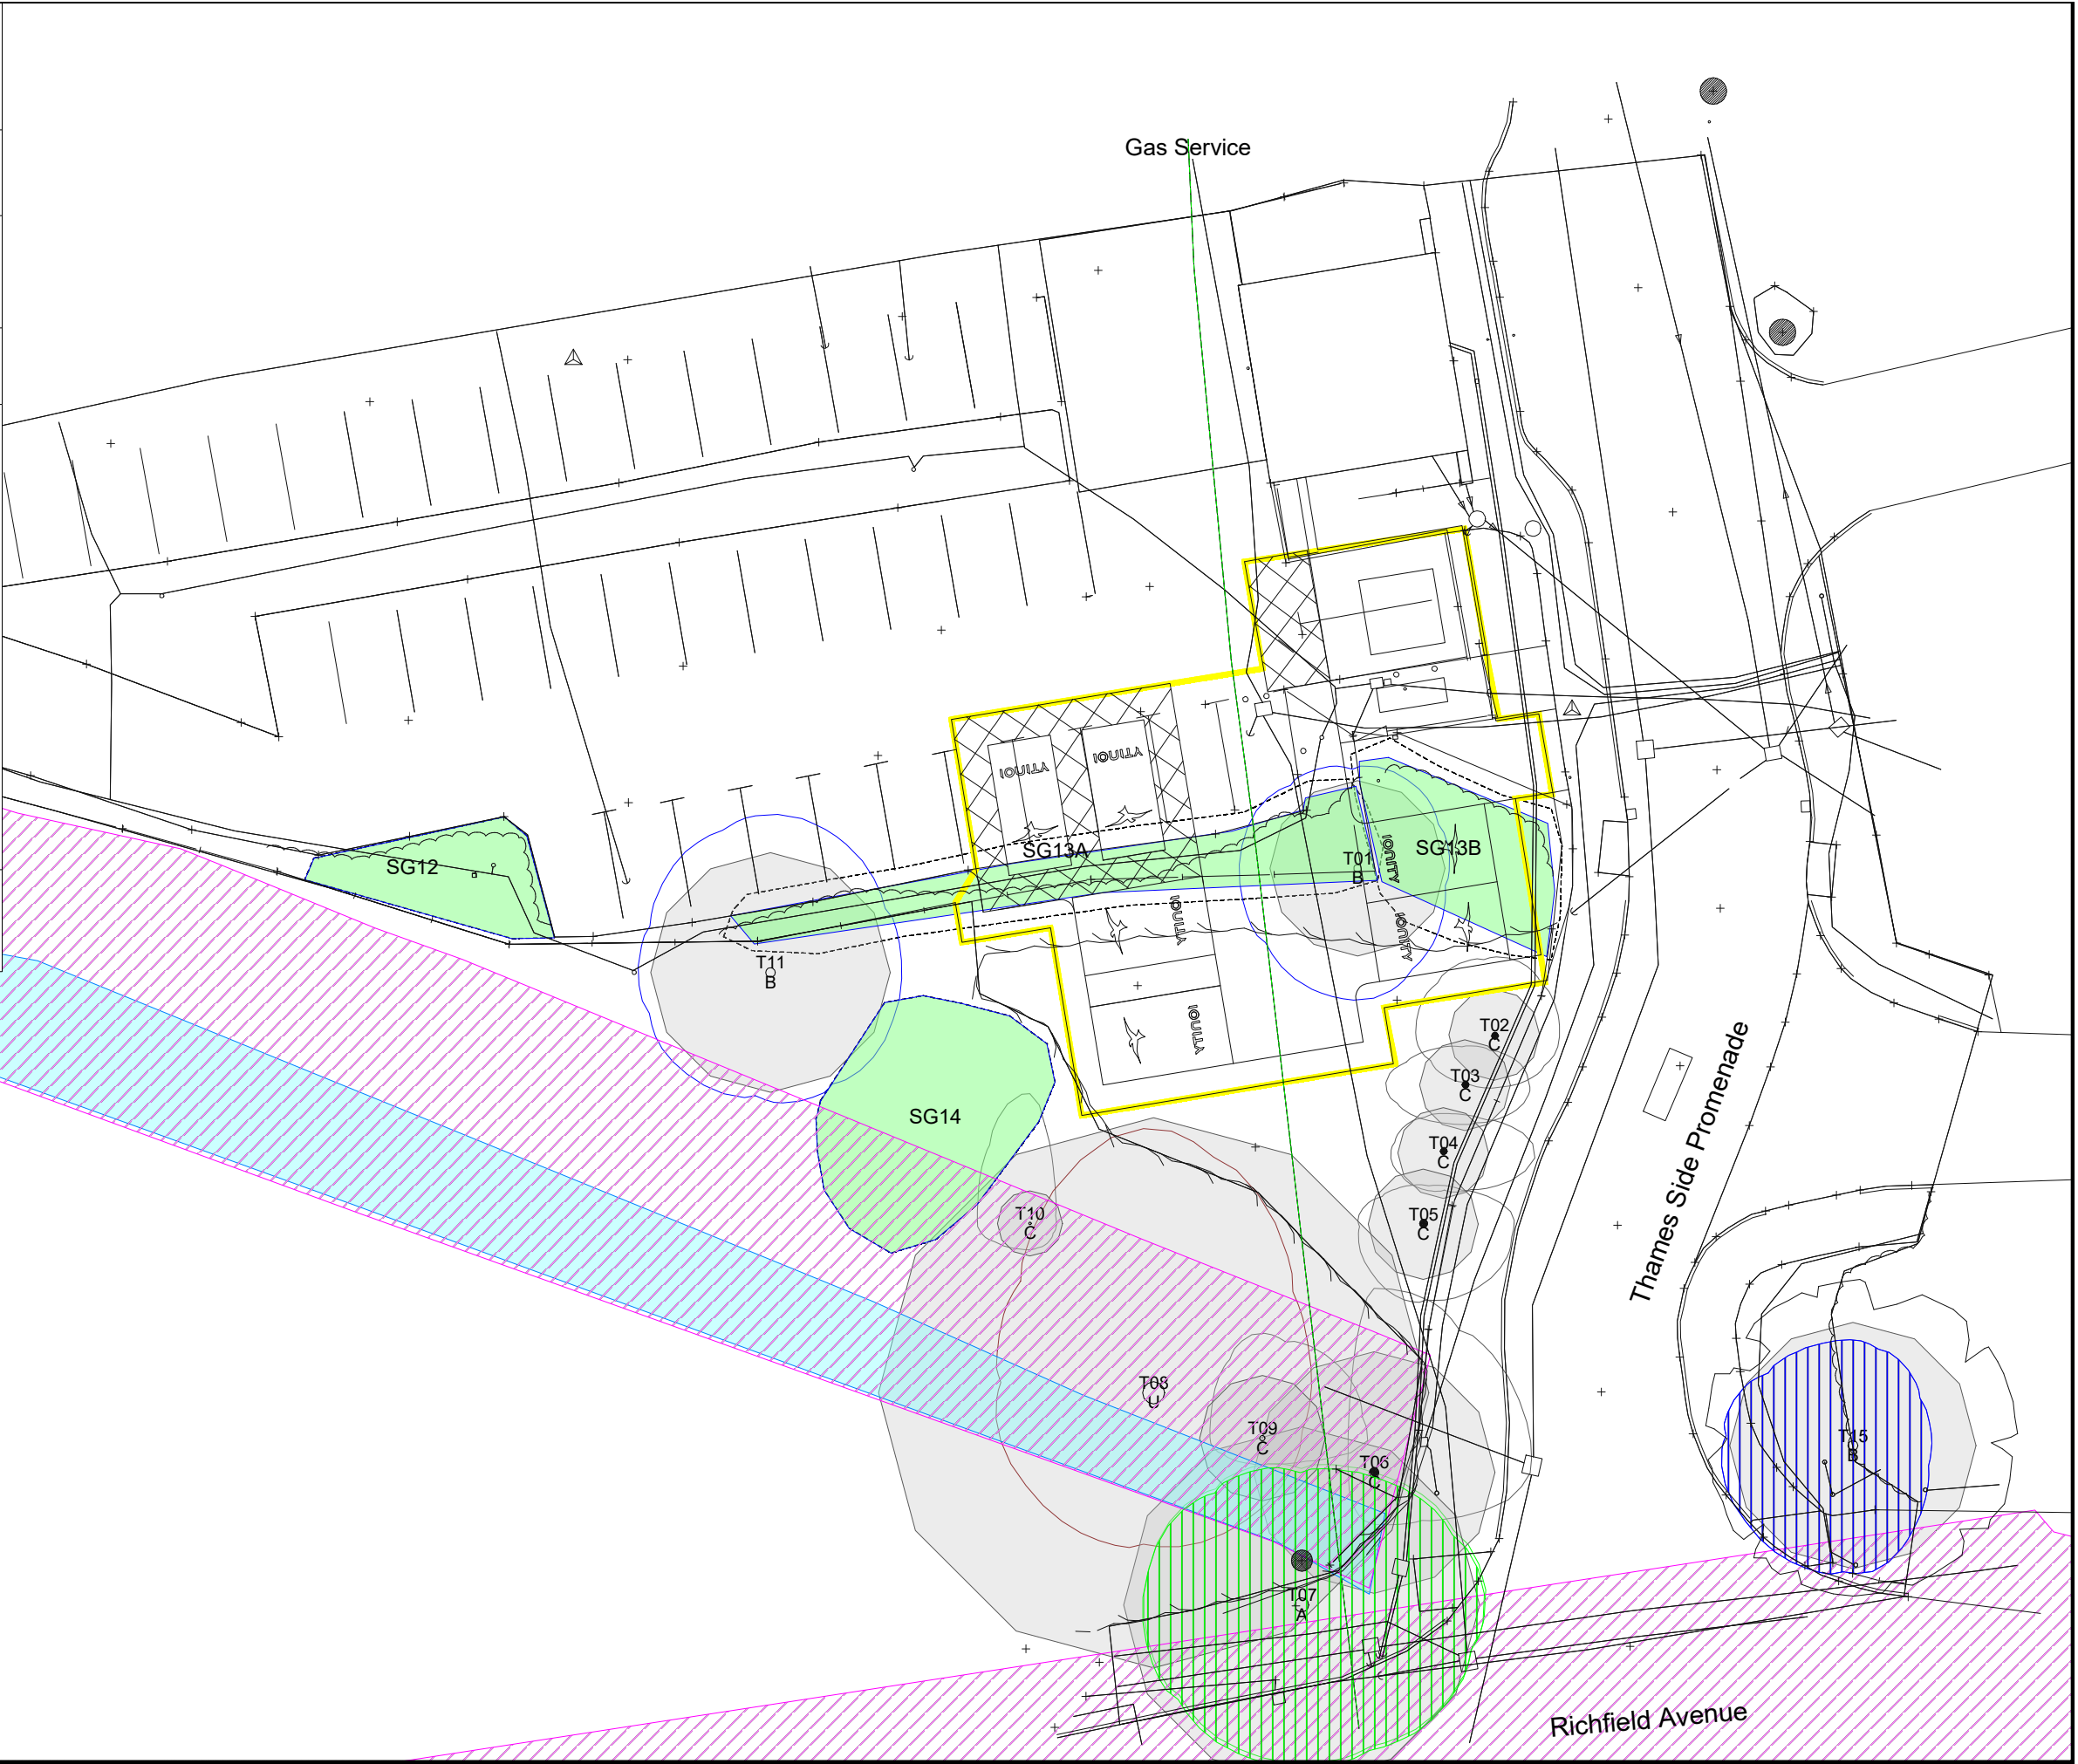
### **13. Appendix 5: Council Owned Land and Protected Trees Superimposed on the Proposed Site Plan with Tree Constraints**

- 7.5 I have looked at the Tree Preservation Order (TPO) plans, and I believe that T07 (London Plane) and T05 (Italian Alder) are included in Tree Preservation Orders.

- 7.10 The Willow (T08) is a twin stemmed tree that was growing on the edge of the waterway/ditch on council owned land. The tree has collapsed and one stem fell south towards Richfield Avenue and the larger stem fell north towards the site. This tree should be removed although it is still living but the fallen stem could increase the risk of flooding, and the stem and branches could roll to the east or west in high winds. The removal of this tree is the responsibility of the owner, Reading Council.
