## Bat Emergence and Re-Entry Surveys (BERS)

Eaton Court, 112 Oxford Road, Reading, Berkshire, RG1 7LL

Eaton Reading Ltd

13<sup>th</sup> November 2025

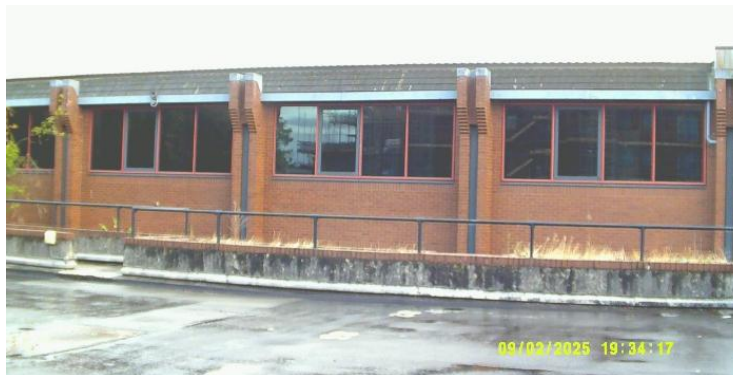
| Surveyor 9 | <p>Summary of general activity:</p> <p><b>No emergencies observed.</b></p> <p>The first bat detected was a common pipistrelle heard not seen at 20:05. Common pipistrelles were heard not seen from 20:05 until 21:04. At 20:06 a common pipistrelle was observed flying from close to the third pillar towards the east. At 20:09, two common pipistrelles passed from east to west across the north elevation of B1. At 20:19 a common pipistrelle passed from west to east across the north elevation of B1a.</p> | <p>Full elevation photo showing surveyor's view</p> |

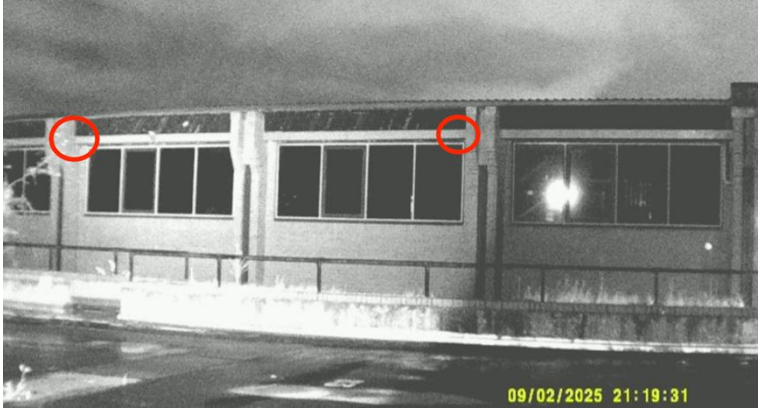
| 02/09/2025 | | | | Sunset 19:32; 19:47 – 22:17 | | |
|---|---|---|---|---|---|---|
| 2 | Common pipistrelle | Day roost – confirmed after third survey | B1a | North elevation of B1a, second pillar from the right | Gap within pillar | N/A |

| | <p>Number: 1<br/>Time: 20:00<br/>Location of access point: second pillar from the right-hand side at the junction of the pillar and soffit,<br/>Direction of travel on emergence: east of B1a<br/>Species ID confirmed on site<br/>Does this line up with the observations of the adjacent surveyor? The surveyor did not observe the emergence, and the emergence was confirmed in IR review.</p> <p><b><u>Common Pipistrelle roost:</u></b><br/>Number: 2<br/>Time: 20:09<br/>Location of access point: soffit above the third window from the right of surveyor nines view of the northwest elevation.<br/>Direction of travel on emergence: west of B1a<br/>Species ID confirmed on site<br/>Does this line up with the observations of the adjacent surveyor? The surveyor did not observe the emergence, and the emergence was confirmed in IR review.</p> <p>The remaining IR review reflects the view of the surveyor</p> | <p>09/02/2025 21:19:31</p> |
