# Arboricultural Impact Assessment (AIA)

**Site:** 122 Kidmore Road, Caversham, Reading, RG4 7NB

| Document Number | J240390-GGC-XX-XX-T-ARB-0600 | | | |

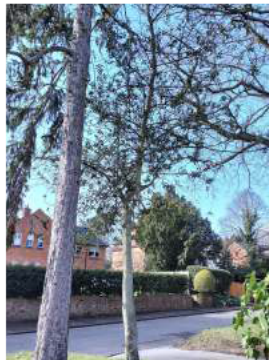
### Common holly Tree ID #1

| Tree ID | Common Name | Scientific Name | Life Stage | Stem Diameter [mm] | Tree Height [m] | Height of Canopy Above Ground Level [m] | Height of First Significant Branch [m] | (N) Branch Spread [m] | (E) Branch Spread [m] | (S) Branch Spread [m] | (W) Branch Spread [m] | Physiological Condition | Structural Condition | Comments | Recommendations | Estimated Remaining Contribution | Quality Category | RPA Radius [m] |
|---|---|---|---|---|---|---|---|---|---|---|---|---|---|---|---|---|---|---|
| 1 | Common holly | Ilex aquifolium | Semi-mature | 210 | 6 | 1.8 | 2.5 | 2.8 | 3 | 1.4 | 1.5 | Good | Good | Council owned tree situated on verge between footpath and property boundary. Tree is growing beneath canopy of neighbouring tree. | | Medium (20 to 40 years) | C | 2.52 |

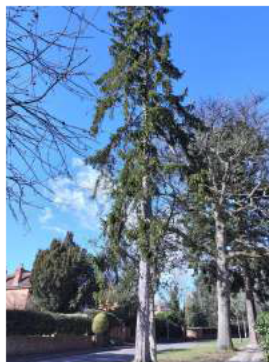
### Norway spruce Tree ID #2

| Tree ID | Common Name | Scientific Name | Life Stage | Stem Diameter [mm] | Tree Height [m] | Height of Canopy Above Ground Level [m] | Height of First Significant Branch [m] | (N) Branch Spread [m] | (E) Branch Spread [m] | (S) Branch Spread [m] | (W) Branch Spread [m] | Physiological Condition | Structural Condition | Comments | Recommendations | Estimated Remaining Contribution | Quality Category | RPA Radius [m] |
|---|---|---|---|---|---|---|---|---|---|---|---|---|---|---|---|---|---|---|
| 2 | Norway spruce | Picea abies | Semi-mature | 400 | 18 | 1.9 | 5.2 | 1.5 | 2.4 | 2.3 | 2.3 | Fair | Good | Council owned tree situated on verge between footpath and property boundary | | Long (>40 years) | B | 4.8 |

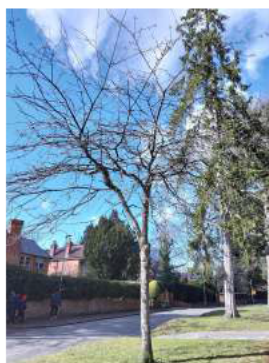
### Cherry species Tree ID #3

| Tree ID | Common Name | Scientific Name | Life Stage | Stem Diameter [mm] | Tree Height [m] | Height of Canopy Above Ground Level [m] | Height of First Significant Branch [m] | (N) Branch Spread [m] | (E) Branch Spread [m] | (S) Branch Spread [m] | (W) Branch Spread [m] | Physiological Condition | Structural Condition | Comments | Recommendations | Estimated Remaining Contribution | Quality Category | RPA Radius [m] |
|---|---|---|---|---|---|---|---|---|---|---|---|---|---|---|---|---|---|---|
| 3 | Cherry species | Prunus sp. | Semi-mature | 170 | 6 | 1.9 | 2.5 | 2.3 | 2.6 | 3.8 | 2.9 | Fair | Good | Council owned tree situated on verge between footpath and property boundary. | | Short (10 to 20 years) | C | 2.04 |

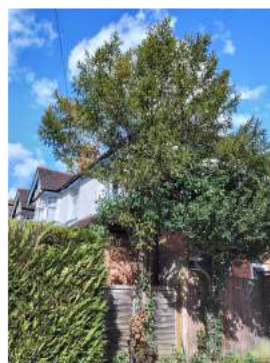
### Common yew Tree ID #6

| Tree ID | Common Name | Scientific Name | Life Stage | Stem Diameter [mm] | Tree Height [m] | Height of Canopy Above Ground Level [m] | Height of First Significant Branch [m] | (N) Branch Spread [m] | (E) Branch Spread [m] | (S) Branch Spread [m] | (W) Branch Spread [m] | Physiological Condition | Structural Condition | Comments | Recommendations | Estimated Remaining Contribution | Quality Category | RPA Radius [m] |
|---|---|---|---|---|---|---|---|---|---|---|---|---|---|---|---|---|---|---|
| 6 | Common yew | Taxus baccata | Young | 192 | 6 | 1 | 1 | 1.5 | 1.9 | 1.9 | 1.9 | Fair | Good | Neighbouring garage was built within the last ten years, due to the proximity of the structure to the trees RPA, the trees physiological state has been affected as is evident in the slight chlorotic tinge to the leaves throughout the crown. | | Long (>40 years) | C | 2.31 |

- 5.23 **T6 & T7** – Fell to ground level.
- 5.24 Any tree works are to be carried out outside of the bird nesting season (March to September inclusive) unless works are overseen with the presence of a suitably trained Ecologist if within this period. Refer to Appendix J for detail.

- 5.26 Due to the addition of the bin storage and bicycle store the removal of 2 low category trees (T6 and T7) will be required.

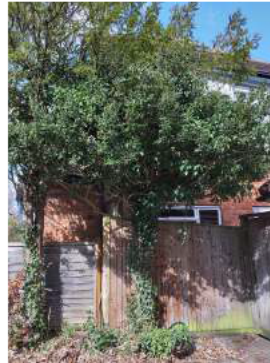
### Common yew Tree ID #7

| Tree ID | Common Name | Scientific Name | Life Stage | Stem Diameter [mm] | Tree Height [m] | Height of Canopy Above Ground Level [m] | Height of First Significant Branch [m] | (N) Branch Spread [m] | (E) Branch Spread [m] | (S) Branch Spread [m] | (W) Branch Spread [m] | Physiological Condition | Structural Condition | Comments | Recommendations | Estimated Remaining Contribution | Quality Category | RPA Radius [m] |
|---|---|---|---|---|---|---|---|---|---|---|---|---|---|---|---|---|---|---|
| 7 | Common yew | Taxus baccata | Semi-mature | 220 | 4 | 1 | 1 | 1 | 1.9 | 1.7 | 1 | Good | Good | Crown has been heavily pruned back on the neighbours side. | | Medium (20 to 40 years) | C | 2.64 |

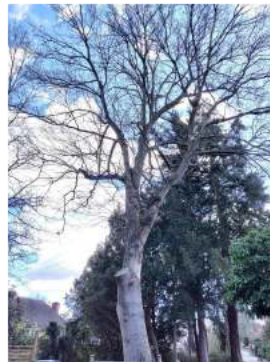
### Pedunculate oak Tree ID #8

- 5.10 With regards to the Oak (T8) it is consider that suitable clearance will be maintained with extension in place, with options of sympathetic pruning in the future that can be undertaken in-line with current best practices.

| Tree ID | Common Name | Scientific Name | Life Stage | Stem Diameter [mm] | Tree Height [m] | Height of Canopy Above Ground Level [m] | Height of First Significant Branch [m] | (N) Branch Spread [m] | (E) Branch Spread [m] | (S) Branch Spread [m] | (W) Branch Spread [m] | Physiological Condition | Structural Condition | Comments | Recommendations | Estimated Remaining Contribution | Quality Category | RPA Radius [m] |
|---|---|---|---|---|---|---|---|---|---|---|---|---|---|---|---|---|---|---|
| 8 | Pedunculate oak | Quercus robur | Mature | 525 | 20 | 6 | 6 | 3.9 | 5.5 | 5 | 5 | Fair | Good | Large limbs growing over parking spaces of 122 have historically been removed (above 1/3rd Parent stem). | | Long (>40 years) | B | 6.3 |

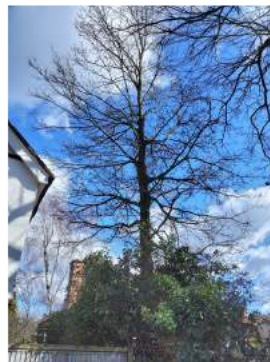
### Pedunculate oak Tree ID #9

- 5.9 The Oak (T9) has a stem diameter of 350mm with future growth potential. In the current location without the extension, it is expected that maintenance of clearance to the property will need to occur as a matter of routine (evidence of pruning already noted). As pruning will be required as the tree gets older, sustainable formative pruning methods can be undertaken to help manage the clearance at an earlier stage and therefore ensure pruning is kept to a minimum branch diameter (reducing wound size). The structure of the branches extending over to 122 Kidmore Road are not substantial and would not give concern for these types of formative pruning works.

| Tree ID | Common Name | Scientific Name | Life Stage | Stem Diameter [mm] | Tree Height [m] | Height of Canopy Above Ground Level [m] | Height of First Significant Branch [m] | (N) Branch Spread [m] | (E) Branch Spread [m] | (S) Branch Spread [m] | (W) Branch Spread [m] | Physiological Condition | Structural Condition | Comments | Recommendations | Estimated Remaining Contribution | Quality Category | RPA Radius [m] |
|---|---|---|---|---|---|---|---|---|---|---|---|---|---|---|---|---|---|---|
| 9 | Pedunculate oak | Quercus robur | Semi-mature | 350 | 20 | 4 | 4 | 4 | 6 | 3 | 2.1 | Good | Good | No access to the base of the stem. | | Long (>40 years) | B | 4.2 |

- 5.21 The following trees have been highlighted for pruning/removal works:
- 5.22 **T9 (T2 of TPO 393/06) Oak** – Potential tip-reduction works may be needed to provide clearance for scaffolding (dimensions to be confirmed). It is recommended that consideration for pruning is given once scaffold has been erected to ensure that only optimal pruning is undertaken.

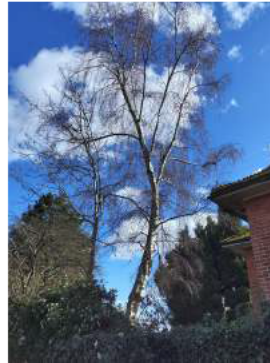
### Silver birch Tree ID #10

| Tree ID | Common Name | Scientific Name | Life Stage | Stem Diameter [mm] | Tree Height [m] | Height of Canopy Above Ground Level [m] | Height of First Significant Branch [m] | (N) Branch Spread [m] | (E) Branch Spread [m] | (S) Branch Spread [m] | (W) Branch Spread [m] | Physiological Condition | Structural Condition | Comments | Recommendations | Estimated Remaining Contribution | Quality Category | RPA Radius [m] |
|---|---|---|---|---|---|---|---|---|---|---|---|---|---|---|---|---|---|---|
| 10 | Silver birch | Betula pendula | Mature | 325 | 16 | 3.8 | 4 | 3.8 | 4 | 4.2 | 5.4 | Good | Good | Stem 1.7m from boundary fence. | | Long (>40 years) | B | 3.9 |

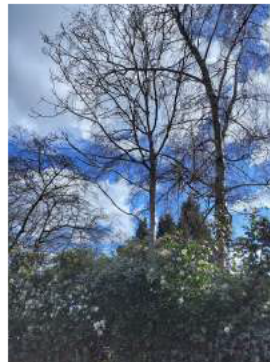
### Common ash Tree ID #11

| Tree ID | Common Name | Scientific Name | Life Stage | Stem Diameter [mm] | Tree Height [m] | Height of Canopy Above Ground Level [m] | Height of First Significant Branch [m] | (N) Branch Spread [m] | (E) Branch Spread [m] | (S) Branch Spread [m] | (W) Branch Spread [m] | Physiological Condition | Structural Condition | Comments | Recommendations | Estimated Remaining Contribution | Quality Category | RPA Radius [m] |
|---|---|---|---|---|---|---|---|---|---|---|---|---|---|---|---|---|---|---|
| 11 | Common ash | Fraxinus excelsior | Semi-mature | 200 | 10 | 3 | 3 | 2.7 | 2.7 | 0.5 | 2.7 | Fair | Good | Stem 1.3m from boundary fence. | | Medium (20 to 40 years) | B | 2.4 |

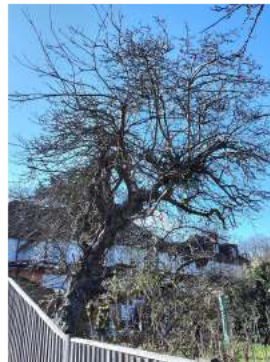
### Apple species Tree ID #14

5.5 In constructing the foundation close to T14, some minor root damage will likely occur. Once the old foundation is removed it is recommended that any exposed roots are pruned in-line with current best practice. The rooting area impacted is at the extremity of the RPA and will likely reveal thinner roots that would be suitable for pruning, which as a species, the apple would tolerate with little impact.

| Tree ID | Common Name | Scientific Name | Life Stage | Stem Diameter [mm] | Tree Height [m] | Height of Canopy Above Ground Level [m] | Height of First Significant Branch [m] | (N) Branch Spread [m] | (E) Branch Spread [m] | (S) Branch Spread [m] | (W) Branch Spread [m] | Physiological Condition | Structural Condition | Comments | Recommendations | Estimated Remaining Contribution | Quality Category | RPA Radius [m] |
|---|---|---|---|---|---|---|---|---|---|---|---|---|---|---|---|---|---|---|
| 14 | Apple species | Malus sp. | Mature | 350 | 7 | 1.6 | 1.4 | 4 | 2.5 | 1.5 | 4.5 | Good | Good | Stem .80cm from boundary fence. | | Long (>40 years) | B | 4.2 |

- 5.6 Additionally, amendments made will see a drainage pipe running through the RPA of this tree (T14) to the new soakaway. It is recommended that the area is “hand dug”, preferably air-spade (under arboricultural supervision). **Note: Do not mechanically excavate in the area.** Once rooting area is exposed roots will require protection from the elements e.g. wrapped in hessian and kept wet, when exposed for long periods. The 150mm diameter drainage pipe will need to be feed beneath the roots, where possible and roots (less than 25mm in diameter) to be pruned, in-line with current best practise. Any roots greater than 25mm in diameter that require pruning to be agreed by project Arboriculturalist.
- 5.7 All works undertaken within the RPA of T14 is to be undertaken under arboricultural supervision.

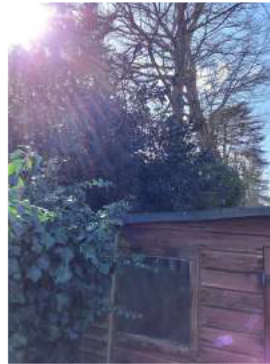
### Group ID #1

| Comments: | Trees have been topped into a hedge. |

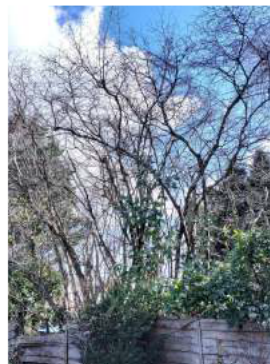
### Group ID #2

| Comments: | Multi-stem Hazel group situated in neighbours property along boundary. |

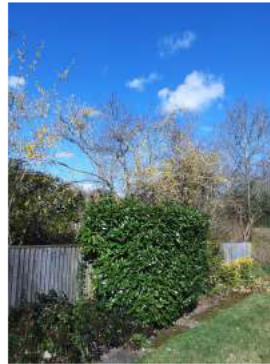
## Group ID #4

| Comments: | Mixed species growing in proximity to each other along boundary fence. Species include Forsythia, Apple and Ash. |
