## PROPOSED RENDER REPLACEMENT ON 136 CASTLE HILL READING

### HERITAGE STATEMENT

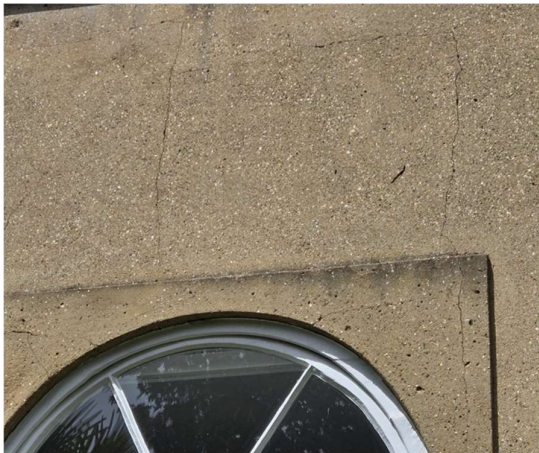
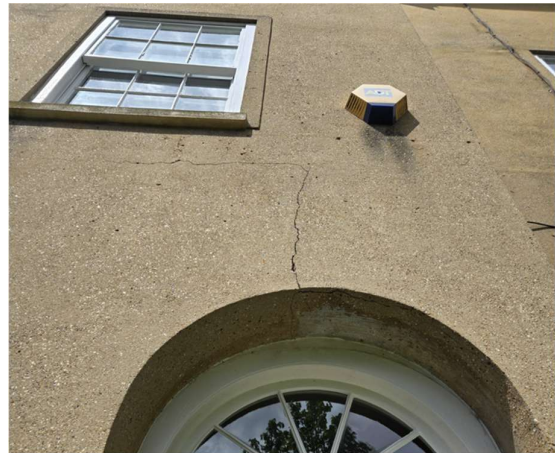
*Photos showing cracking and legacy alarm box that will be removed*

The current owners propose to remove and replace the tan render on the front elevation which has become cracked, discoloured and pock-marked by water ingress and freeze-thaw action.

The proposed replacement render will be lime based and colour matched to the remaining properties within the terrace. The window detailing will be left in place, but re-skimmed to create a uniform finish.

The present owners have sought out contractors with considerable listed building experience, who specialize in heritage techniques and materials. Samples will be provided to ensure an accurate colour match before the work is undertaken in earnest. Non-original features such as a legacy burglar alarm box will be removed from the frontage along with cable tacks that at some point held television aerial cable. After removal of the old render the underlying brickwork will be assessed and where needed repairs will be carried out to ensure the structural integrity of the elevation is maintained. Appropriate materials will be used, with mortar being matched and any replacement bricks will come from stores of bricks salvaged when removed for previous alterations.

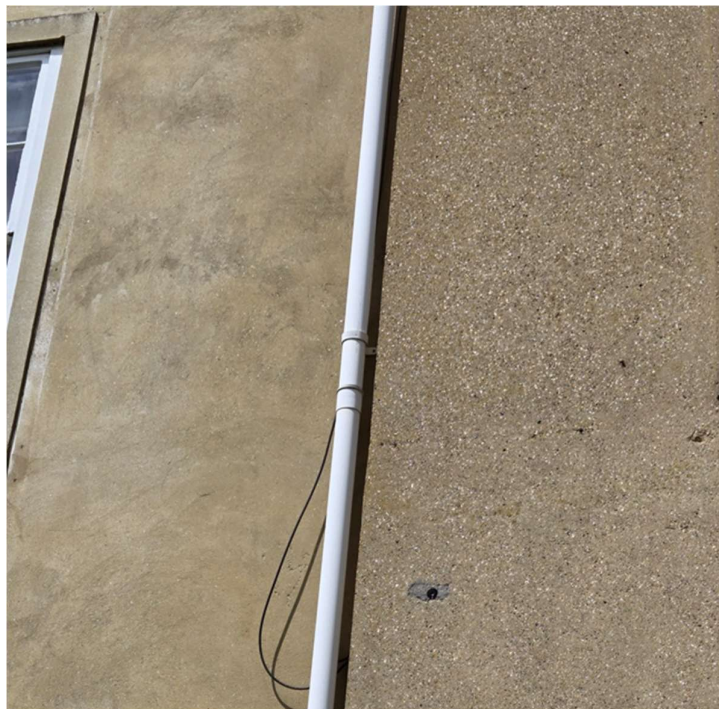
*138 Castle Hill (Left) compared to 136 Castle Hill (Right) showing proposed finish vs damage/wear*

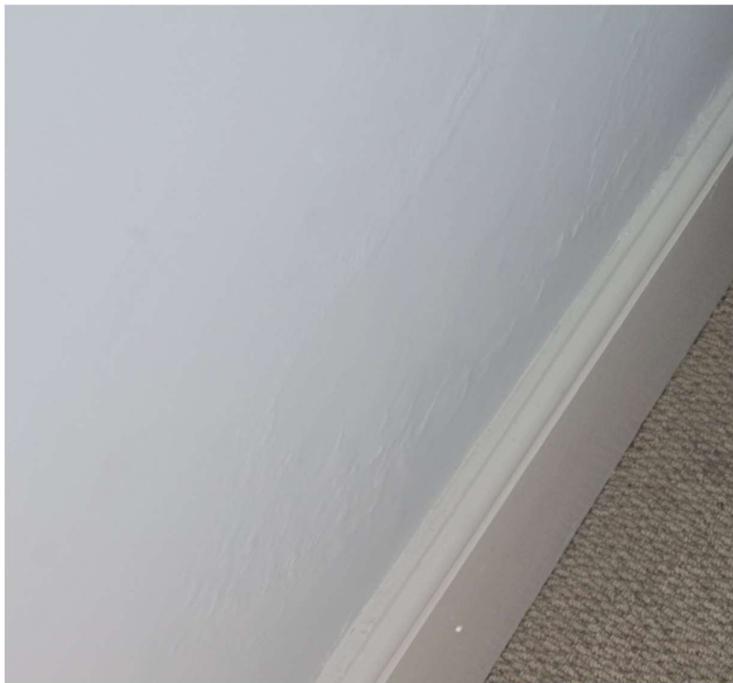
*Internal photograph showing damage from water ingress*
