Our Ref: PL/26/0502  
Your Ref:

29<sup>th</sup> May 2026

**RE: PROPOSED WORKS TO 2NO. BEECH TREES AND 5NO. YEW TREES AT PINEMead, UPPER WARREN AVENUE, AND 2NO. BEECH TREES AT 7 UPPER WARREN AVENUE, CAVERSHAM, READING - PART OF A2 & A1 RESPECTIVELY OF TREE PRESERVATION ORDER NUMBER 339.**

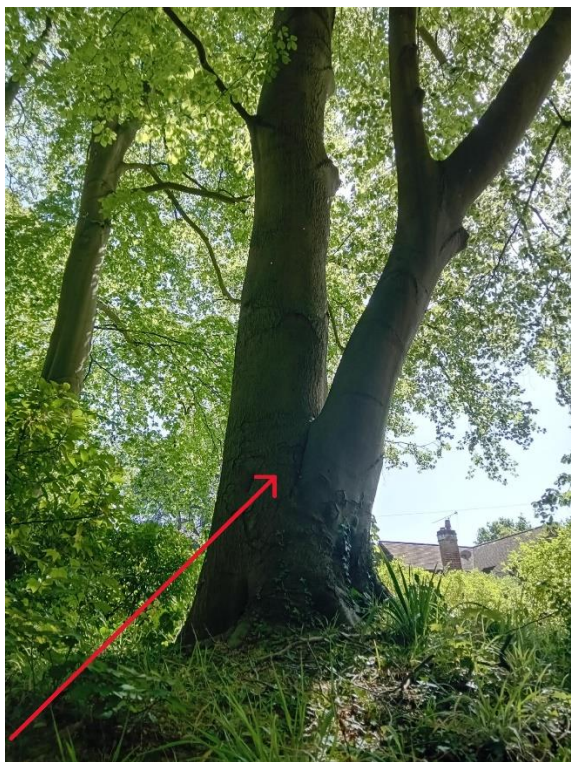
The proposed works to T1 Beech, which is located on the property's frontage adjacent to the driveway, are considered reasonable. There is a co-dominant stem growing over the driveway and is in close proximity to the base of the tree, shown in Figure 1 below. This co-dominant stem is where the branch failure has occurred (described as a snapped limb in your application); hence reducing the branches growing from this co-dominant stem, to manage the weight load on the union and to reduce the likelihood of failure is considered reasonable.

Figure 1- T1 Beech: co-dominant stems/union - the stem to the right is the one in question having its canopy reduced

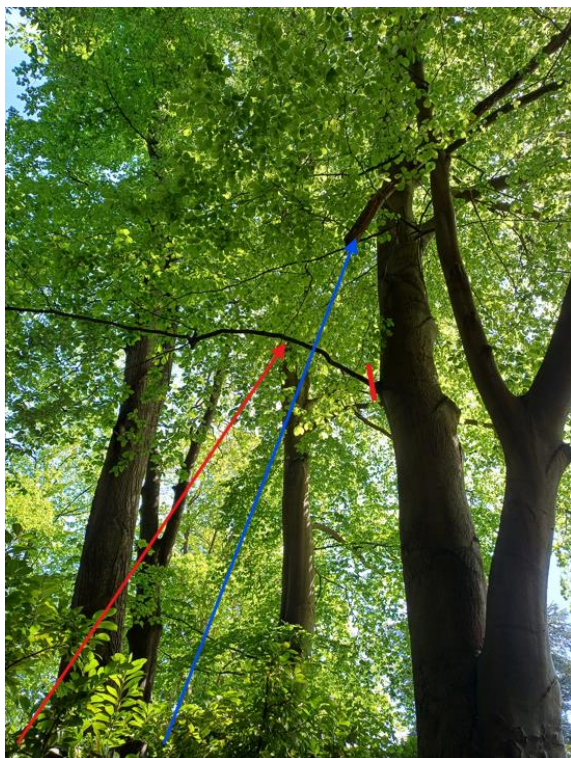
Figure 2 - T1 Beech: small diameter branch removed from main stem as part of crown lift (red arrows/lines); failed branch (blue)

- T1 Beech (frontage of Pinemead): remove branch which has failed/snapped within the canopy (shown in Figure 2); reduce branches which are growing from the co-dominant stem overhanging the driveway, back to previous pruning points, as shown as in Figure 3, to form a natural canopy shape, ensuring no more than one third of the foliage is removed from each branch, leaving suitable growth points; crown lift, through 360°, to approximately 3.5m above ground level, removing secondary growth only and leaving suitable growth points but including the removal of one identified branch growing towards the road, back to source (see Figure 2).

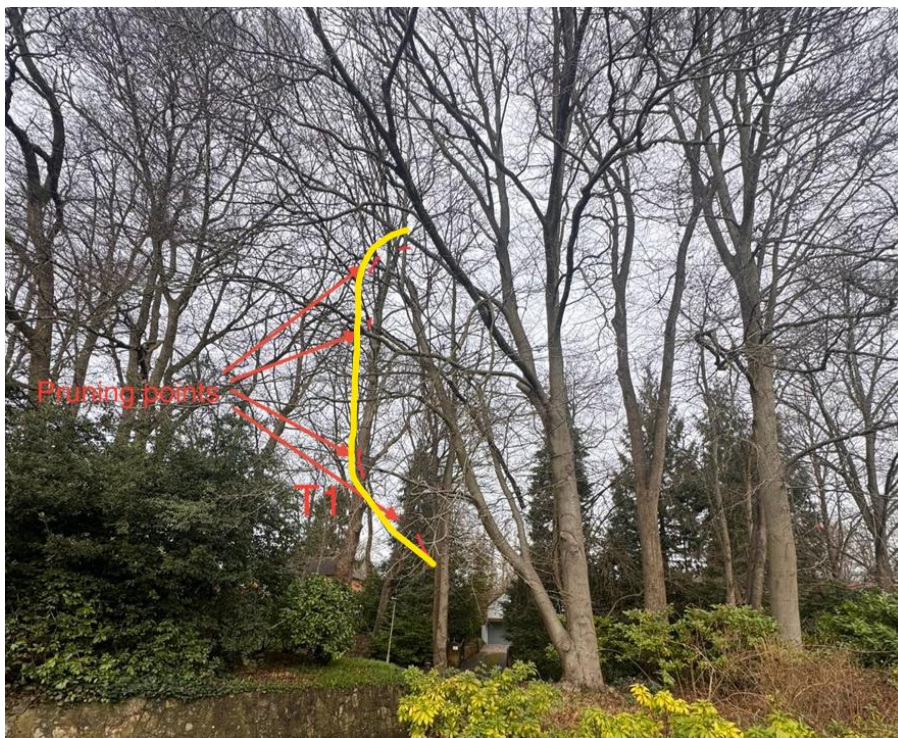
I note the canopy has previous pruning points; hence the reduction should focus on previous pruning points, rather than the branch reductions being of 2.5m which is your application specification, as it difficult to envisage what extremity this would be taken from. I acknowledge you have provided an annotated photograph showing the previous pruning points. However, I have reproduced your annotated photograph below as you didn't specify previous pruning points in your specification; this is shown in Figure 2, with further annotation of the indicative reduction as a yellow curve. We have also included a crown lift to the height of approximately 3.5m above ground level, including the removal of one small diameter branch (detailed in the approved works below). The branches were relatively low to the ground/driveway entrance during our visit, and it is likely that these works will be required in the near future, hence negates the need for another application for these reasonable works.

Figure 3 - T1 Beech: previous pruning points to be reduced back to (your red arrows/lines); indicative reduction back to these previous pruning points (yellow curve)

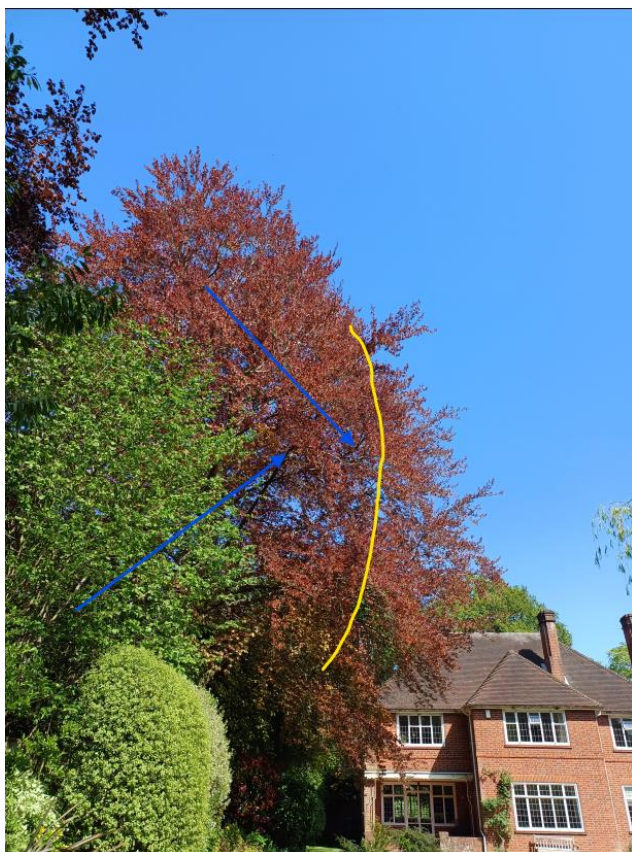
Regarding T2, T3 & T4 Beech trees, which are located in the rear garden, the works are also considered reasonable. These trees have been reduced over the garden previously; hence the reduction should focus on reducing the branches back to previous pruning points. It is difficult to envisage what extremity the 2m would be taken from T2 & T3, and what extremity the 2.5m would be taken from for T4. Hence, we have approved the reductions back to previous pruning points, rather than the lengths of the branches in metres in your application specification. We have also included some additional works to T4, including the removal of 1no. identified, small diameter branch from its source (main stem) and 1no. crossing/rubbing branch. I note that your justification for some of these works includes the shading the Beech trees cause over the rear garden. Whilst this won't eliminate all of the shade, we hope these works improve light availability into the garden, as Mrs Caswell expressed this was desired.

Figure 4 - T2 Beech: previous pruning points to be reduced back to (blue arrows); indicative reduction back to these previous pruning points (yellow curve)

- T2 & T3 Beech trees (overhanging rear garden from No. 7): reduce branches overhanging the rear garden back to previous pruning points, as shown in Figure 4 & 5 below, to form a natural canopy shape, ensuring no more than one third of the foliage is removed from each branch, leaving suitable growth points.

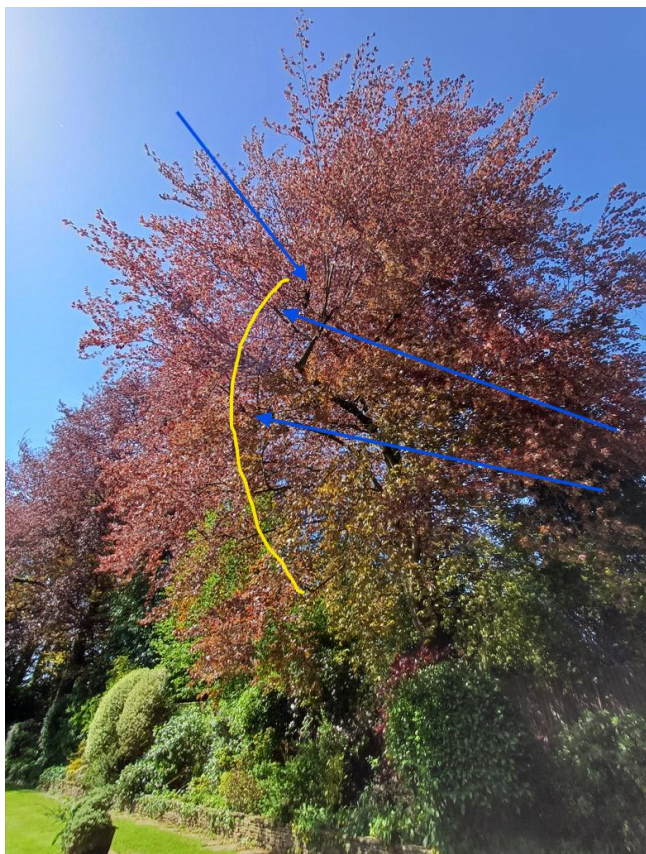
Figure 5 - T3 Beech: previous pruning points to be reduced back to (blue arrows); indicative reduction back to these previous pruning points (yellow curve)

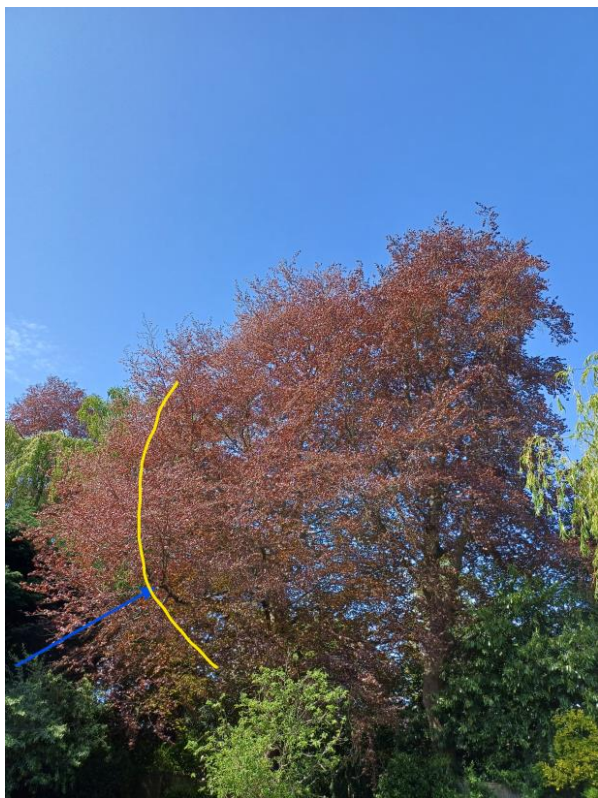
Figure 6 - T4 Beech: previous pruning points to be reduced back to (blue arrows); indicative reduction back to these previous pruning points (yellow curve)

- T4 Beech (rear garden of Pinemead): reduce branches overhanging the rear garden back to previous pruning points, as shown in Figure 6 & 7 below, to form a natural canopy shape, ensuring no more than one third of the foliage is removed from each branch, leaving suitable growth points; remove one identified small diameter branch back to source (see Figure 8); remove one identified crossing/rubbing branch back to source (see Figure 8).

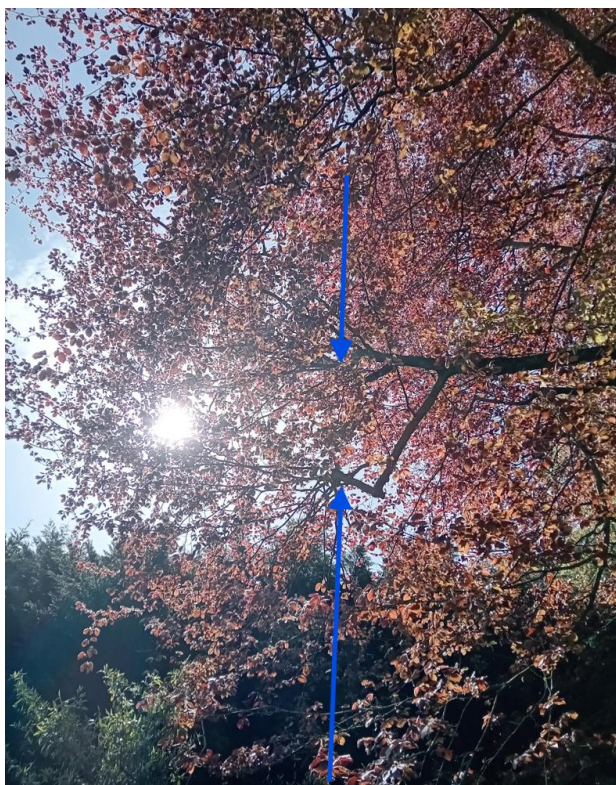
Figure 7 - T4 Beech - clearer previous reduction points

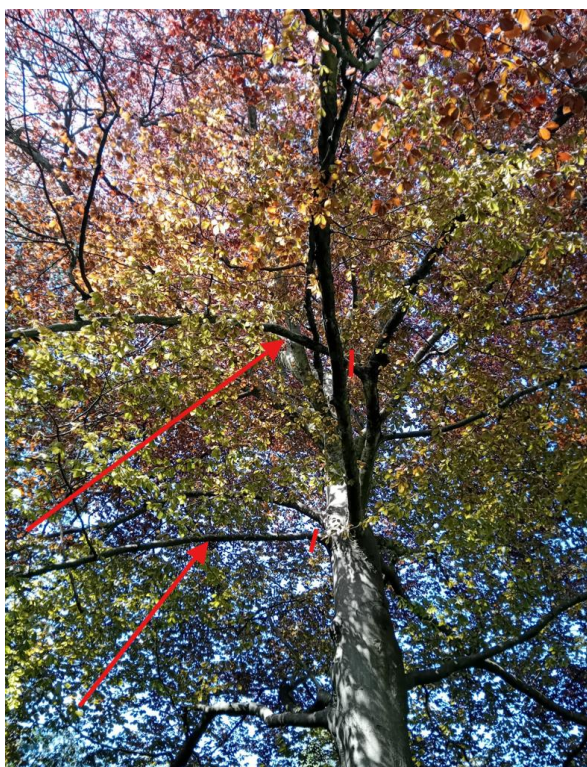
Figure 8 - T4 Beech: small diameter branch to be removed back to source (lower arrow/line); crossing/rubbing branch to be removed back to source (upper arrow/line)

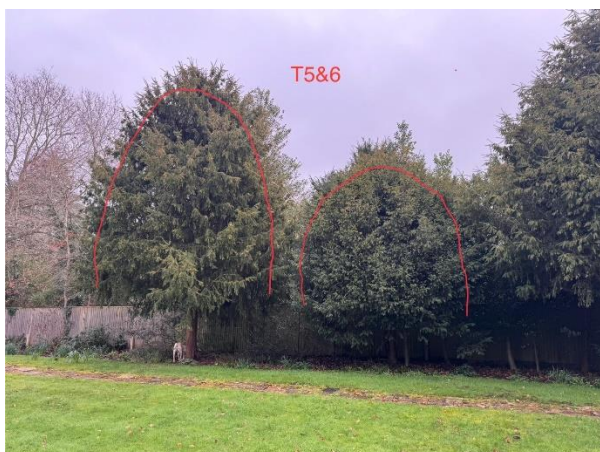
The works to the Yew trees (T5-T9), are considered reasonable as these trees have been reduced/reshaped previously. These works form a cyclical maintenance programme; hence they are considered reasonable. Whilst we don't consider aesthetics to justify works which were mentioned in your justification; in this instance, the trees have been maintained as part of a cycle, hence it is appropriate repeat these works which is reasonable management.

Figure 9 - T5 & T6 Yew trees: indicative reduction/reshape

- T5-T9 Yew trees (front & rear garden of Pinemead): reduce and reshape by approximately 1m in height and spread, as shown in Figures 9,10 & 11, ensuring no more than one third of the foliage is removed from each branch, leaving suitable growth points.

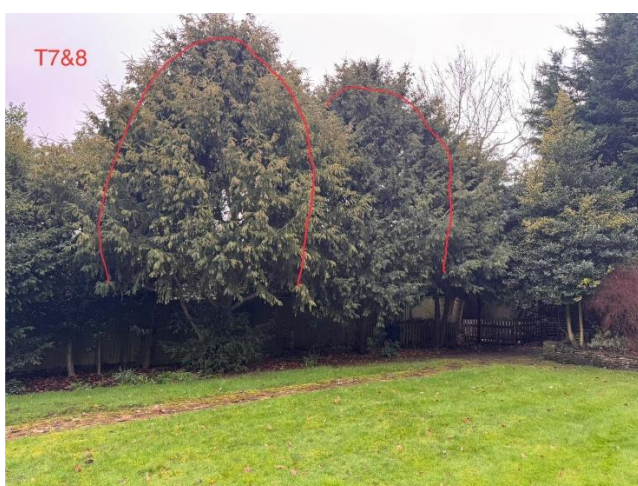
Figure 10 - T7 & T8 Yew trees: indicative reduction/reshape

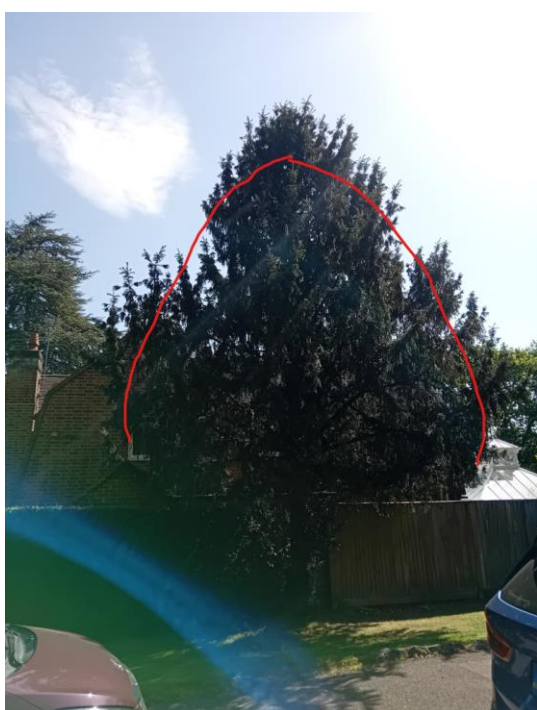
Figure 11 - T9 Yew tree: indicative reduction/reshape
