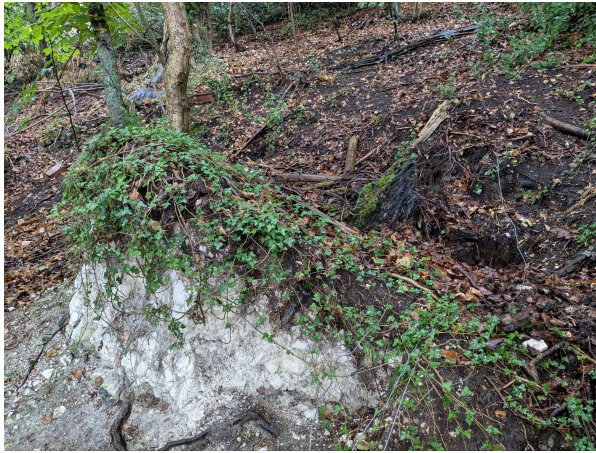
1: Sett entrance 1

| Sett entrance number | Location | Assessment | Status |
|---|---|---|---|
| 1 | SU 69699 75197 | Clearly disused, with dense accumulation of leaf litter and twigs in hole entrances. Tunnels found to be collapsed and not extending beyond 30-40 cm upon inspection. | Disused |

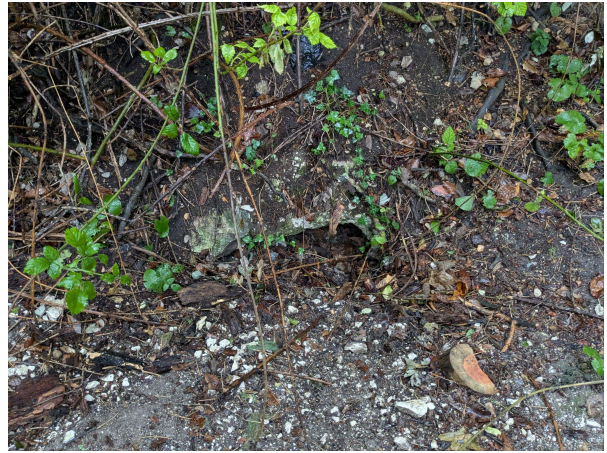
2: Sett entrance 2

| Sett entrance number | Location | Assessment | Status |
|---|---|---|---|
| 2 | SU 69675 75199 | Clearly disused, partially cobwebbed with extensive leaf litter, twigs and soil accumulating in the entrance. The entrance tunnel turned sharp right then appeared to narrow significantly upon inspection, suggesting most recent use by rabbits. | Disused |

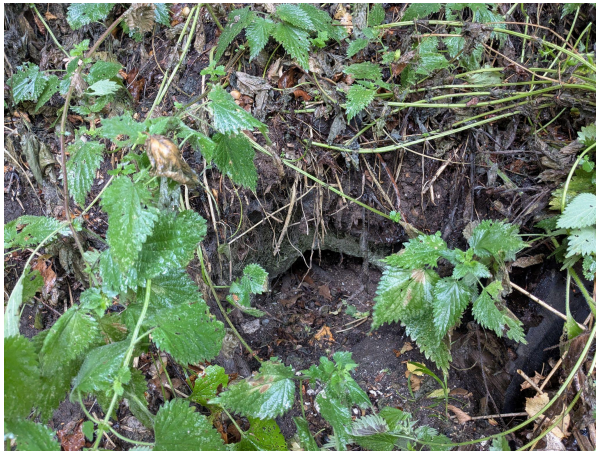
3: Sett entrance 3

| Sett entrance number | Location | Assessment | Status |
|---|---|---|---|
| 3 | SU 69669 75204 | Appeared currently disused with accumulated soil, leaf litter and stinging nettle growth in entrance. | Disused |

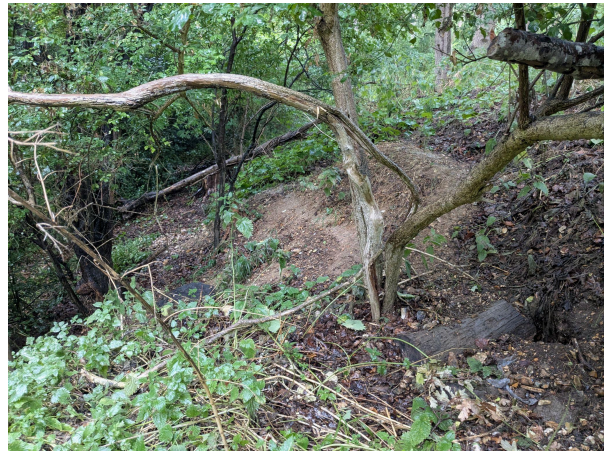
4: Sett entrance 4

| Sett entrance number | Location | Assessment | Status |
|---|---|---|---|
| 4 | SU 69666 75205 | Appeared potentially active, with notably greater soil disturbance around entrance and less leaf accumulation in entrance. | Potentially active |

What appeared to be a well worn badger path was observed around sett entrance 4. This path continued eastwards to sett entrances 2 and 3, where it quickly became notably less worn, with ground flora establishing and increasing leaf and twig litter accumulating, indicating the path is not in regular use by badgers around sett entrances 2 and 3. No further evidence of badger activity such as latrines, badger hair, footprints or snuffle holes was recorded during the site visit. Rabbit droppings were recorded near sett entrance 2.

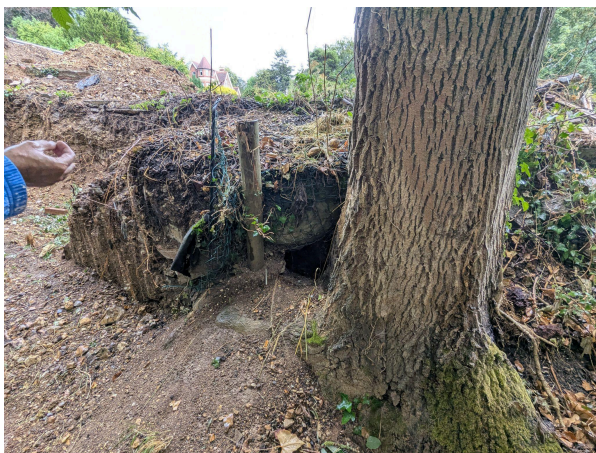
5: Sett entrance 5

| Sett entrance number | Location | Assessment | Status |
|---|---|---|---|
| 5 | SU 69689 75231 | The entrance hole was found to be clear of debris with a well worn path leading up to it, however this path appears established by people and the lack of leaf accumulation is likely caused by an overhang above the hole. Upon inspection the hole was found to bend left then right, continuing beyond the reach of inspection towards the centre of the site, narrowing as it went. The sett entrance is situated at the base of an ash tree in obvious poor health (hollow at base, standing dead wood, leaning) that seems about to collapse. | Potentially active |

There is no definitive evidence that sett entrance 5 is in active use, and while badgers typically avoid high-disturbance environments, the possibility of this burrow being used as an outlier sett by badger cannot be ruled out. Adhesive hair traps were deployed at this entrance on 31st July 2025. If these traps remain in place for a significant time and badger hairs are not found to have adhered to the tape, this would indicate a lack of current use by badger. Camera trapping would provide the most robust conclusion on current badger use.

It is understood that landscaping of the central portion of the garden with heavy machinery and demolition of the derelict house is scheduled for summer 2026 at the earliest. Sett entrance 5 should be checked for badger use prior to the commencement of such significant works within its 30 m buffer zone. Significant works would constitute movement of tracked vehicles, use of heavy machinery, digging/excavation, movement of soil and reprofiling of grounds. Sett entrance 5 should also be checked prior to the commencement of works involving hand tools within its 10 m buffer zone. Buffer zones are indicated in Figures 2 and 3. The 30 m buffer zone around sett entrance 5 may be simplified to mean works south of the existing footprint of the derelict house.

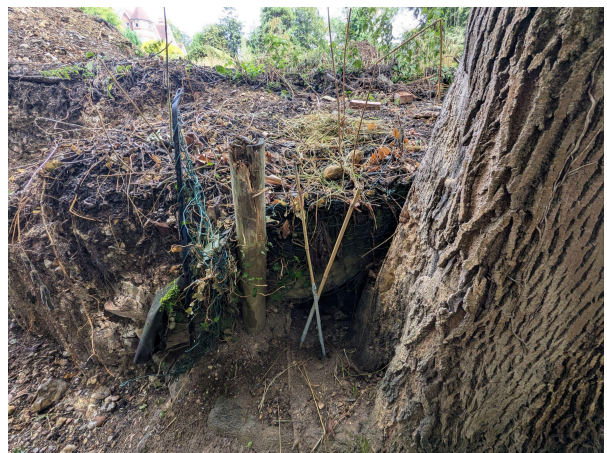
6: Sett entrance 5 with adhesive hair trap

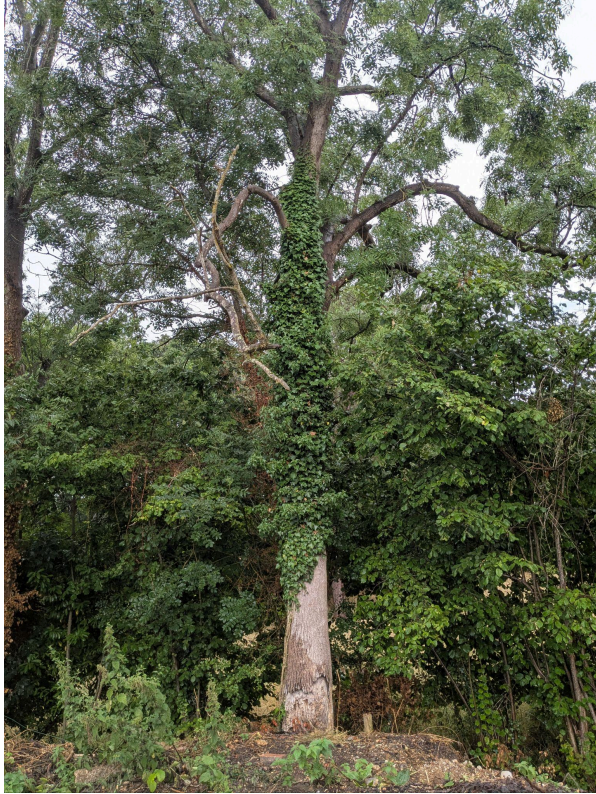
7: Ash tree in obvious poor health adjoining sett entrance 5

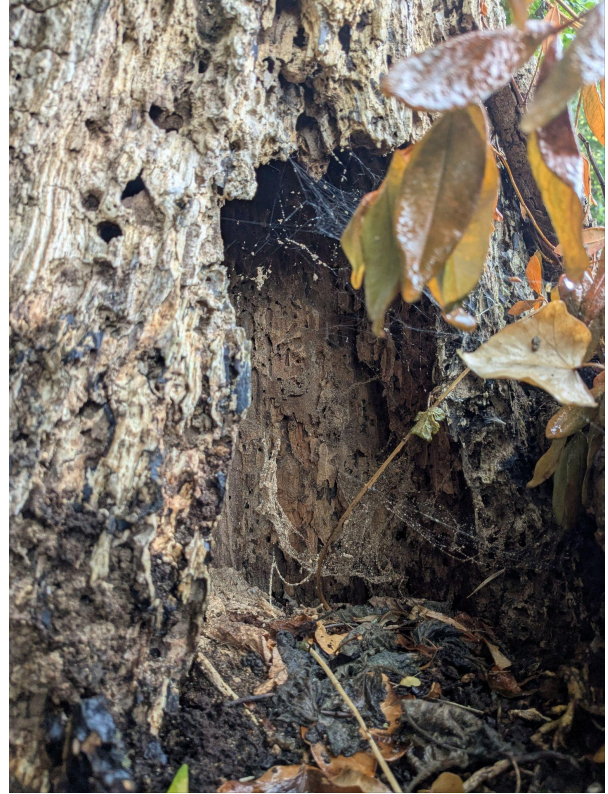
8: Hollow base of ash tree

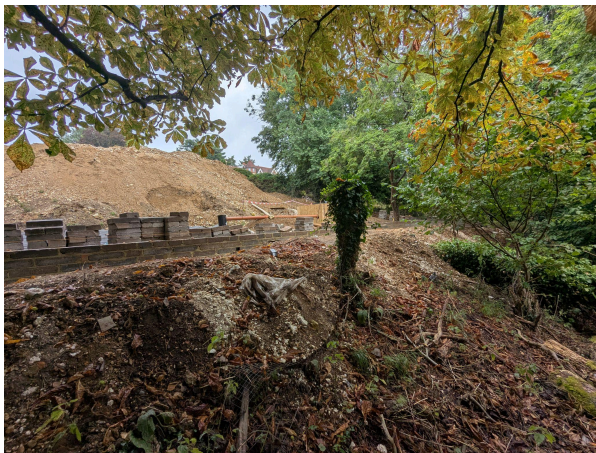
The site has been subject to some recent vegetation clearance, with the current active works areas consisting of the construction of a garage in the northernmost portion of the site (between Upper Warren Avenue and the derelict house), and a low wall being built at the southern edge of the garden, above the escarpment (indicated in Figure 2). It is understood that the completion of this wall will involve neither heavy machinery nor further excavations, therefore a 10 m buffer zone is considered appropriate mitigation for the completion of works in this area.

9: Wall construction at southern edge of garden

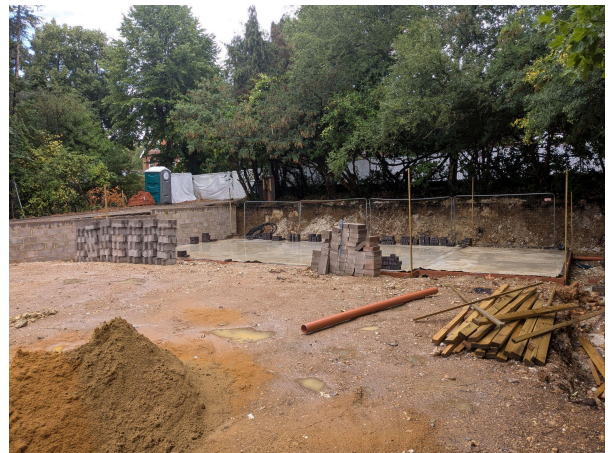
The derelict house and the active works area north of it are clearly beyond 30 m of all recorded badger setts. The northern portions of neighbouring properties were inspected by looking over fences and it was clear that no badger sett entrances were present in these areas. Therefore, continued works in this portion of the site are not expected to have an adverse impact on local badgers and their setts.

10: Active works area between derelict house and Upper Warren Avenue

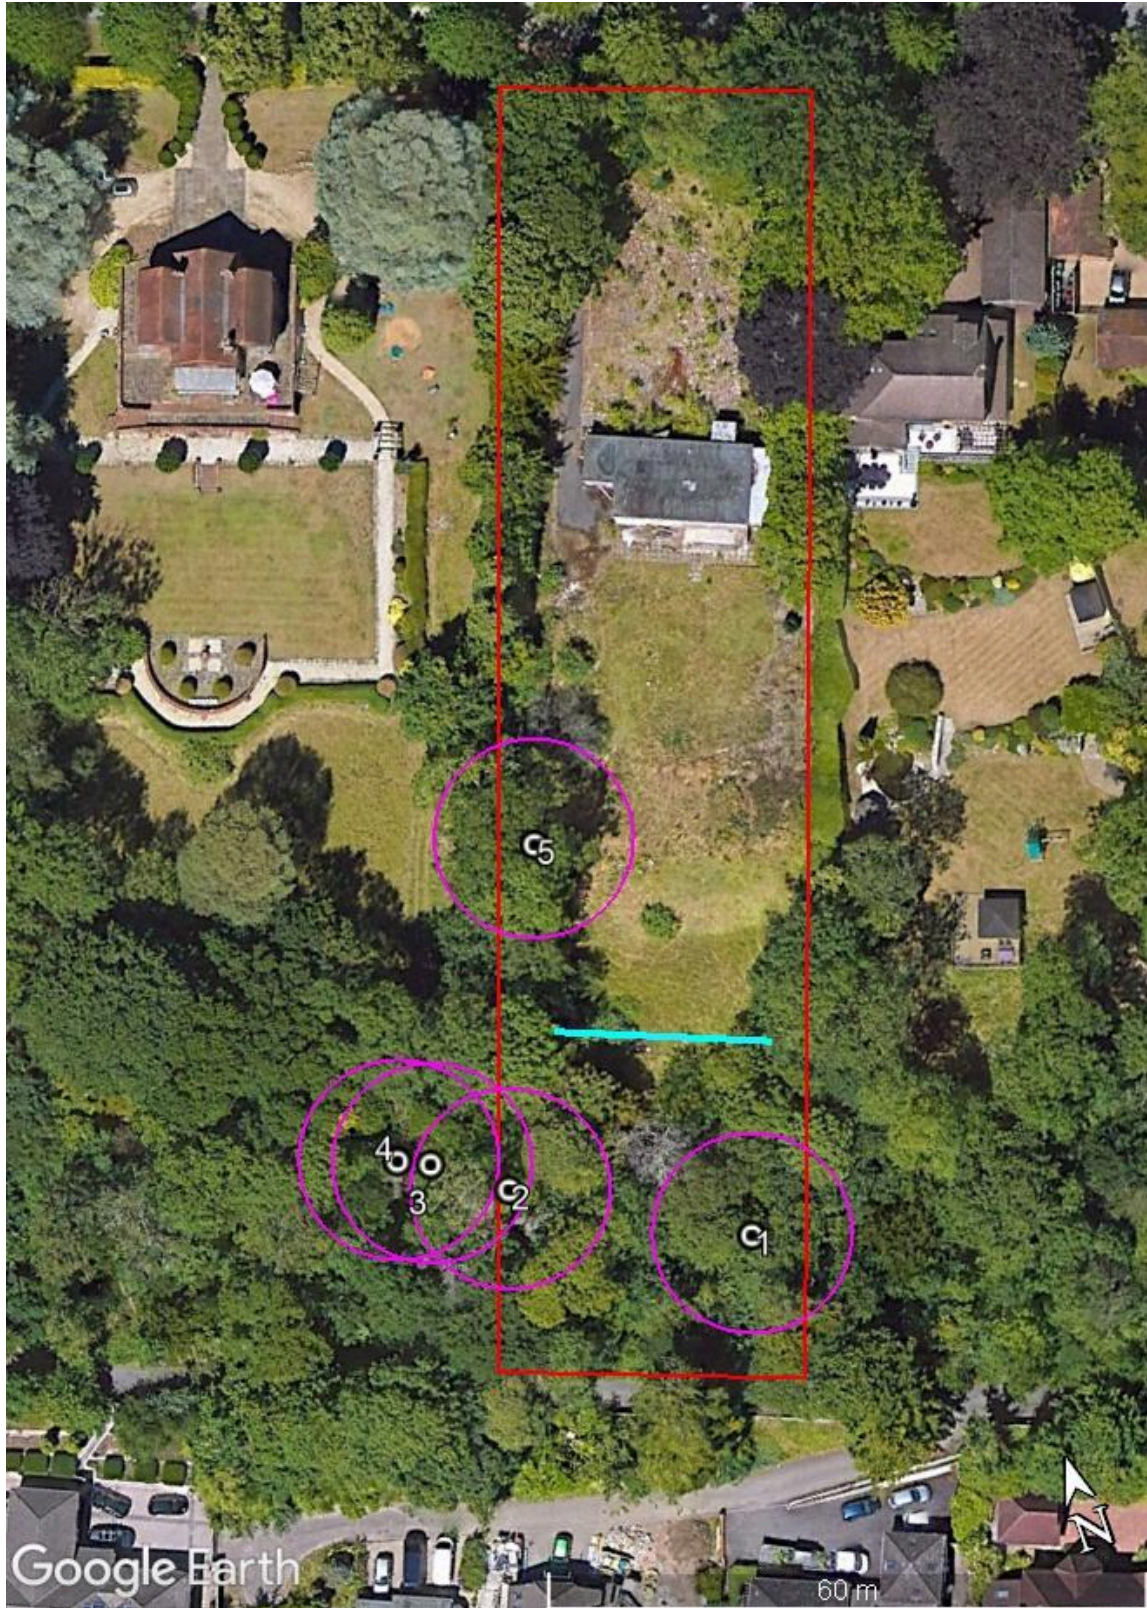
Figure 2: Badger sett entrances with 10 m buffer zones (pink-purple) sketched, approximate location of wall in mid-construction illustrated in cyan-blue

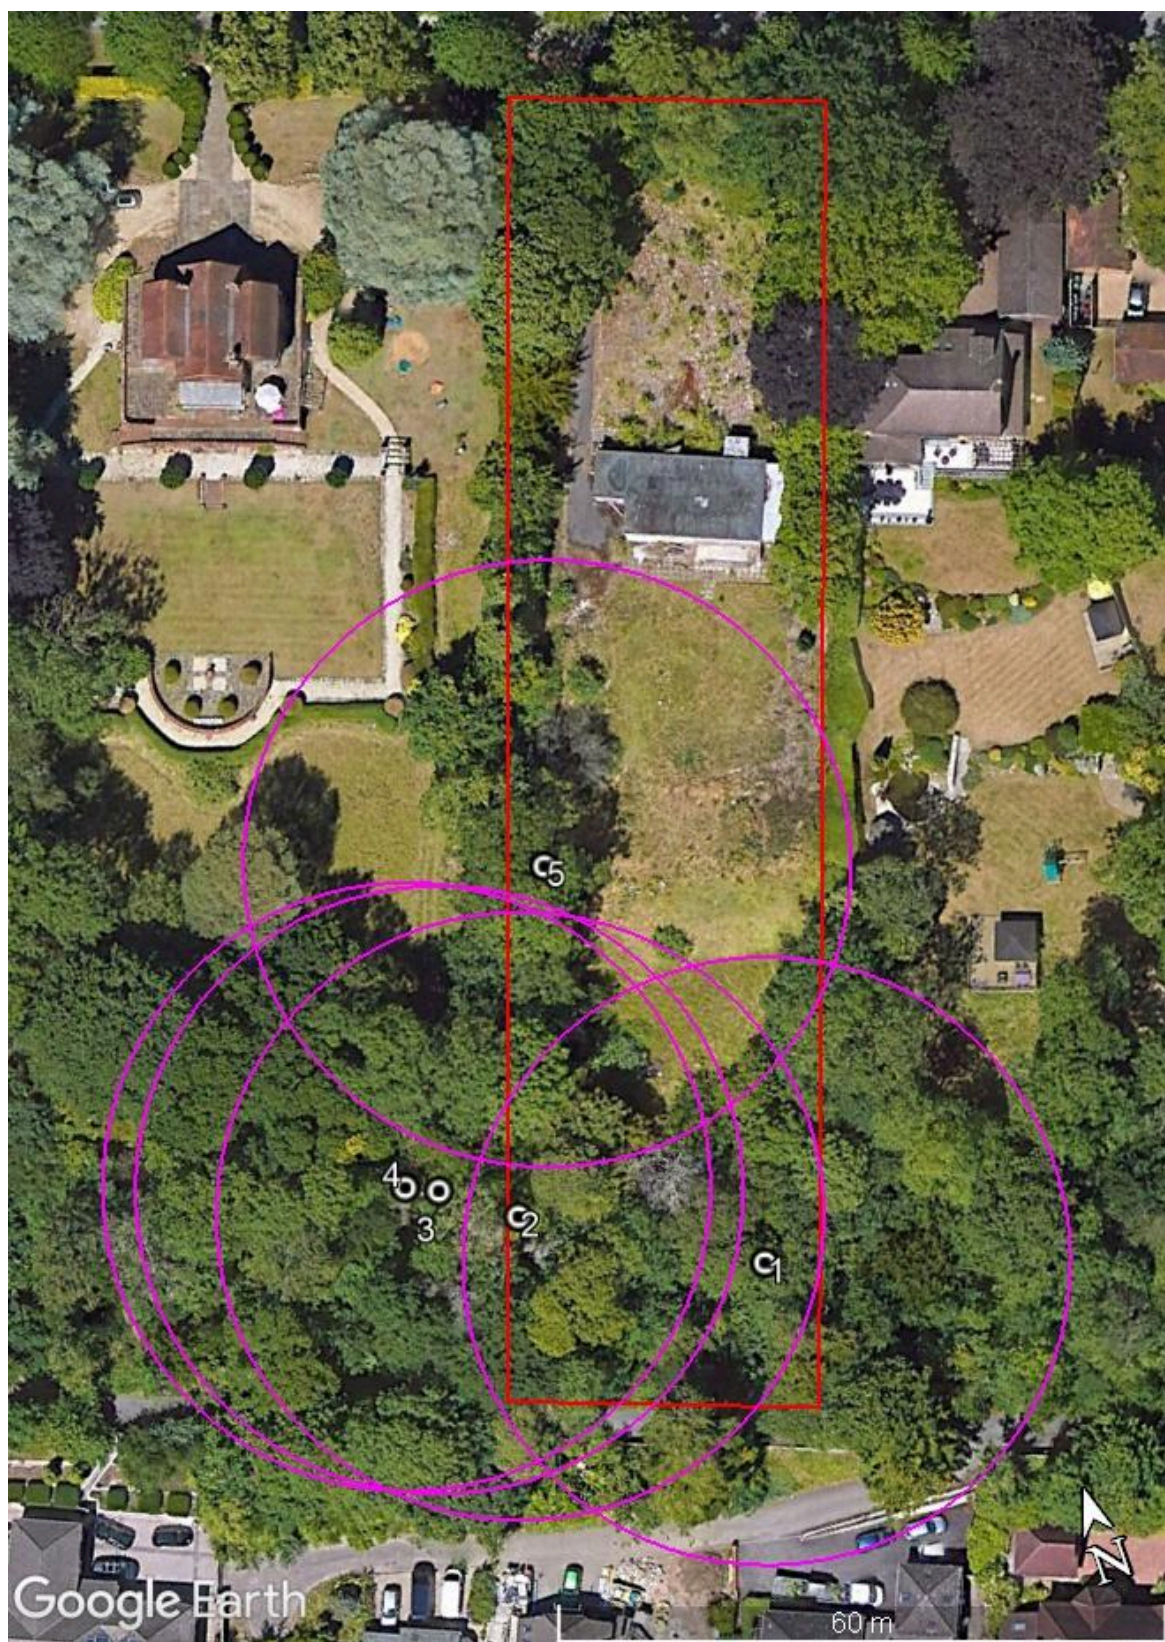
Figure 3: Badger sett entrances with 30 m buffer zones sketched
