# Memo

**Re:** Consultation on an Application

**Planning Application Ref:** PL/26/0868

**Proposal:** Erection of new detached garage

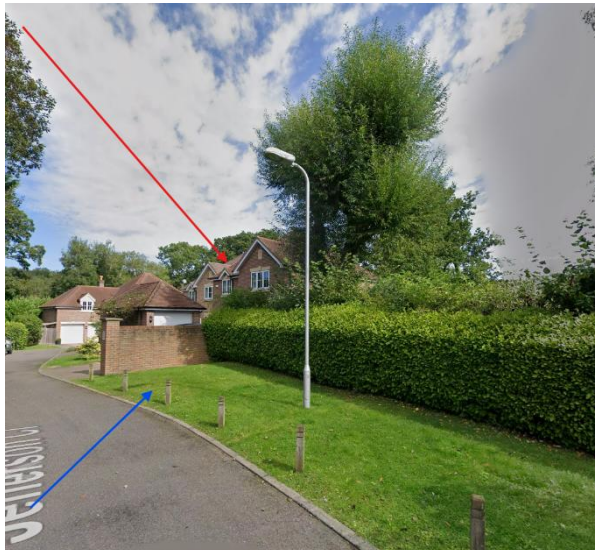
Google StreetView – 16 Jefferson Close (red arrow); approximate location of proposed garage (blue arrow)

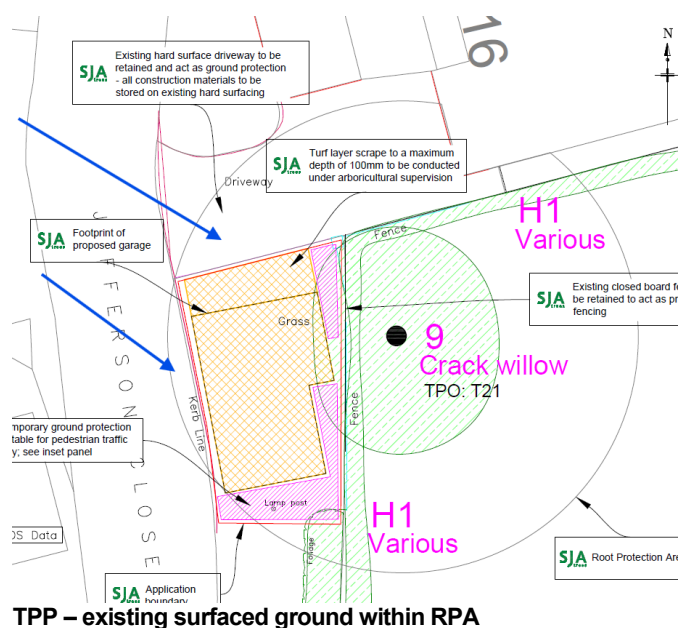
Section 6.1.2. states 'Consequently, a tree within the RPA of which no disturbance will occur can be regarded as one that will not suffer any significant or long-lasting harm because of the proposals and will therefore remain "viable". The RPA incursion of the Willow (No.9 of AIR; T21 of TPO) is calculated as 15.2%, Section 2.6.1 states 'As shown in **Table 2** the surface area of the incursion equates to 15.2%, and so does not exceed the 20% maximum incursion into currently unsurfaced ground recommended in BS 5837, and, as will be discussed below, the actual RPA impact will be significantly less than this two-dimensional calculation would suggest'. The RPA has not been adjusted (as per 4.6.2 of BS5873) and both the road and the driveway are included which are not likely to be favourable rooting environments. Whilst I appreciate that the BS5837 does quote the said percentage, it also states in 7.4.2.1 that 'The design should not require excavation into the soil, including through lowering of levels and/or scraping, other than the removal, using hand tools, of any turf layer or other surface vegetation', which the methodology discussed below, does not comply with.

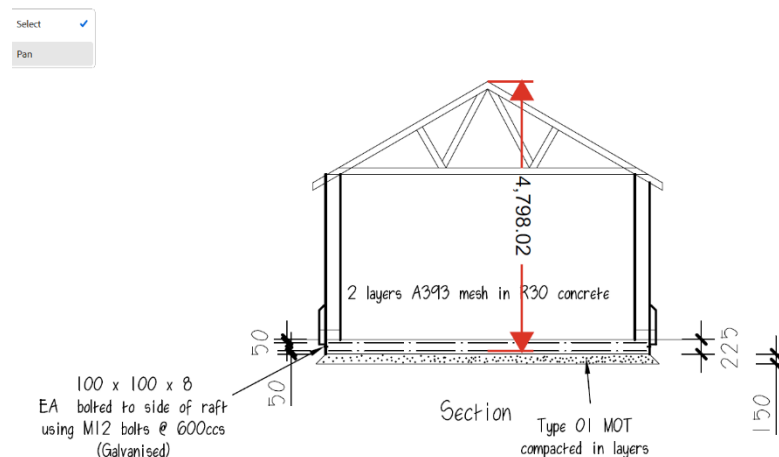
Section 6.2.2. states *'The foundation of the proposed garage will be of a slab design which will be situated on top of the existing ground level. Consequently, ground preparation will consist of the removal of the turf layer and levelling of the minor change in ground level from the fence at the northern extent to the kerb to the south, resulting in excavation no deeper than 100mm. This maximum depth will be isolated to the northern extent of the garage, due to the minor level difference. The extent of excavation gradually reduces in extent from that point down to towards the road, with ultimately only the removal of the turf layer being required.'* As mentioned above, we do not consider this acceptable as the BS5837 advises that ground levelling should not occur within an RPA beyond the turf layer. The Proposed Section Plan below, doesn't seem to show only 100mm of excavation - the plan appears to show 225mm of excavation for the concrete base, and a further 150mm for the Type 01 MOT. Whilst I appreciate there is a *'very minor upward slope (approximately 100mm) from the kerb to the eastern boundary'*, the elevation shows further excavation than that detailed within the AIR. The existing ground level is not labelled in the elevations, which makes this particularly unclear to understand. It would also be useful to include several section diagrams to demonstrate where the existing and proposed ground levels are compared to the garage.

**Section Drawing – existing ground level not clear; excavation shown more than 100mm**

Section 6.2.3. states *'As there are underground services in the area, piles will not be utilised, further limiting the impact on the RPA. Additionally, over dig during construction will be negligible as there is no need to set the foundation into the ground, which might otherwise necessitate additional workspace, the turf removal and ground levelling will be contained within the area of the foundation.'* I'm unclear what is meant by this when if the foundations were built on piles, this would limit excavation to the piles - the foundations are shown to be set into the ground in the elevation drawings.
