Our Ref: PL/26/0628  
Your Ref:

20<sup>th</sup> August 2026

**RE: PROPOSED WORKS TO 2NO. OAK TREES AT 23 MANDEVILLE CLOSE, TILEHURST, READING - T1 & T2 OF TREE PRESERVATION ORDER NUMBER 24/01.**

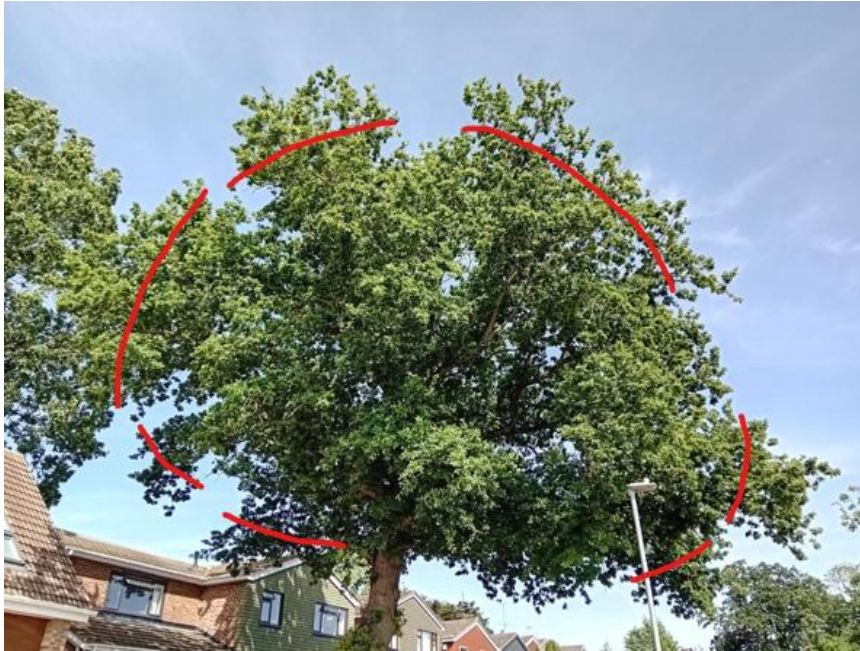
Figure 1 (Oak T2 of Report; T1 of TPO): selectively reduce overextended branch by 1-2m to bring back into the main crown line

- Selectively reduce identified, overextended, lateral branches shown in Figures 1 & 2 by approximately 1-2m, using 'drop crotching' and in accordance with the BS3998 guidance as per Condition 2, bringing them back into the main crown line to form a natural canopy shape, ensuring no more than one third of the foliage is removed from each branch and leaving suitable growth points. This is to include pruning the branches growing towards both No. 23 & No. 25 to create approximately 2-3m of clearance from the outer extremity of the roof line, as shown in Figure 3 & 4.

- Selectively reduce identified, overextended branches to reduce the height of the crown by approximately 0.5-1m, as shown in Figure 1 & 2, bringing them back into the main crown line to form a natural canopy shape, ensuring no more than one third of the foliage is removed from each branch, leaving suitable growth points;
- Reduce branch growing towards to lamppost to provide approximately 1m of vertical clearance from the lamp head and approximately 1m horizontal clearance from the lamp column, as shown in Figure 5, ensuring no more than one third of the foliage is removed from each branch, leaving suitable growth points.

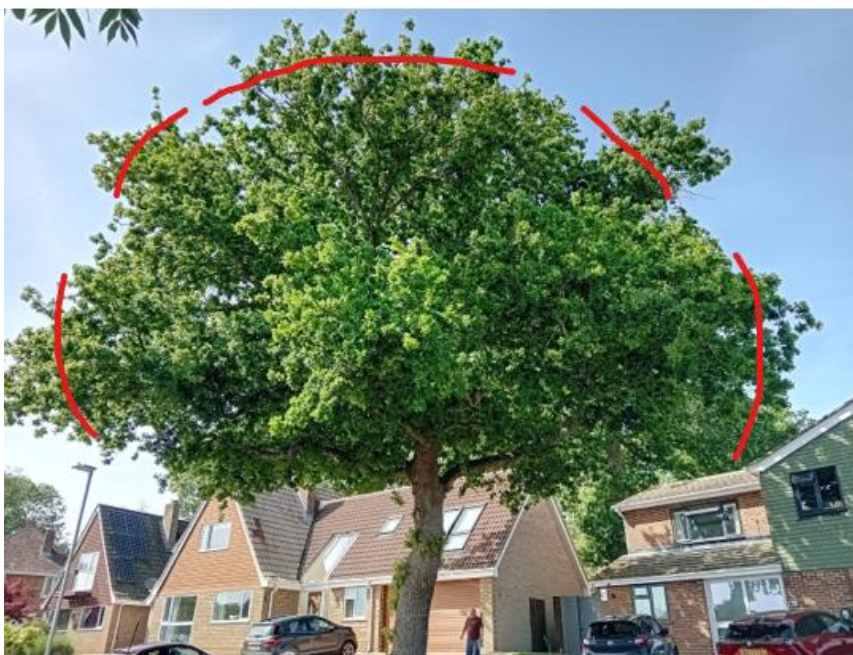
Figure 2 (Oak T2 of Report; T1 of TPO): selectively reduce overextended branches by 1-2m to bring back into the main crown line

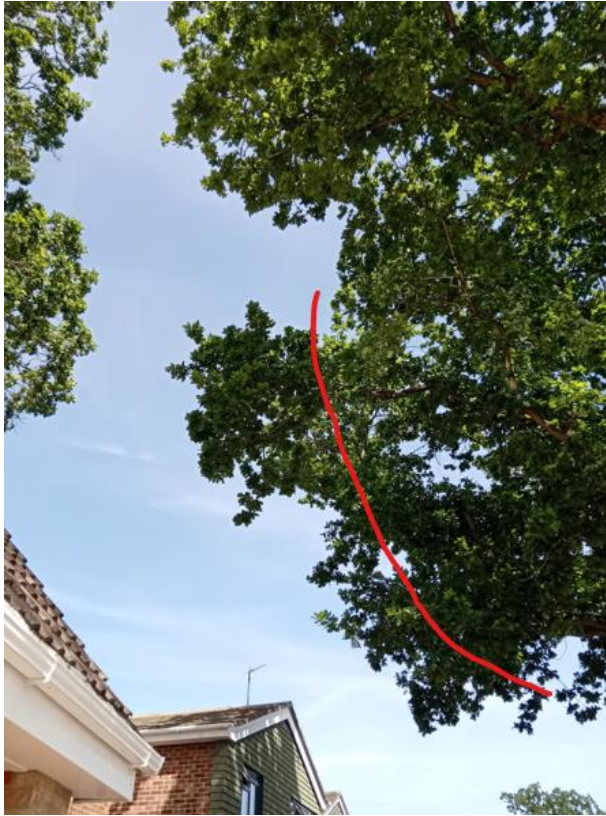
Figure 3 (Oak T2 of Report; T1 of TPO): reduce branches growing towards No. 23 to provide clearance of roof line

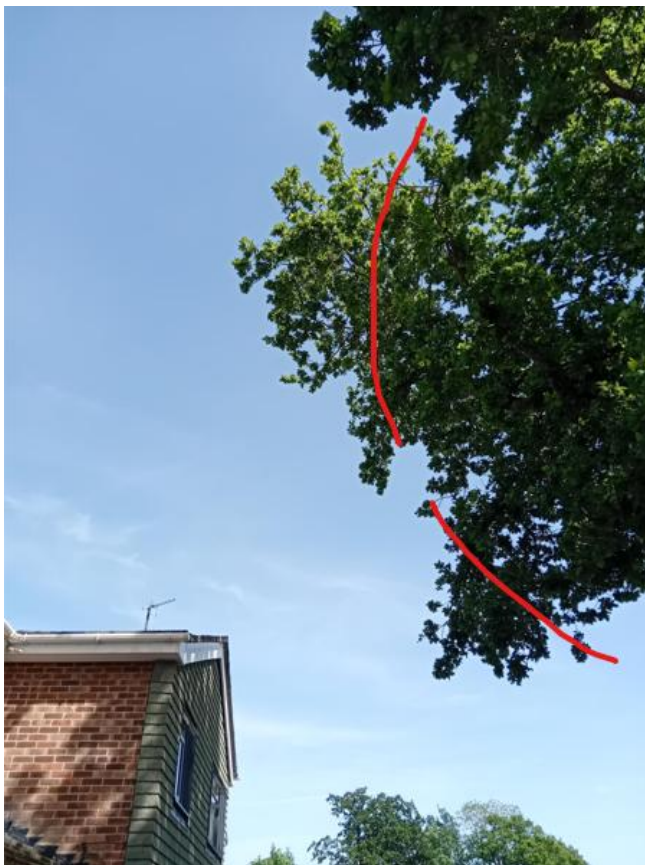
Figure 4 (Oak T2 of Report; T1 of TPO): reduce branches growing towards No.25 to provide clearance of roof line

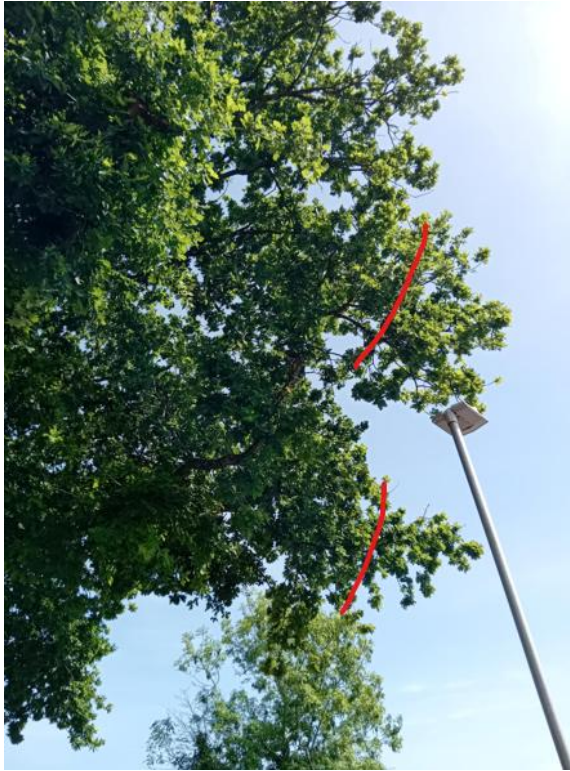
Figure 5 (Oak T2 of Report; T1 of TPO): reduce branches growing towards the lamppost to provide clearance

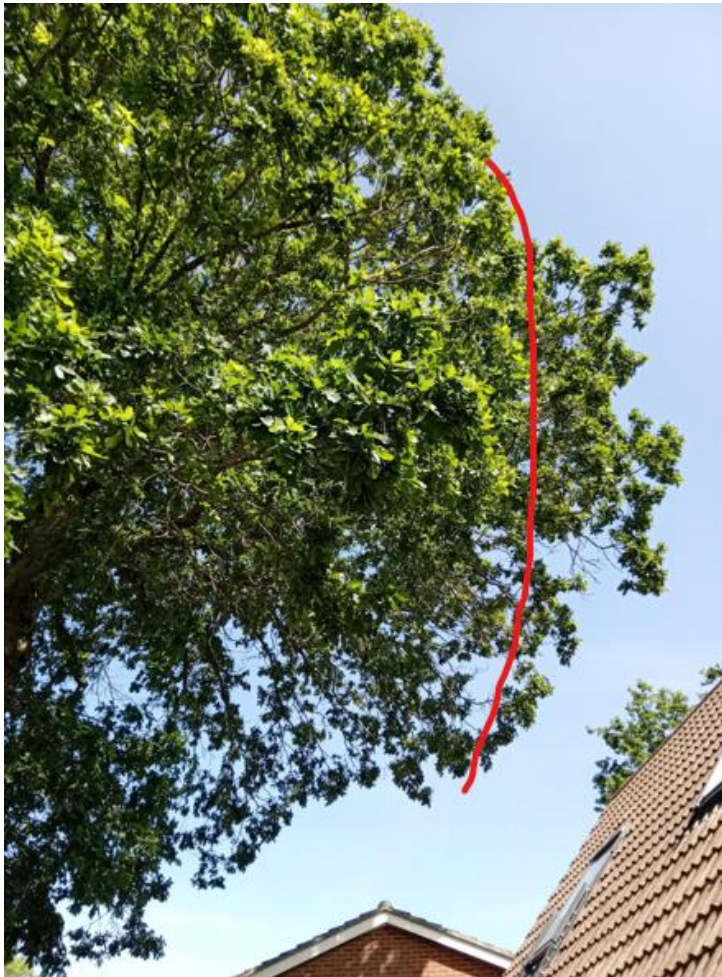
Figure 6 (Oak T1 of Report; T2 of TPO): reduce branches growing towards No. 23 to provide clearance of the roof

- Selectively reduce identified, overextended, lateral branches shown in Figures 6 & 7 by approximately 2-2.5m, using 'drop crotching' and in accordance with the BS3998 guidance as per Condition 2, creating approximately 2-3m clearance of the roofs of No. 23 and No. 25, bringing them back into the main crown line to form a natural canopy shape, ensuring no more than one third of the foliage is removed from each branch and leaving suitable growth points.

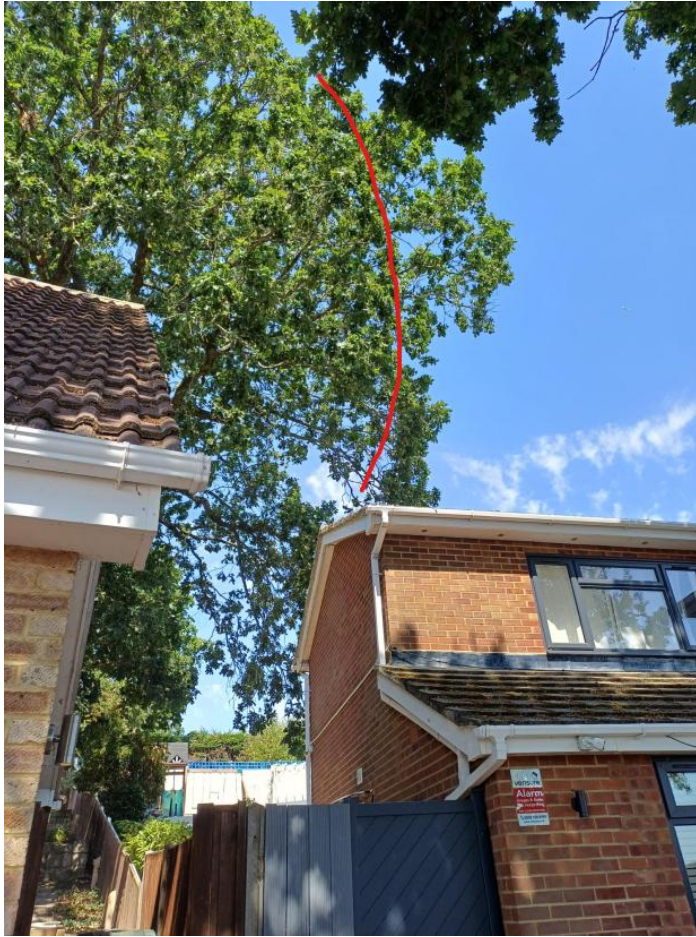
Figure 7 (Oak T1 of Report; T2 of TPO): reduce branches growing towards No. 25 to provide clearance of the roof

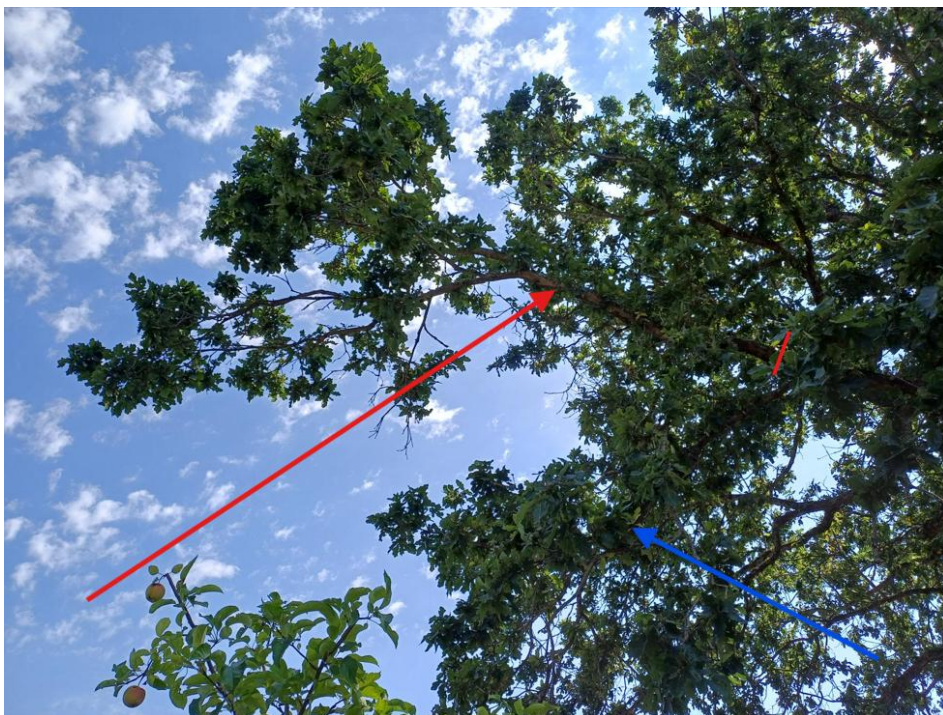
Figure 8 (Oak T1 of Report; T2 of TPO): remove one branch back into the point shown in red, retaining the growth point shown in blue, then reduce said growth point by approximately 1m.

- Remove the identified branch (growing north) in Figure 8 into the lower identified growth points; reduce the lower growth point by approximately 1m, ensuring no more than one third of the foliage is removed, leaving suitable growth points.

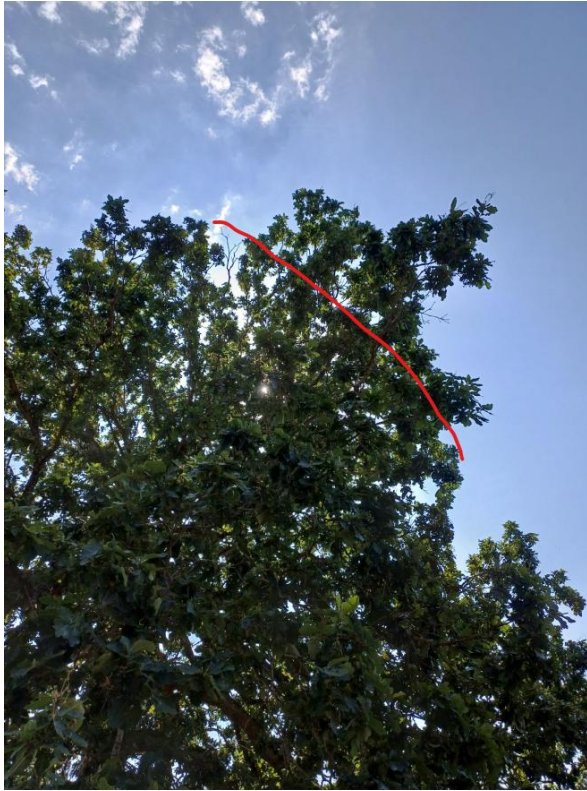
**Figure 9 (Oak T1 of Report; T2 of TPO): selectively reduce overextended upright branches by 1-1.5m to bring back into the main crown line**

- Selectively reduce the identified upright branches (growing northwest in Figure 9 by approximately 1-1.5m, bringing them back into the main crown line to form a natural canopy shape ensuring no more than one third of the foliage is removed from each branch, leaving suitable growth points.

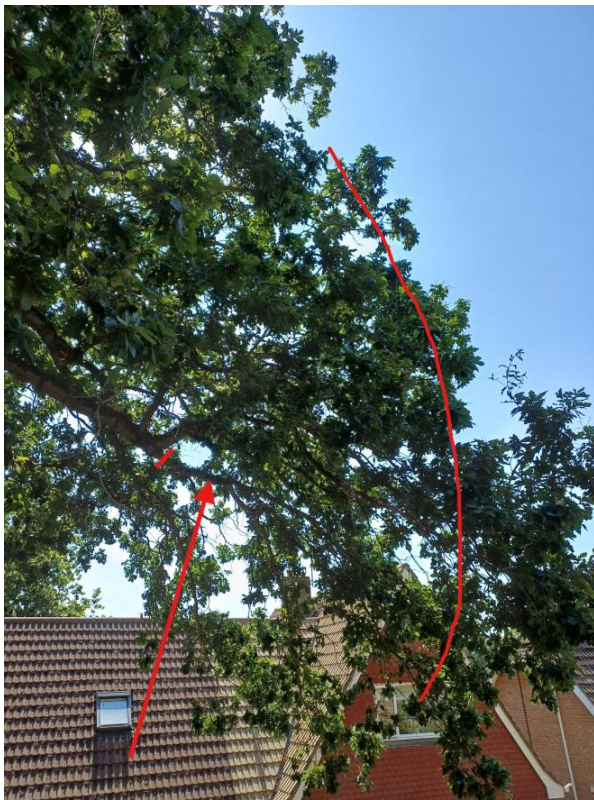
**Figure 10 (Oak T1 of Report; T2 of TPO): remove one branch back into the point shown by the red arrow and straight red line; selectively reduce overextended branches by 1-1.5m to bring back into the main crown line shown by the red curve**

- Remove the identified lowest branch (growing west) in Figure 10 back to the point shown in Figure 10 (a previous pruning point); selectively reduce the identified, overextended branches as shown in Figure 10 by approximately 1-1.5m, bringing them back into the main crown line to form a natural canopy shape, ensuring no more than one third of the foliage is removed from each branch, leaving suitable growth points

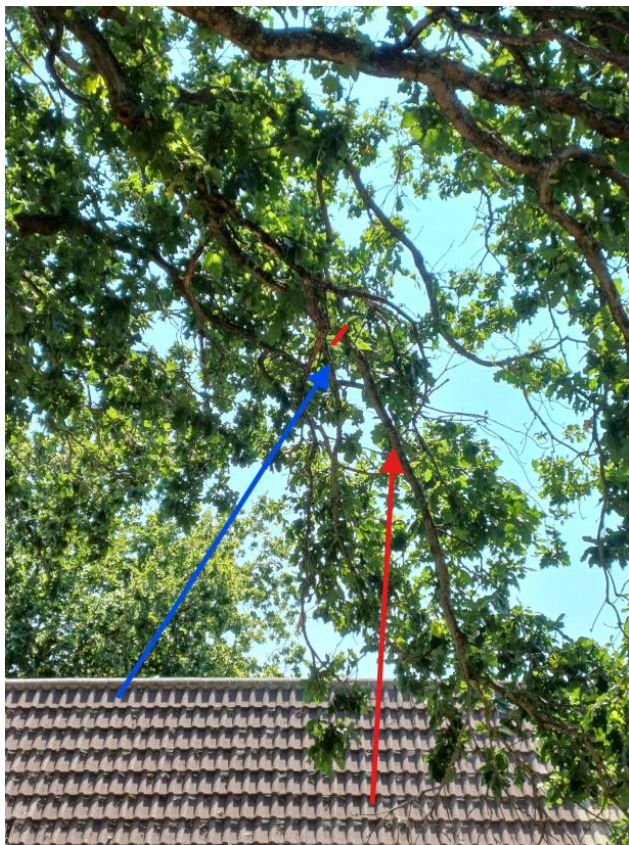
Figure 11 (Oak T1 of Report; T2 of TPO): remove one branch back into the point shown in red, retaining the growth point shown in blue

- Remove the identified lowest branch (growing south) in Figure 11 back to the identified growth point shown in Figure 11.

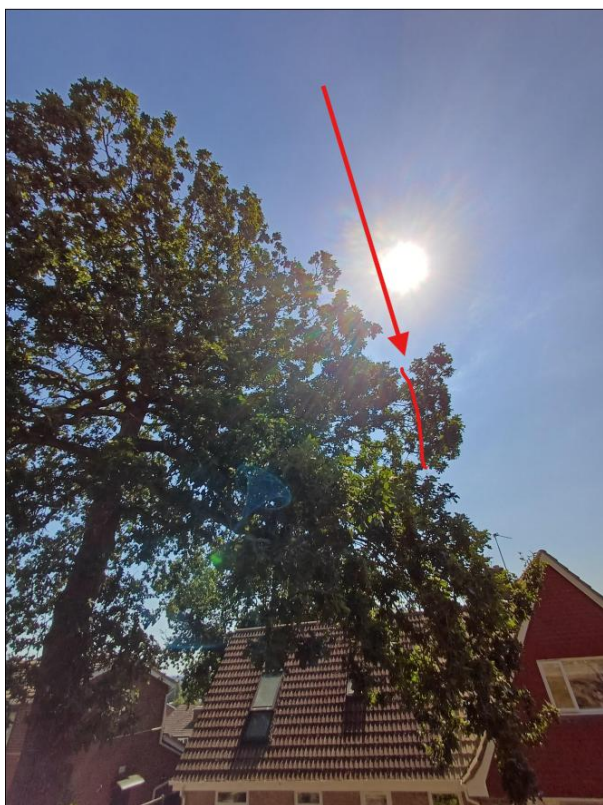
Figure 12 (Oak T1 of Report; T2 of TPO): selectively reduce overextended upright branches by 0.5m to bring back into the main crown line

- Selectively reduce the identified, overextended, upright branches (growing west) as shown in Figure 12 by approximately 0.5m, using 'drop crotching' and in accordance with the BS3998 guidance as per Condition 2, bringing them back into the main crown line to form a natural canopy shape, ensuring no more than one third of the foliage is removed from each branch, leaving suitable growth points.
- Reduce the height of the crown by approximately 2-2.5m, as shown in Figure 13, bringing them back into the main crown line to form a natural canopy shape, ensuring no more than one third of the foliage is removed from each branch, leaving suitable growth points.

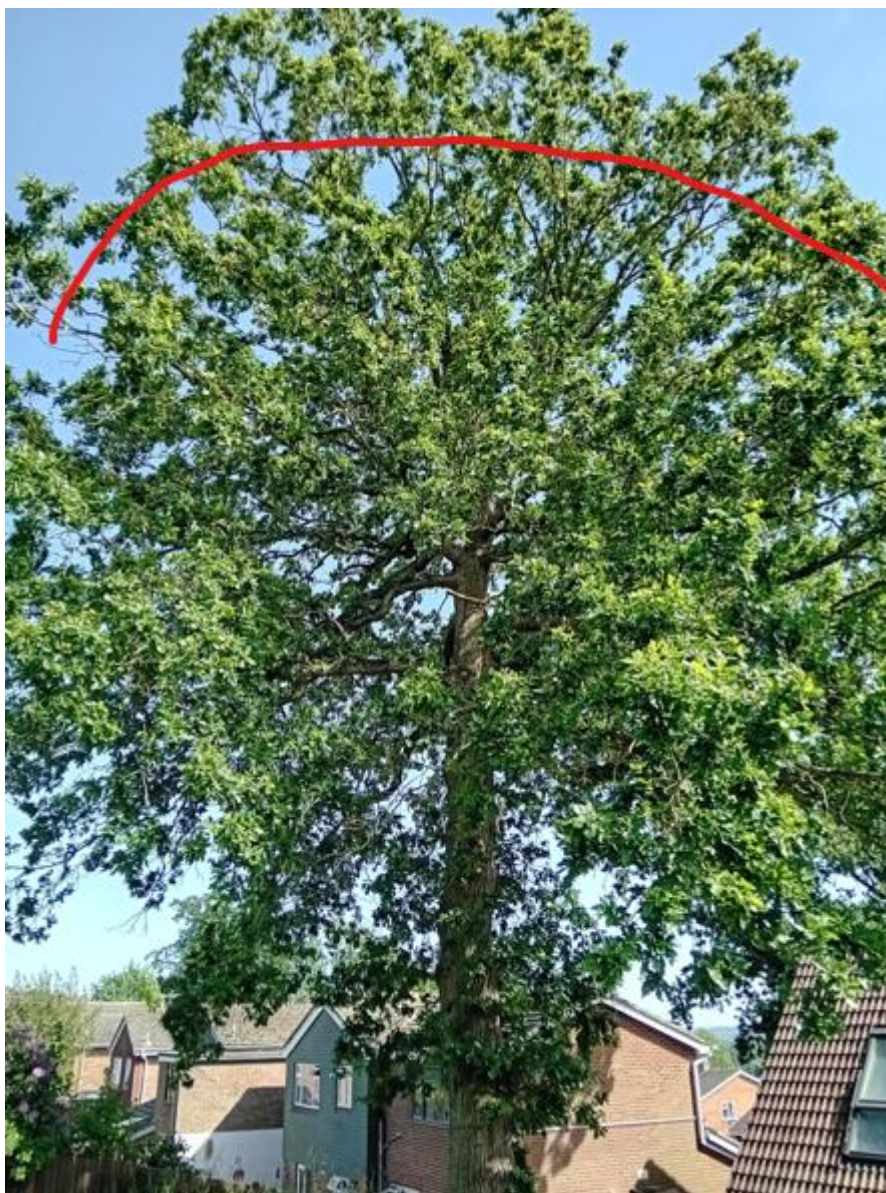
The works to T1 Oak (T2 of TPO) in the rear garden, were also clarified during our site visit. We identified the overextended branches with Mr Tiling and came to an agreement of which branches these were considered to be, including specific branch reductions to identified growth points. As with T2 (T1 of TPO), the works are considered reasonable to manage the weight load on overextended branches, and to provide clearance of both adjacent properties. This tree has also been historically topped; hence the height reduction is considered justified to manage the weight load on the potentially comprised area which is supporting the weight of the upper canopy.

Figure 13 (Oak T1 of Report; T2 of TPO): Reduce the height of the crown by 2-2.5m
