DUCKWORTHS  
ARBORICULTURE LTD.

Ref: 07111 / 2026

**Site:** Warren Creek, The Warren, Caversham, Reading RG4 7TQ

**RE: ARBORICULTURAL REVIEW AND ENDORSEMENT OF COORDINATED PLAN 3863/308 REV B (WC-SCAC-001)**

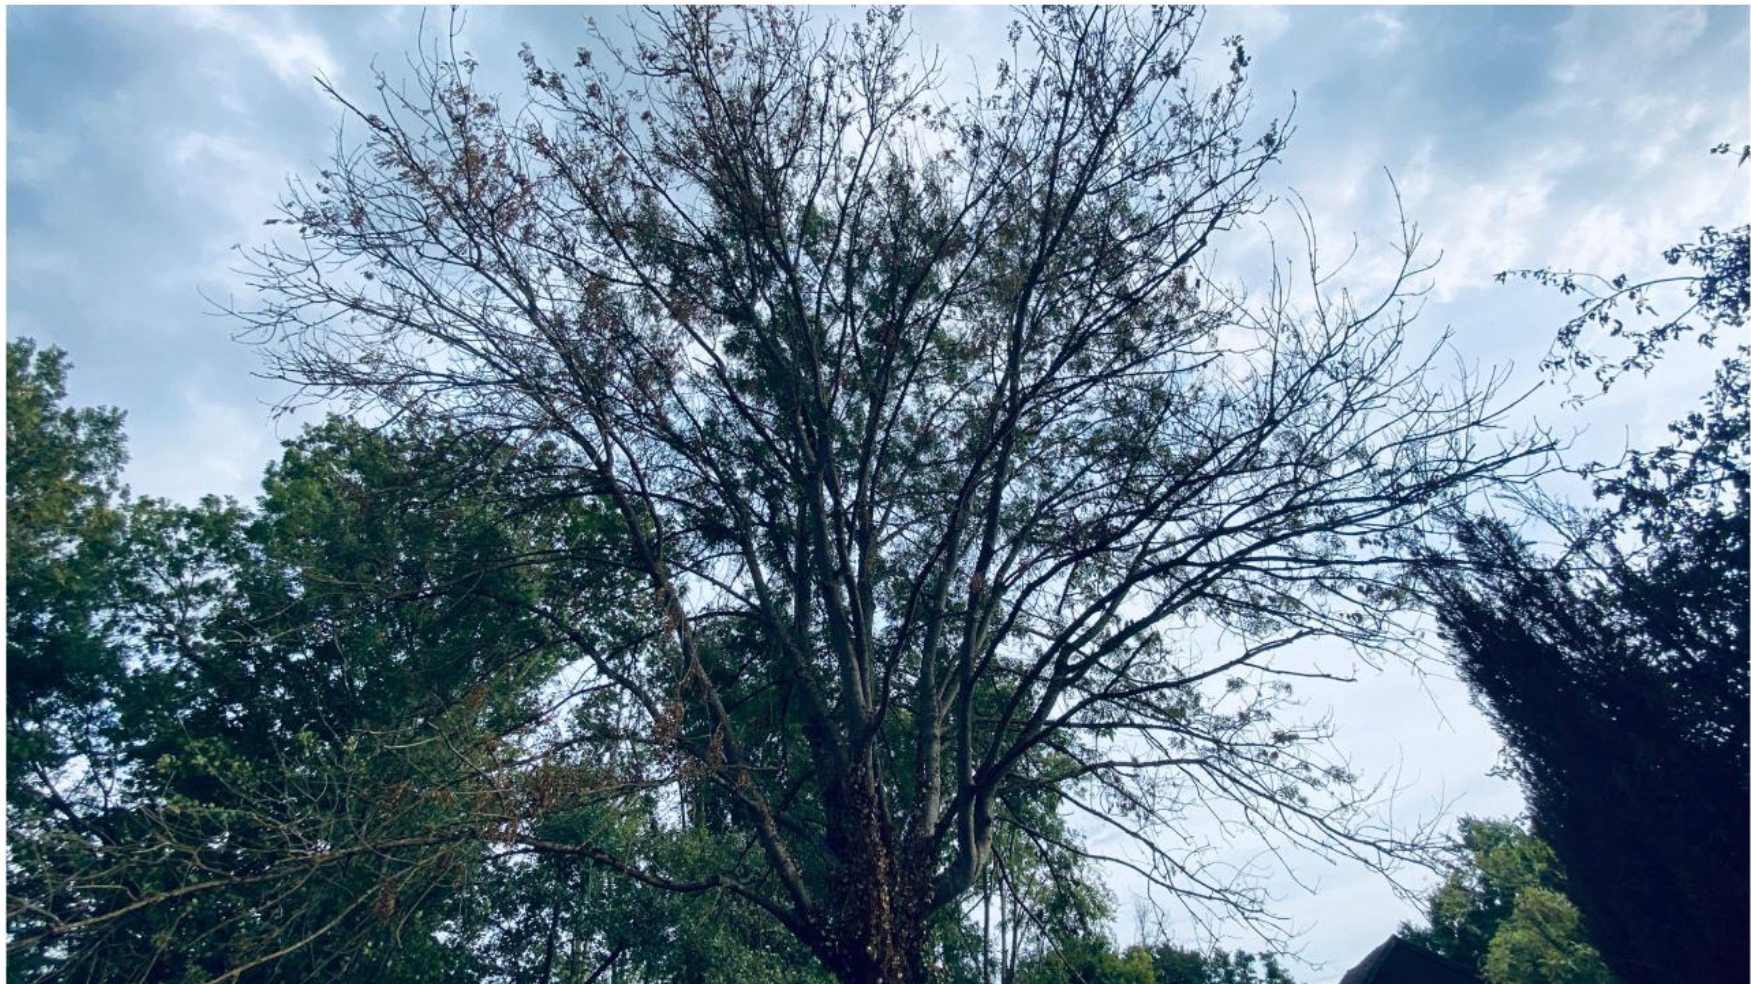
During my site visit, I noted that T7 (Ash) is now in an advanced state of decline. The tree has shown some canopy dieback throughout the five years in which I have inspected the property, and this has materially increased.

The recent drought conditions and fire affecting the garage building appear to have accelerated the decline. Approximately 25-30% of the canopy is now dead, and the remaining canopy is retrenching and in advanced decline. I now categorise T7 as a BS 5837 Category U tree with an anticipated remaining contribution of less than 10 years and recommend its removal, subject to the necessary separate consent or notification process.

Mr Arnold has consistently sought to retain T7 and has made substantial efforts to protect it throughout the development process. However, in my professional opinion, its decline is terminal and long-term retention is no longer sustainable. Pending any separate decision on removal, the existing protection measures shall nevertheless remain in force.

Photo 1 – Canopy of T7 (Ash)

Given the TPO status of T7, I would welcome guidance on the appropriate separate consent or notification process for its removal and replacement. Mr Arnold proposes replacement planting, potentially a native oak positioned near the existing location but set slightly farther back from the bank, subject to the Council's advice and any necessary approval.

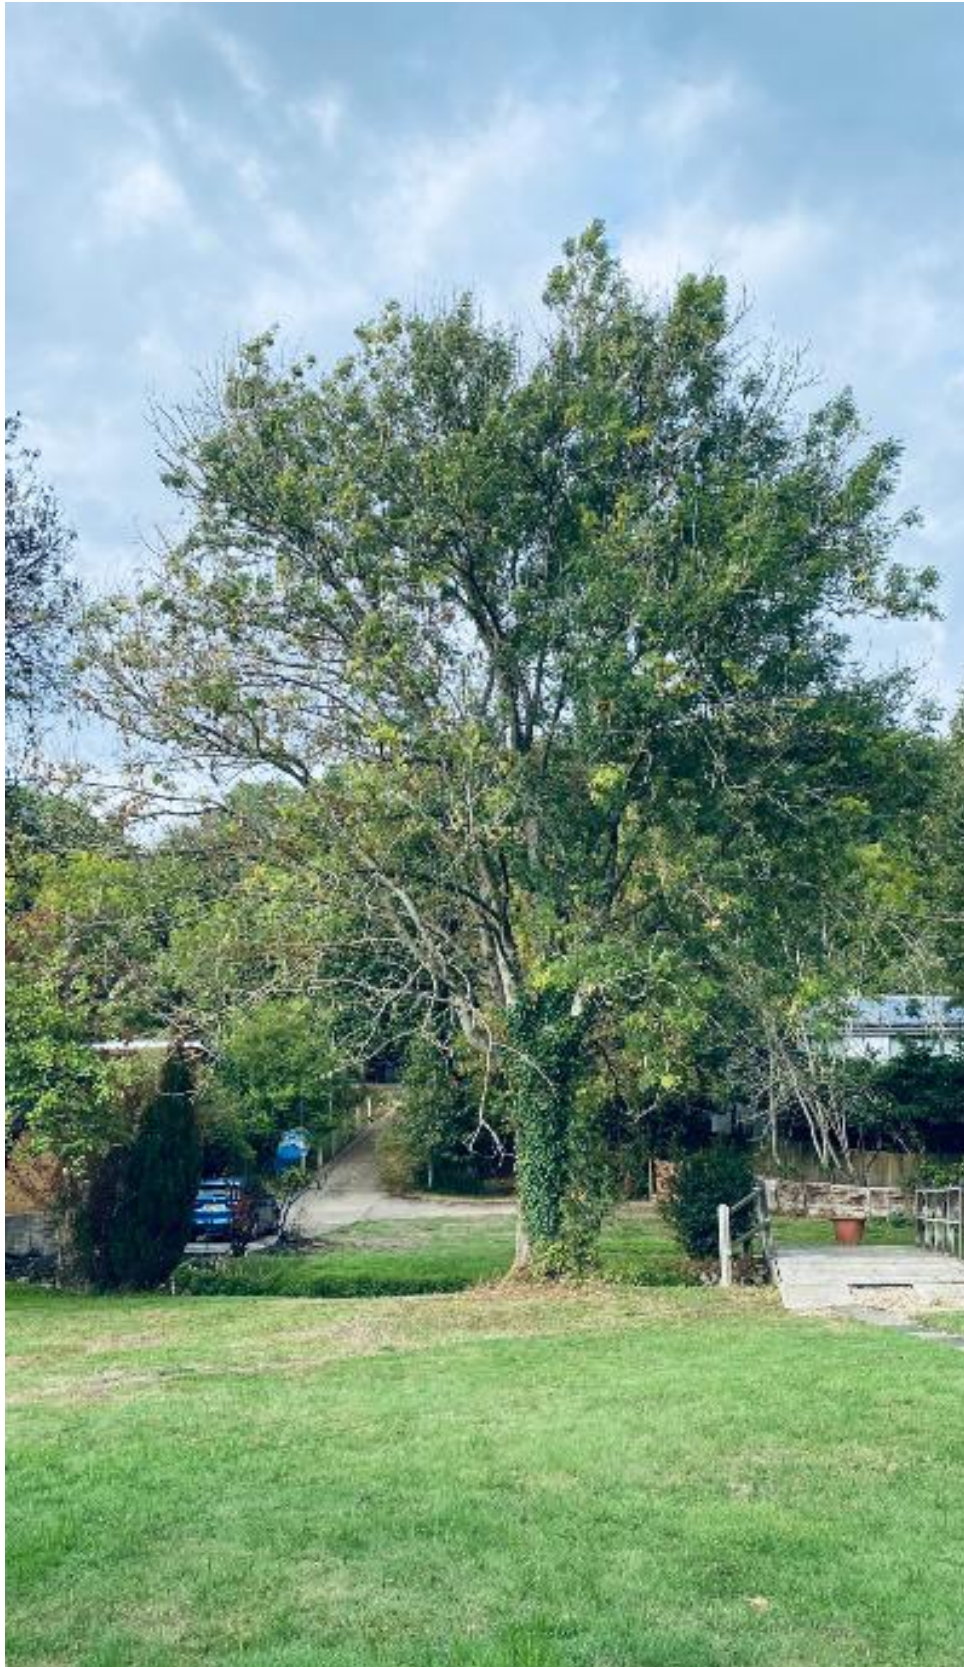
Photo 2 – Dieback in canopy of T7 (Ash)

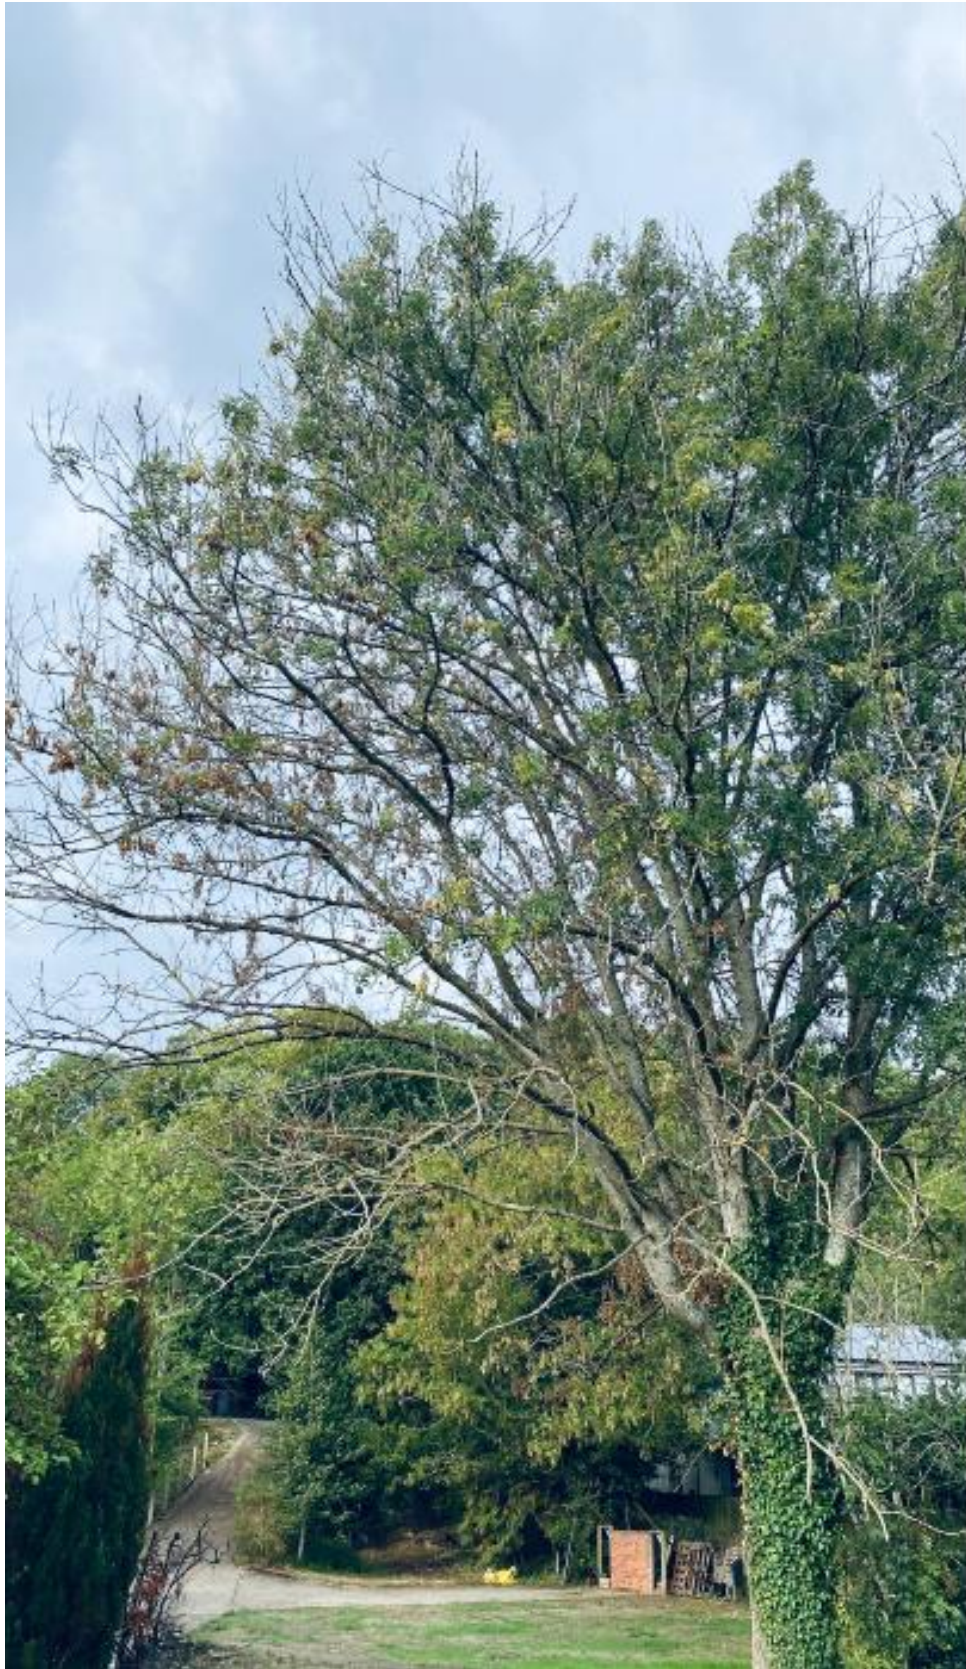
Photo 3 – Dieback in canopy of T7 (Ash)
