## Arboricultural Impact Assessment

SEN School

The Ridgeway Primary School  
Hillbrow  
Reading  
RG2 8JD

Survey Date: 21<sup>st</sup> & 26<sup>th</sup> August 2025  
Report Date: 24<sup>th</sup> September 2026  
Project no: 2485

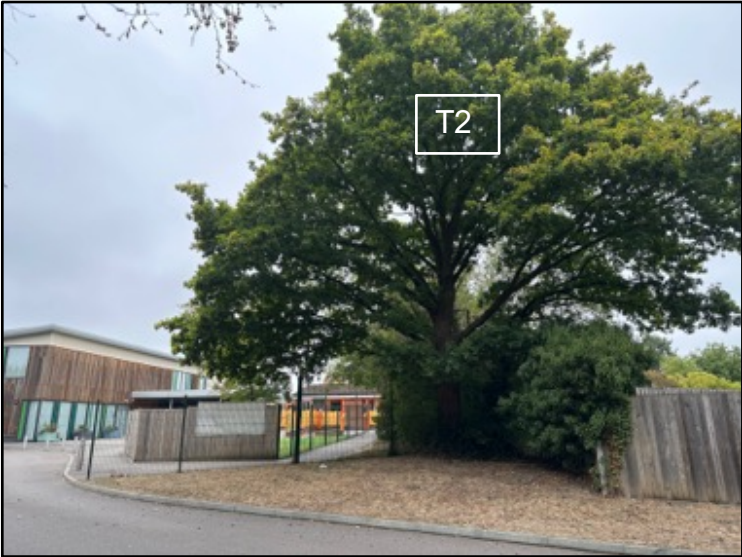
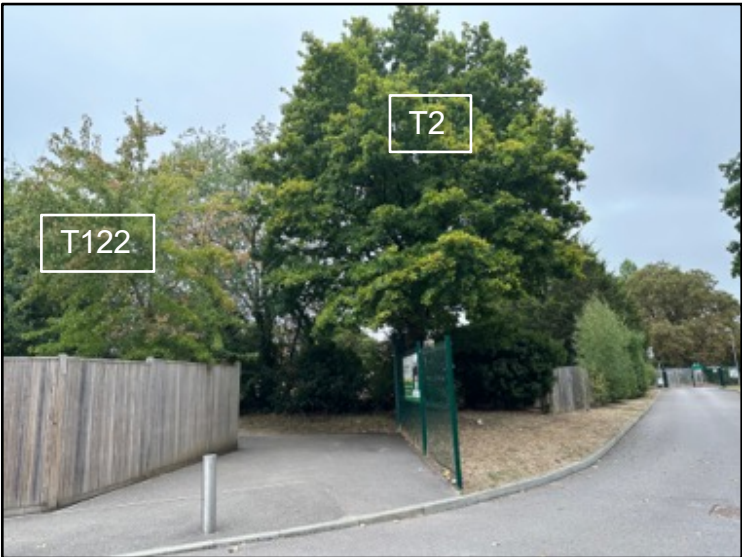
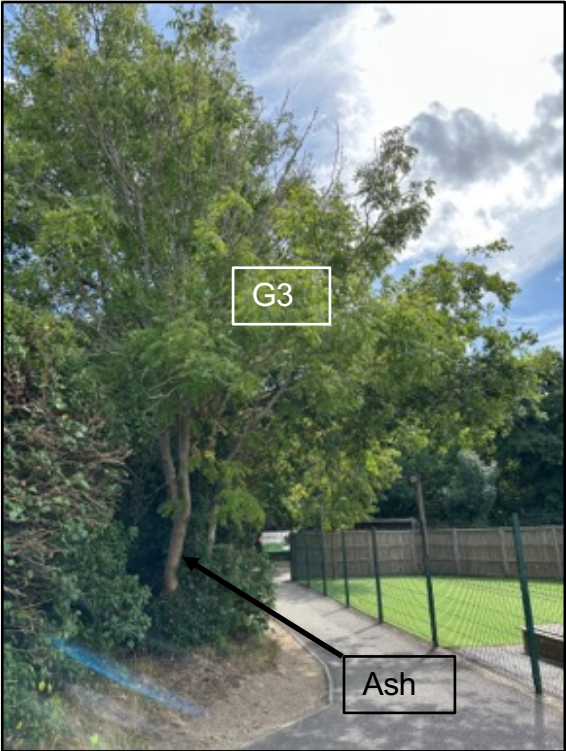
Above: Group of closely spaced trees and hedging. Ash tree in foreground has dieback and should be removed.

Above left and left: Views of good quality oak T2.  
T122 has insufficient space to develop, as it will become suppressed by T2.

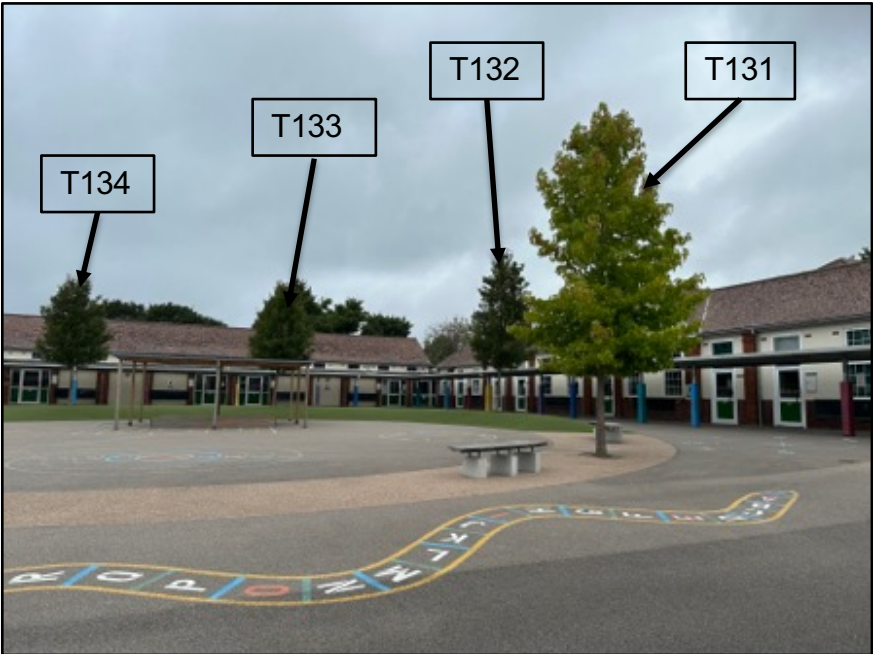
Left: View of internal courtyard area.

T133 proposed for removal to facilitate installation of new play area.

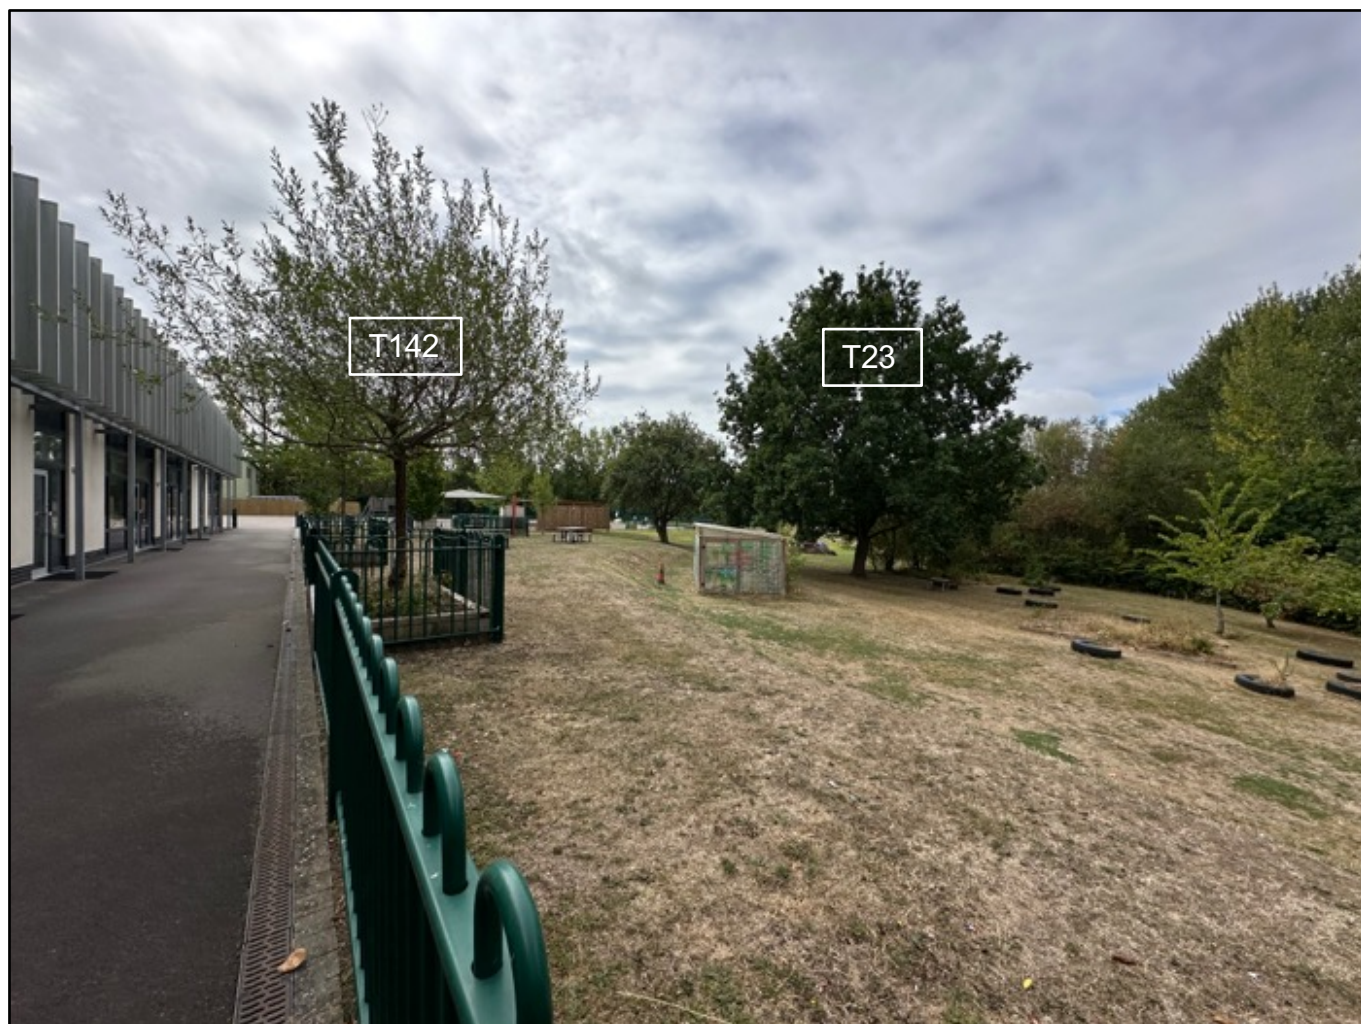
Views along west side of school building where new play area is proposed. Some trees in raised timber beds may be unsustainable in the long term and replacement with more suitable trees is recommended.

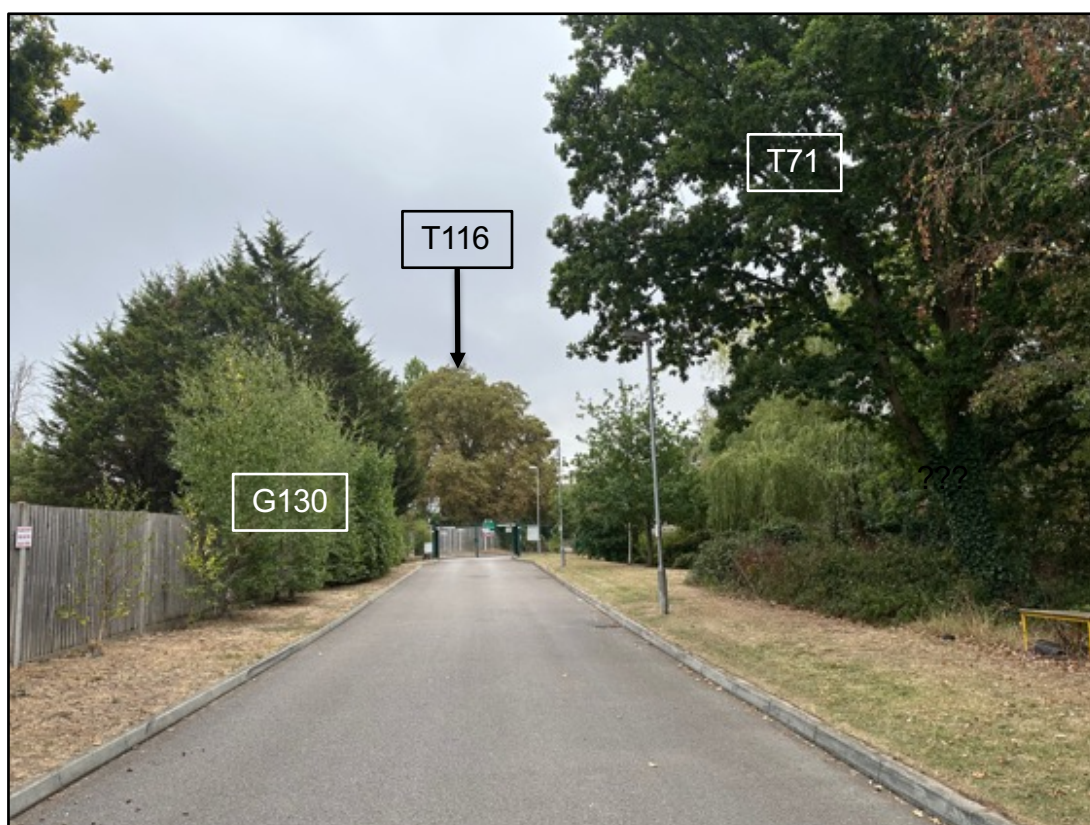
Above: Internal view towards school gates. Trees are set back at sufficient distance from the road edges so that tree protection fencing is considered unnecessary in this area.

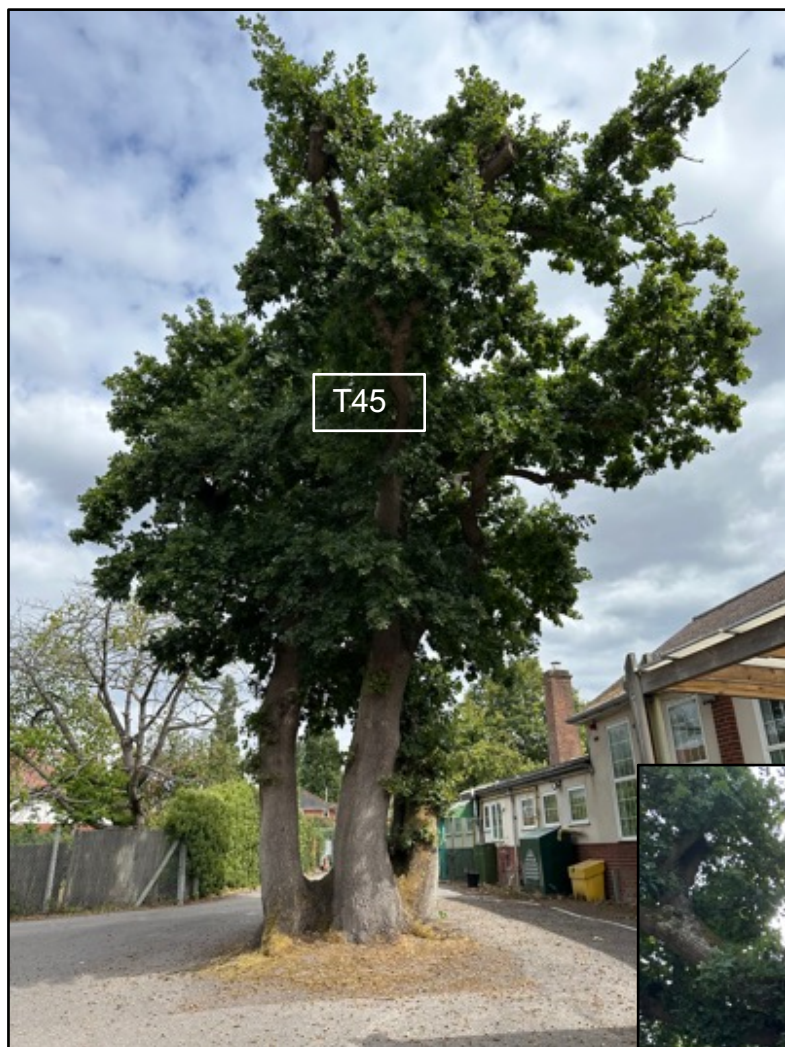
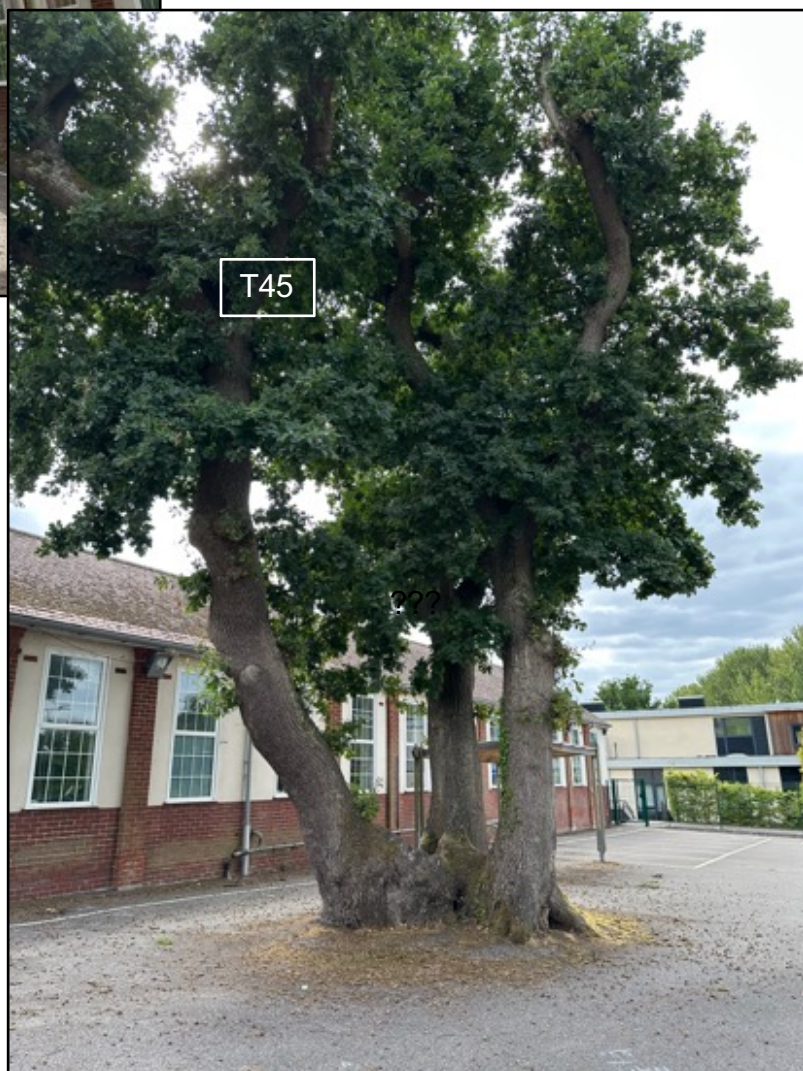
| Tree/<br>Group<br>No. | Species | Height<br>(m) | Stem<br>Diam. at<br>1.5m<br>(mm) | Branch Spread (m) | | | | Canopy<br>Cleara-<br>nce<br>(m) | Age<br>Class | Observations | Management<br>Recommendations | Estimated<br>Remaining<br>Contribution<br>(years) | BS 5837<br>Category<br>Grading | Protect-<br>ion<br>Distnce<br>(m) | Tree<br>Protect.<br>Area<br>(m2) |
|---|---|---|---|---|---|---|---|---|---|---|---|---|---|---|---|
| T45 | Oak | 10.5 | 1165 | 2.5 | 4 | 6 | 5 | 3.5 | Mature | Heavily reduced. Three stems from wide base - 590, 710 & 710mm. Area between southeastern and central stem decaying and hollow on resonant hammering but stems appear sound. Surrounded by tarmac. Feature tree with good vitality. Potential veteran. | Carry out internal decay detection test to assess extent of decay. Carefully remove tarmac from immediately around base to allow for stem growth. | >40 | A2 | 14.0 | 614 |

Above and right: T45 is surrounded by tarmac surfacing of car park, which is protecting underlying roots.

Tree protection fencing has been specified to protect the stems during the works to remove and replace the roof of the adjacent building.
