## Preliminary Roost Assessment

12 Grafton Road, Tilehurst, Reading, RG30 1QJ

20<sup>th</sup> January 2026

*“Two-storey rear wrap around extension and front porch extension.”*

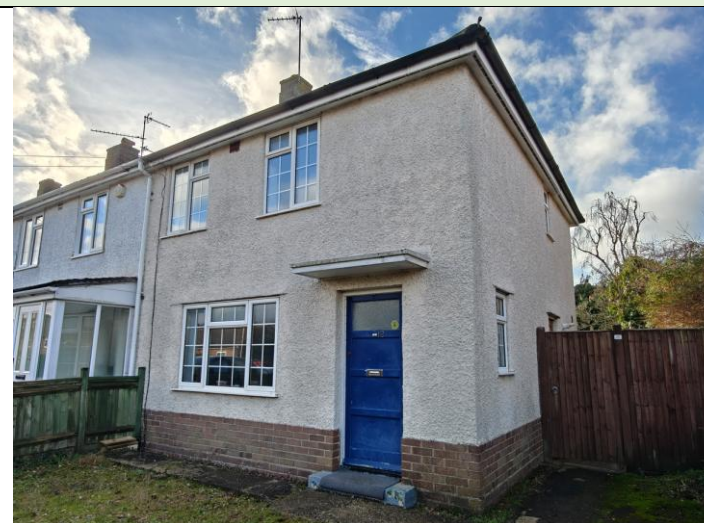
North-western aspect

| Feature | Materials | Condition/description | Photograph(s) |
|---|---|---|---|
| Wall/façade | Primarily painted pebble dash with a short red-brick section along the base | <p><b>Condition/description</b></p> <p>The walls in themselves appear to be in a good state of repair with no visible gaps recorded.</p> <p><b>Suitability/access/evidence of bats</b></p> <p>No suitable roosting features observed.</p> | <p>A photograph showing the western aspect of the house. It focuses on the white pebble dash wall, a wooden door on the ground floor, and a small window on the first floor. A red brick section is visible at the base of the wall. A small square vent is also visible on the wall. The sky is blue with some clouds.</p> |

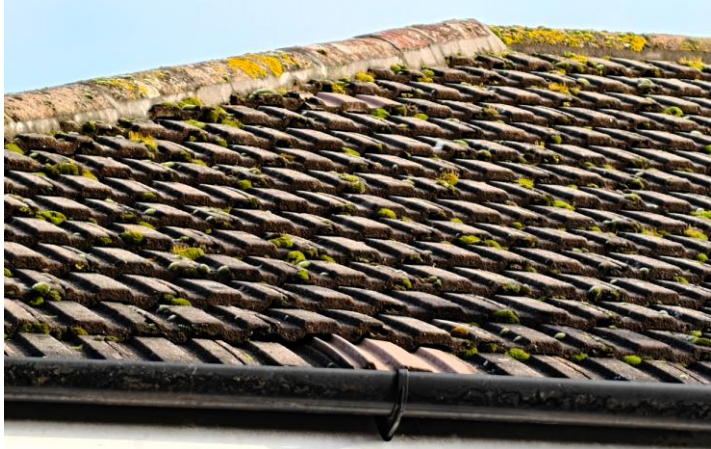
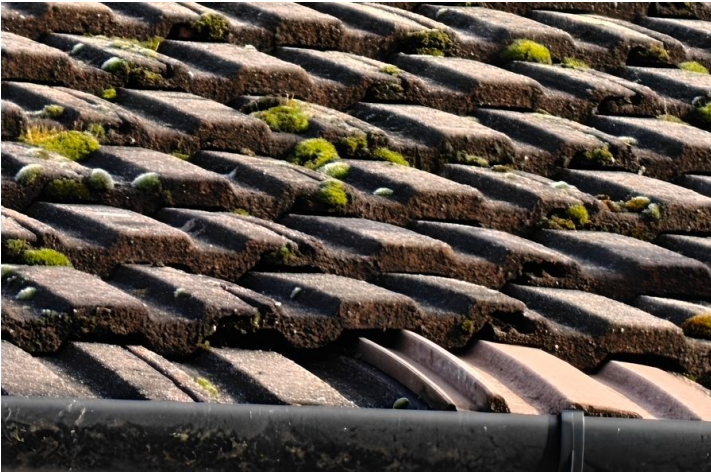
Western aspect

| Roof | Interlocking concrete tiles, with mortar and concrete ridge tiles | <p><b>Condition/description</b></p> <p>A low number of gaps beneath the tiles on building B1 across the southern, western, and northern aspects were present. Only one gap beneath a lifted tile was observed on the northern aspect, the roof was notably moss-covered along this elevation. One missing roof tile was observed on the southern elevation within the area of impact of the proposed extension. The ridge line and mortar were noted to be well-sealed with no visible gaps recorded.</p> <p><b>Suitability/access/evidence of bats</b></p> <p>Gaps under tiles could provide roosting opportunities for individual crevice dwelling bats. It was not possible to determine during the survey if these gaps are connected underneath the tiles, and lead to a larger void between the tiles and underlining of the roof. It was also not possible to determine if gaps under tiles provided internal access into the roof void. If such features are present, it increases the suitability for roosting bats.</p> | <p>Southern aspect of the roof</p> <p>Close up view of the southern aspect of the roof showing a low number of gaps beneath lifted tiles and a gap from a missing tile</p> |

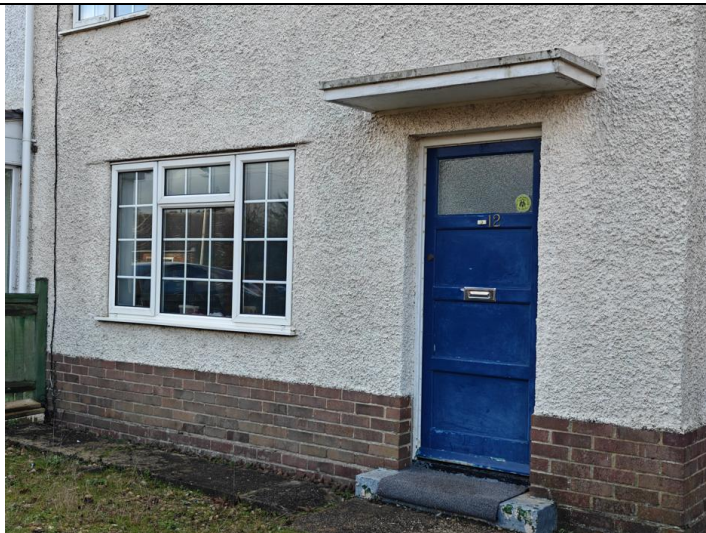
| Window/door frames/porchway | uPVC window and doorframes | <p><b>Condition/description</b></p> <p>The window and door frames within themselves were in a good state of repair and well-sealed, with no visible gaps recorded. The small porchway above the front door on the northern aspect was also noted to be well-sealed with no visible gaps recorded.</p> <p><b>Suitability/access/evidence of bats</b></p> <p>No suitable roosting features observed.</p> | <p>Northern aspect</p> |

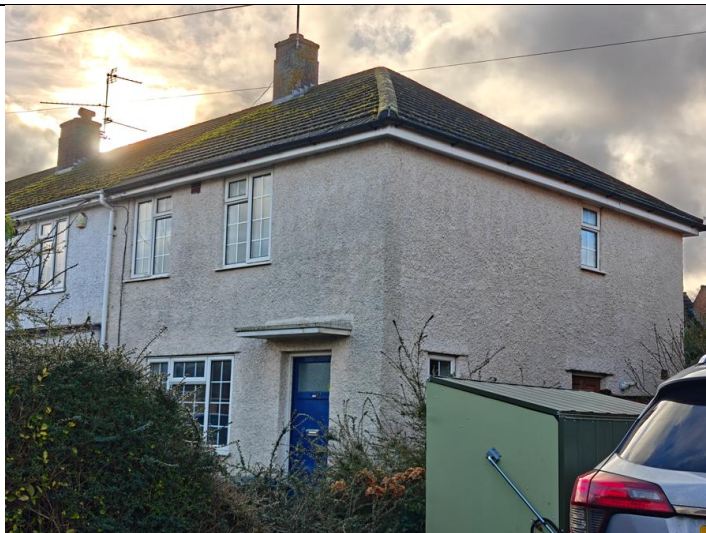
| Chimney | Brick with mortar | <p><b>Condition/description</b></p> <p>The chimney itself appeared to be in a good state of repair, with no signs of deterioration of the mortar or bricks, and no gaps were recorded.</p> <p><b>Suitability/access/evidence of bats</b></p> <p>No suitable roosting features observed.</p> | <p>North-western aspect showing the chimney</p> |

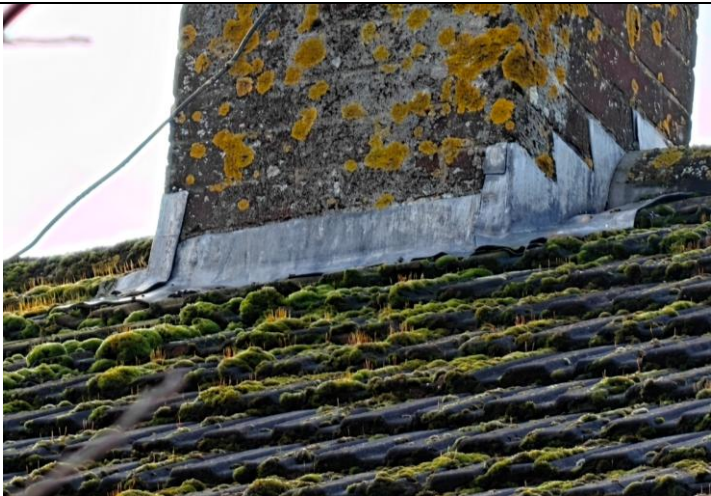
| Lead flashing | Lead | <p><b>Condition/description</b></p> <p>Lead flashing is present on all aspects of the building at the base of the chimney. Gaps were recorded underneath the lead flashing where it has become raised.</p> <p><b>Suitability/access/evidence of bats</b></p> <p>Gaps underneath raised areas of lead flashing may provide roosting opportunities for crevice dwelling bats.</p> | <p>Raised lead flashing and gaps at the base of the chimney on the northern aspect</p> |

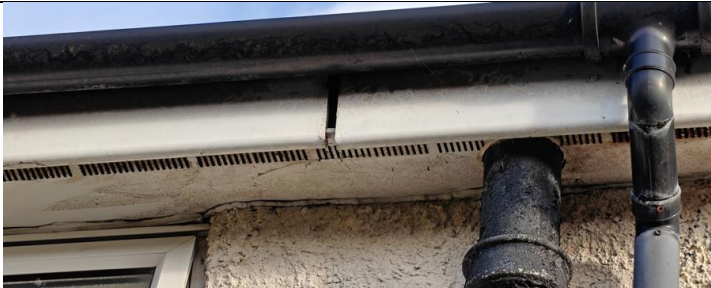
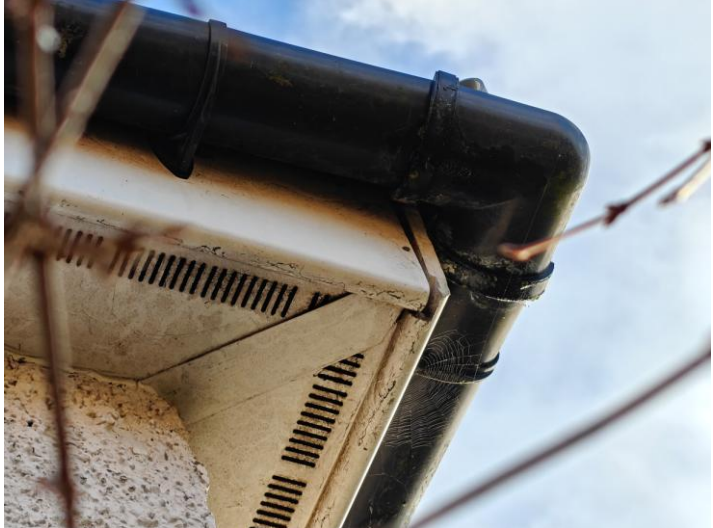
Gap between the fascia boards on the south-western corner

| Soffits and fascias | uPVC | <p><b>Condition/description</b></p> <p>Soffits and fascias are present along the northern, western, and eastern aspects of the building. The soffits were noted to be well-sealed and flush against the walls with no visible gaps recorded. Vent gaps are present within the soffit along all aspects, although these gaps were noted to be very small and narrow. Two gaps were recorded between the fascia boards, on the southern aspect and on the south-western corner of the building.</p> <p><b>Suitability/access/evidence of bats</b></p> | <p>Gap between fascia boards on the southern aspect</p> |

| | | <p>The gaps between the fascia boards could provide roosting opportunities for individual crevice dwelling bats. It was not possible to determine during the survey if these gaps are connected behind the fascia boards, and lead to a larger void. It was also not possible to determine if the gaps between the fascia boards provided internal access into the roof void. It is noted that the vent gaps along the soffits are very small and narrow, due to their small and narrow size, it is considered these vent gaps are unlikely to be suitable for roosting bats.</p> | |

| <i>Recommendations</i> | <p><b><i>Further Surveys</i></b></p> <p>One bat emergence survey is required for Building B1 and the nearby off-site neighbouring single-storey extension during the active bat season (optimal May to August) to confirm the presence / likely absence of bats roosting in or on the building. Ideally this survey should be completed during the optimal survey period mid-May to July inclusive (to ensure the pipistrelle maternity season is not missed). Infra-red cameras should be used as an aid covering all elevations. See <b>Appendix 3</b> for suggested surveyor locations. An internal inspection should also be undertaken immediately prior to the emergence survey to look for evidence of bats within the internal roof void and to assess if the conditions have changed from this survey and report.</p> |

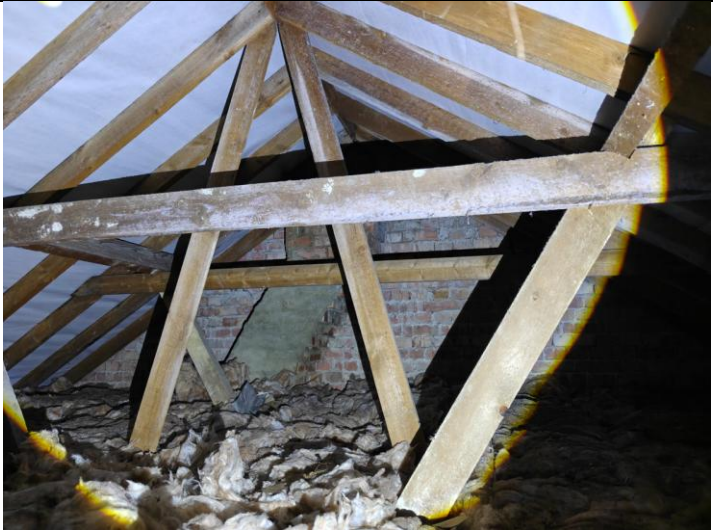
Internal roof void, facing east

| Internal roof void | Timber rafters and ridge beam, fabric underlining, and rockwool insulation at floor level | <p><b>Condition/description</b></p> <p>It was not possible to fully access the internal roof void during the survey due to health and safety restrictions. Therefore, the survey was limited to the view from the ladder. The entire roof void is open and connected, with one loft hatch present, enabling free flight access throughout. The internal roof void was noted to be c. 1.5m high at its highest point, c. 4.5-5m long, and c. 4.5m wide. The roof void was generally noted to be well-sealed and in a good state of repair with no visible gaps recorded. A small area of light ingress was observed along</p> | |

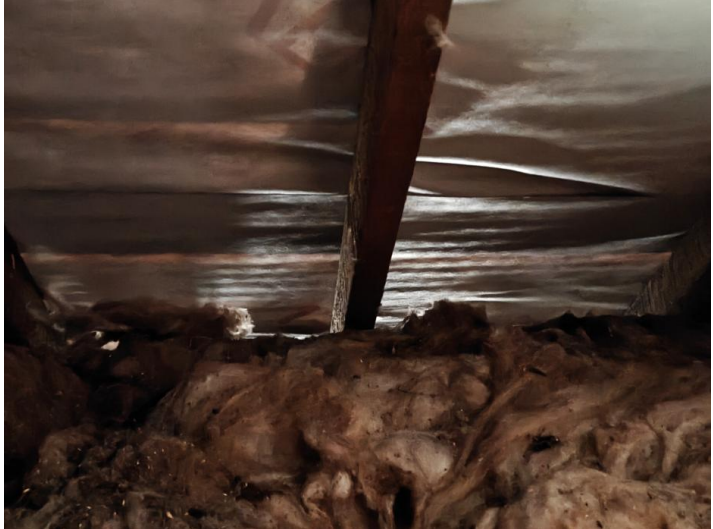
| | <p>the western aspect, its location is consistent with the approximate location of the gap between the fascia board. It was not possible to determine if these gaps are linked and if that is the source of the light ingress. No breeze was felt within the roof void. One small historic wasps nest was recorded along the western aspect.</p> <p><b>Suitability/access/evidence of bats</b></p> <p>One gap was recorded where an area of light ingress was observed entering the roof void on the western aspect. This feature could not be fully inspected due to visibility being restricted to the ladder, therefore it was not possible to determine during the survey if this feature enables bats access into the internal roof void. If it does, it increases the suitability for void dwelling bats. No evidence of bats was recorded during the survey.</p> | <p>Area of light ingress, facing south</p> |

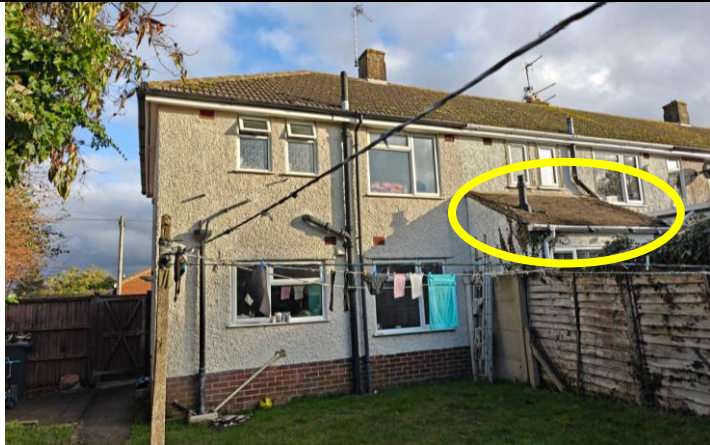
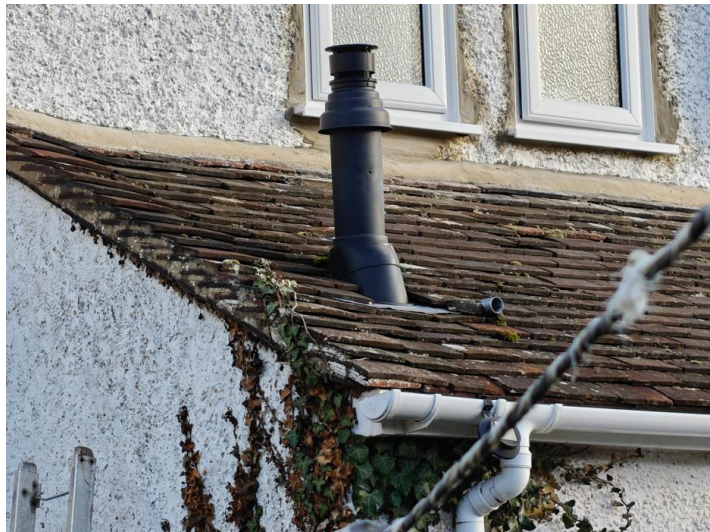
| <p>Off-site neighbouring single-storey extension</p> | <p>Painted pebble dash walls and clay roof tiles</p> | <p><b>Condition/description</b></p> <p>A number of gaps beneath lifted and missing tiles was observed on the neighbouring dwelling single-storey extension to the east of building B1. It is understood that the proposed extension on building B1 will not directly adjoin the single-storey extension and will be positioned approximately 1 – 2ft away from the neighbouring extension. However, due to the close proximity of this to the proposed development this off-site feature has been included within the assessment.</p> <p><b>Suitability/access/evidence of bats</b></p> <p>Gaps under tiles could provide roosting opportunities for individual crevice dwelling bats. It is possible that if any bat(s) roost along the western edge of the single-storey extension their flightlines may be impacted by the proposed development.</p> | <p>Southern aspect, with the off-site neighbouring single-storey extension circled</p> <p>Close-up of the off-site neighbouring single-storey extension</p> |
