**GEO-ENVIRONMENTAL REPORT  
TESCO CAR PARK  
READING  
BERKSHIRE  
RG30 1AW**

**Report Prepared For:**

**RIDGEPOINT HOMES LTD  
TERRIERS HOUSE  
201 AMERSHAM ROAD  
HIGH WYCOMBE  
BUCKINGHAMSHIRE  
HP13 5AJ**

**Date of Issue: August 2019**

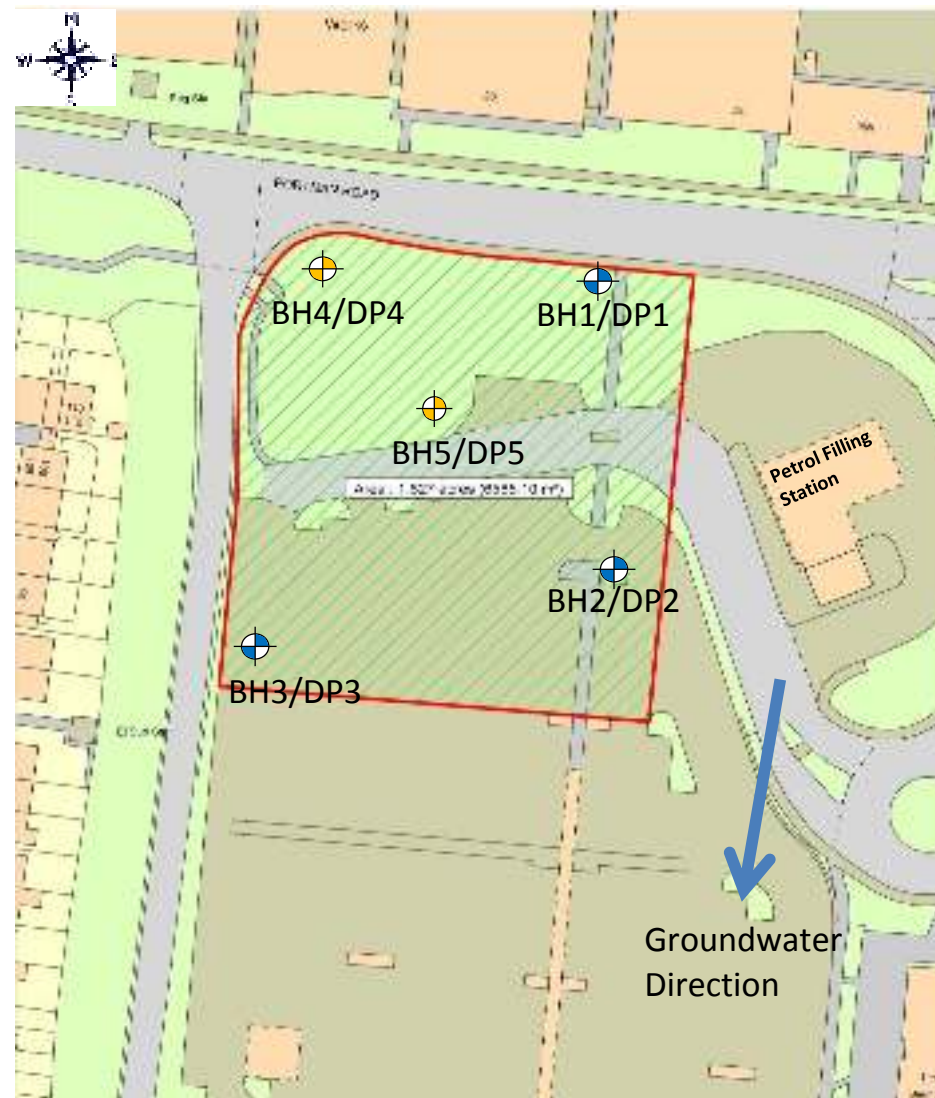
Borehole with monitoring well
