# 3 CWMCARN, EMMERGREEN READING

## Preliminary Bat Roost Assessment Report

*May 2023*

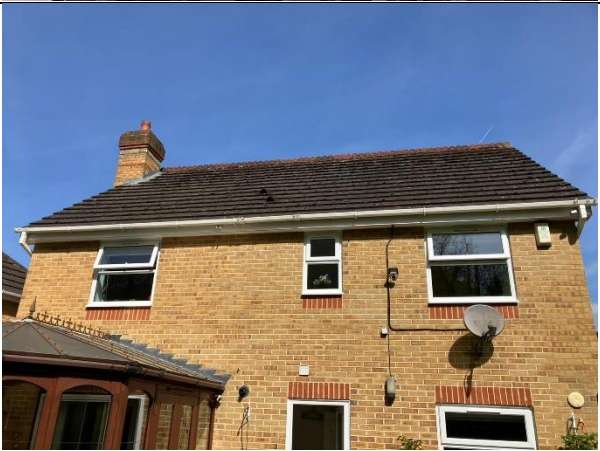
3.2.1. The site consisted of a two-storey brick residential dwelling with a conservatory extension located on the southern aspect and a detached garage on the northern aspect of the site. All brickwork surrounding the residential dwelling was found to be in good condition with no gaps or crevices and no missing mortar identified throughout. All windows and doors surrounding the dwelling were found to be in good condition and they led directly into the internal residential aspect of the house, they did not provide any PRF's throughout. All rooms within the internal aspect of the dwelling were sealed throughout with no access points identified. All overhanging eaves surrounding the dwelling were well sealed, vents were identified on the northern and southern aspect of the eaves which were well sealed, they did allow natural lighting into the loft space however, it did not create an access point into the loft, and they were not identified as a PRF.

3.2.2. The roof consisted of slate tiles throughout which were all found to be well sealed and there were no gaps or crevices identified along the tiles which could create a PRF. A chimney was located on the western aspect of the dwelling, one small gap was identified within the led flashing which surrounded the chimney, it is unknown if this remained as a small gap or led to a larger area, this was identified as a PRF.

| Feature | Photograph |
|---|---|
| Southern aspect of the building. | |

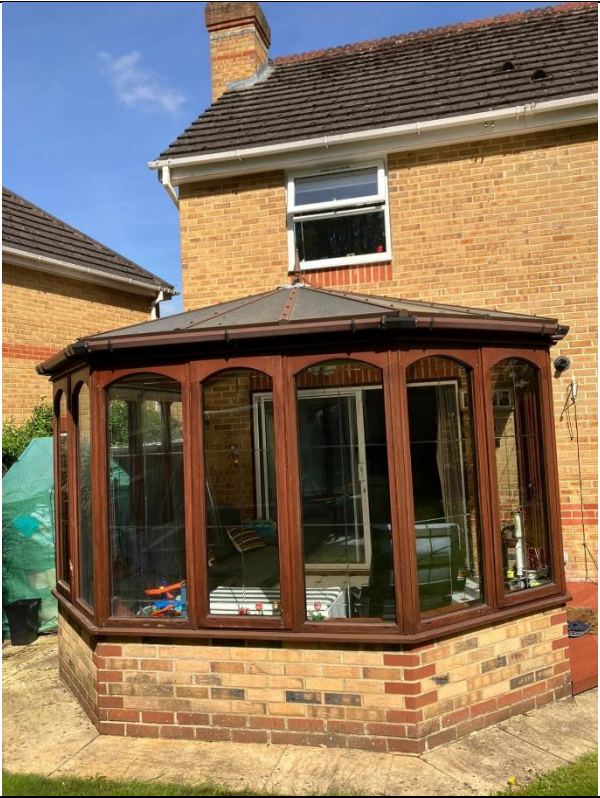
3.2.5. A conservatory is located on the southern aspect of the dwelling, this is to be demolished throughout the proposed development. The consisted of glass and supporting beams throughout and led to the residential area of the dwelling. There were no gaps or crevices identified throughout, it did not provide any PRF.

| Feature | Photograph |
|---|---|
| Conservatory located on the southern aspect of building. | |

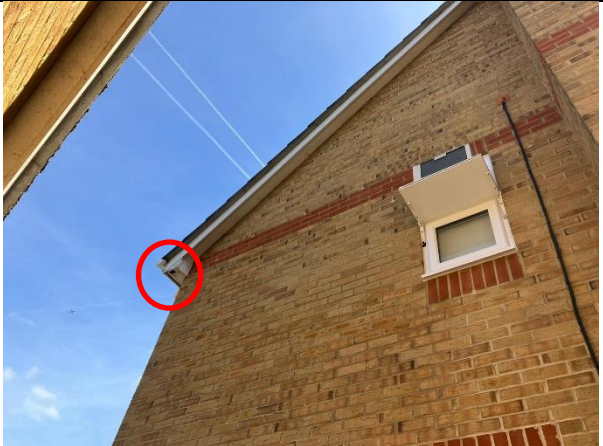
3.2.3. A total of two gaps were identified within the soffit boards of the house, they were located on the south-eastern corner and the north-western corner. It is unknown if these lead to a small gap or create a larger roosting feature, these were identified as a PRF as it is anticipated that these gaps may be used by bats opportunistically. It should be noted that the gap on the north-western aspect of the dwelling will not be affected throughout the proposed development.

| <p><i>Eastern aspect of dwelling with hole in soffit circled in red.</i></p> | |

3.3.1. The following survey identified a total of two PRF's in relation to the two holes identified within the soffit boards on the south-eastern and the north-western corner. It is unknown if these create small gaps or larger gaps along

the soffit boards of the dwelling. A total of one small gap was also identified within the led flashing surrounding the chimney, the size of the gap is unknown. As such, the building was assessed as having low bat roosting potential.

- 4.1.1. The building was found to provide **low bat roosting potential** and therefore, in accordance with Best Practice guidance (Collins, 2016) further nocturnal/ re-entry surveys should be undertaken between May-August (inclusive) to determine usage by roosting bats. It was assessed as **low bat roosting potential**; therefore, a minimum of **one further survey** is recommended.
- 4.1.2. The results of the further surveys will determine if any mitigation is required for roosting bats. If roosting bats are located within any of the buildings, a Natural England Mitigation Licence may be required for development to proceed. The Licence can only be obtained once planning permission has been granted and all wildlife conditions discharged. However, the bat emergence surveys must be undertaken prior to planning permission being applied for as they are a material consideration.

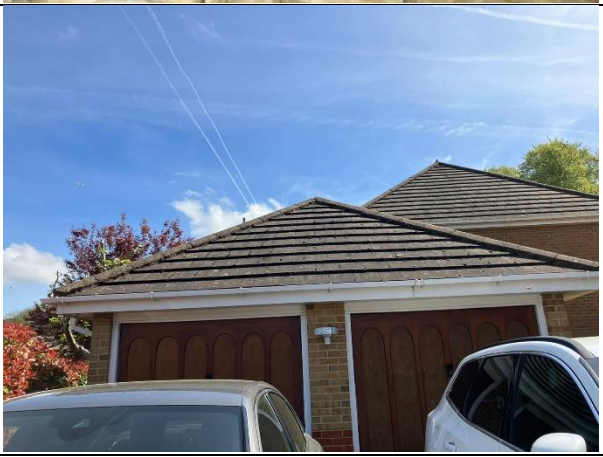
3.2.6. A detached garage was located on the northern aspect of the dwelling which consisted of the same brickwork and roofing tiles as identified on the residential dwelling. All brickwork and tiles were well sealed throughout, there were no gaps or crevices identified, this did not provide any PRF's.

| <p><i>Detached garage on northern aspect.</i></p> | |
