# Bat Survey Report – Preliminary Roost Assessment and Dusk / Dawn Surveys

99 Hartland Road, Reading,  
Berkshire

For  
Reading Borough Council

July 2023

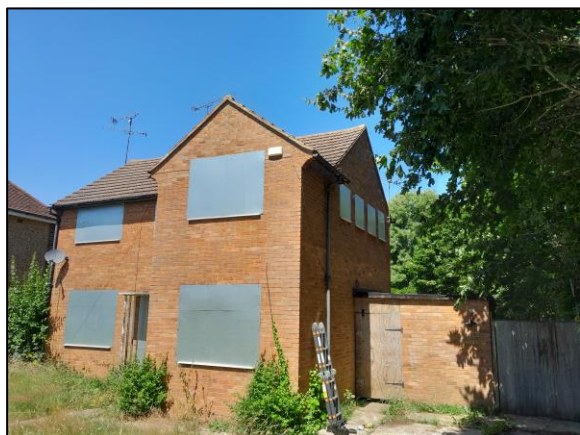
**Photo 1** Front (south) elevation and east side elevation, showing flat roof extension

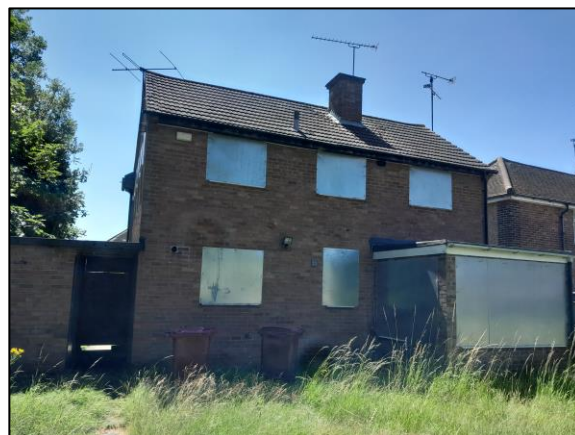
**Photo 2** Rear (north) elevation showing flat roof rear extension

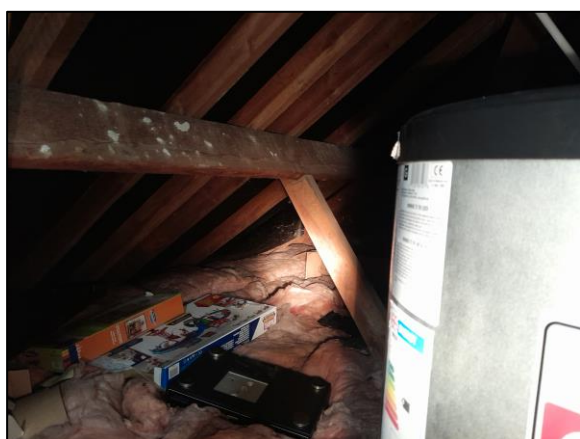
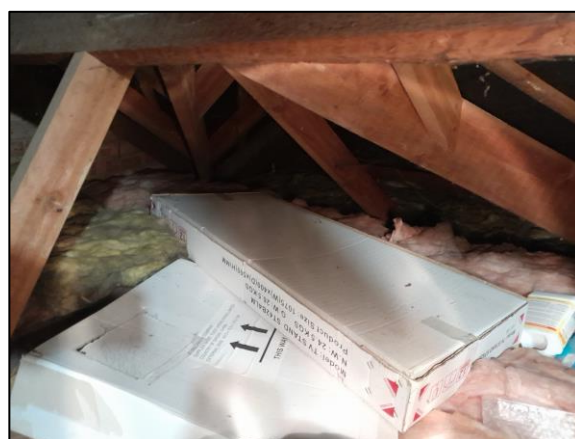
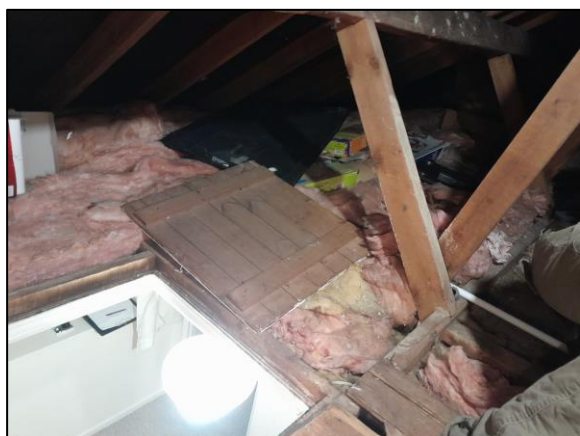
- 3.11. The adjacent areas of exposed loft insulation were searched and again, no evidence of bat activity noted. Spot checks beneath areas of insulation found no old bat droppings underneath. Areas of loft insulation further from the directly accessible areas around the hatch were searched using a torch and binoculars, and no bat droppings or other evidence was noted. See Photos 3 to 6.

**Photo 3** Loft internals

**Photo 4** Loft internals

**Photo 5** Loft internals

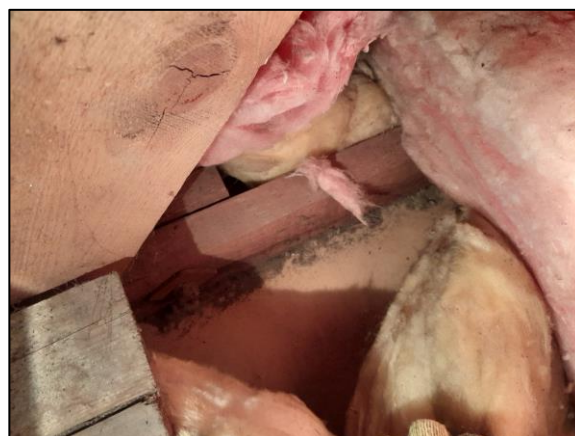
**Photo 6** Spot checks under insulation

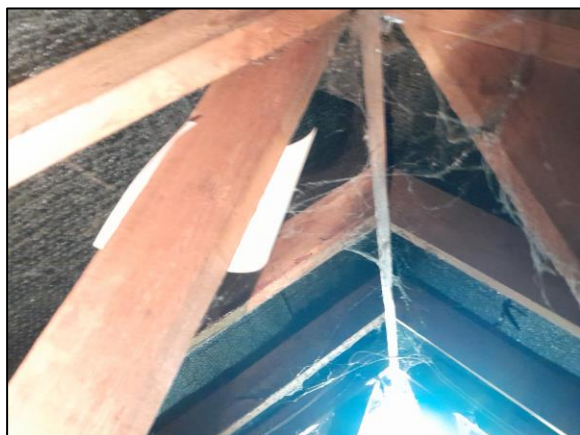
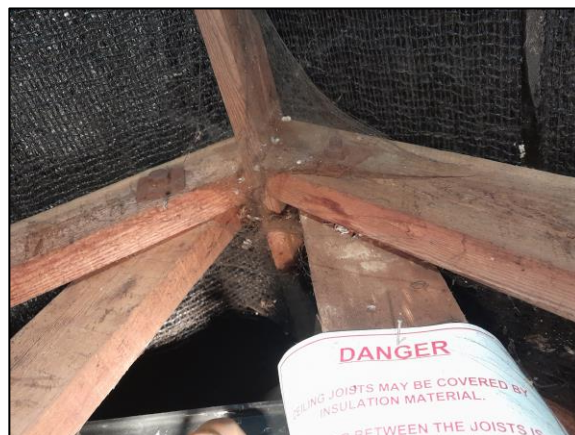
- 3.12. The timbers were examined; no bat droppings, fur staining, or other evidence was seen. It was also noted that there were extensive cobwebs across all areas of the loft, including along the central ridge beam. See Photos 7 and 8

**Photo 7** Ridge beam

**Photo 8** Beams

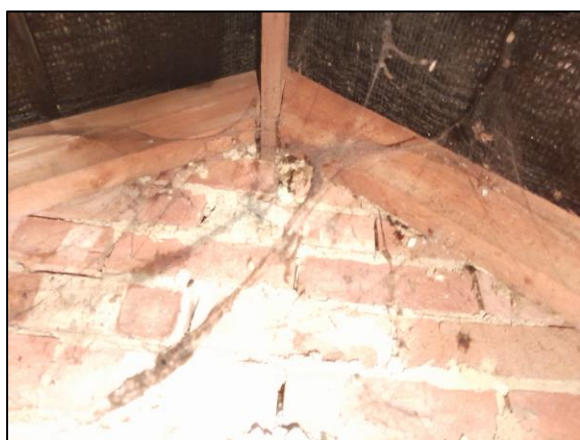
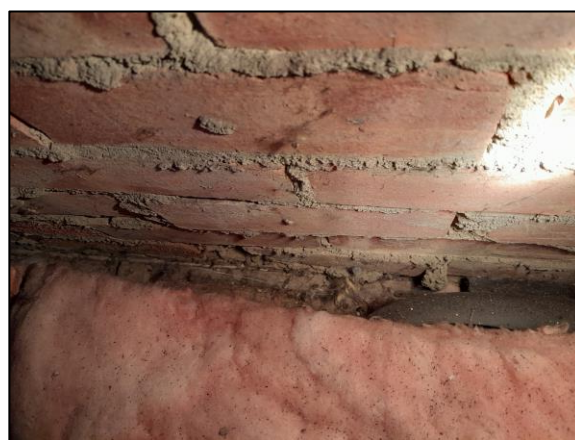
- 3.13. Inspection of the internal gable apexes, gable walls, and the floor areas beneath the gable apexes found no bat droppings. Again, extensive cobwebs were noted in these areas – see Photos 9 and 10.

**Photo 9** Gable apex

**Photo 10** Floor at base of gable apex

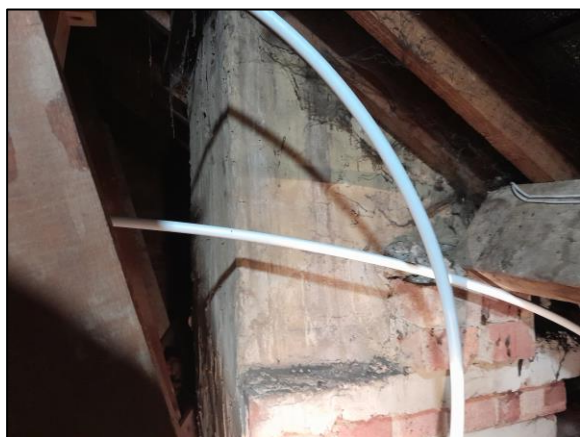
- 3.14. The chimney breast, roof areas around the top of this, and the floor areas in the loft around the base of the chimney were inspected and as with other parts of the loft, no direct bat evidence noted, and these areas also exhibited substantial cobwebs. See Photo 11.

**Photo 11** Chimney breast

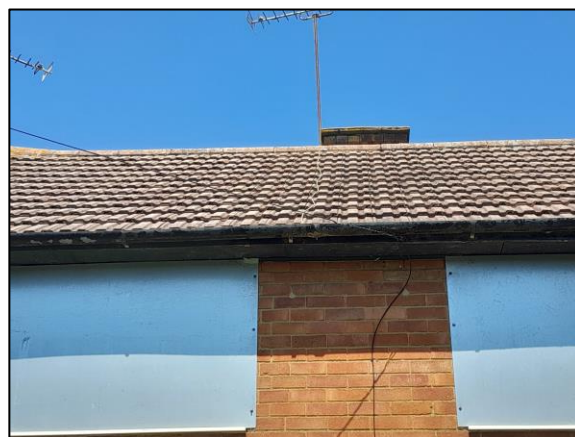
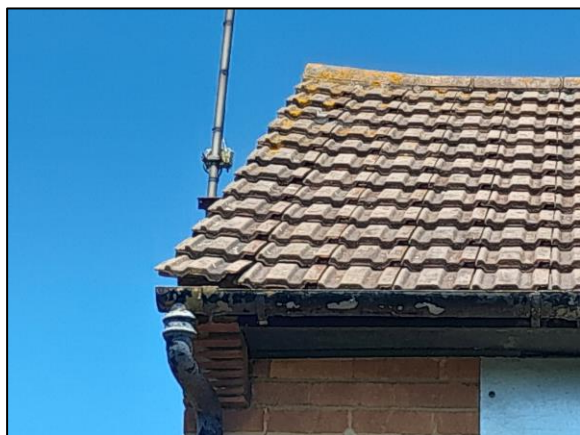
- 3.17. Externally, the roof tiles were generally in good condition and well fitting, with no gaps or damaged tiles across the majority of the roof faces. However, a small area of tiling along the western side of the southern roof face exhibited some slippage / gaps, likely where the natural setting of the timber roof frame against the external gable wall has resulted in a degree of unevenness. Down this section, some of the gaps – particularly lower down the roof – were found to be sufficiently large to allow bats to access and potentially roost in crevices between the tiles, battens, and the upper surface of the underfelt. See Photos 12 and 13.

**Photo 12** Roof tiles

**Photo 13** Lifting to tiles on eastern edge of south roof face

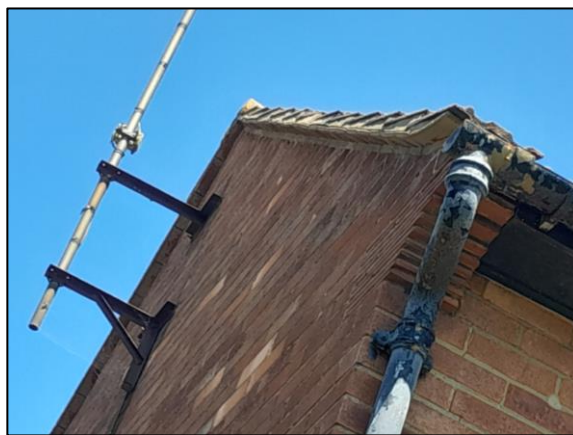
- 3.19. The verge tile bedding mortar around the gable ends was found to be in good condition with no gaps noted at all – see Photo 14.
- 3.20. The soffits were found to be in fair condition, with some slight deterioration and weathering, as well as occasional gaps and damage that had resulted in holes that could potentially allow bat access. However, these holes were generally directly adjacent to smooth metal security shuttering over the windows, which would not allow bats to grip onto it prior to crawling up into these gaps. See Photos 15 and 16.

**Photo 14** Verge mortar

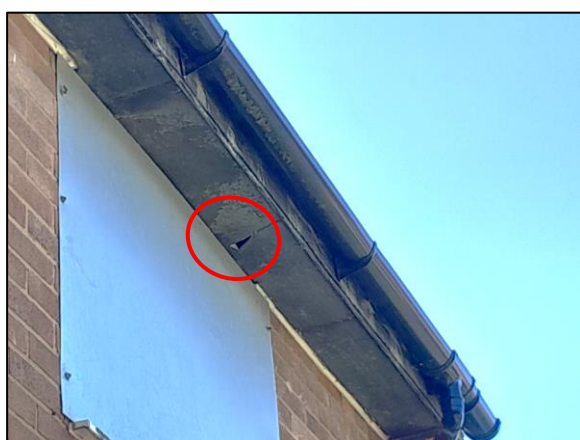
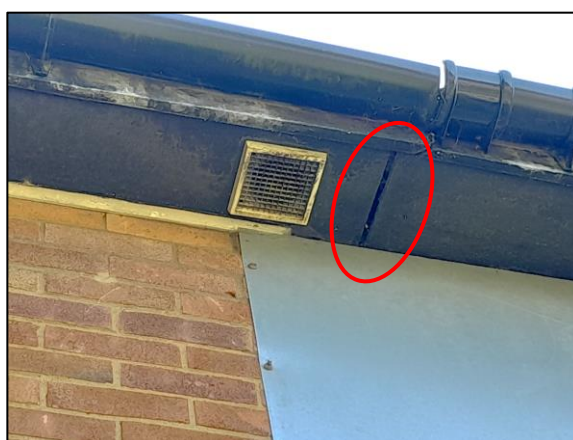
**Photo 15** Soffit to rear well sealed, but damage present

**Photo 16** Gap to soffit

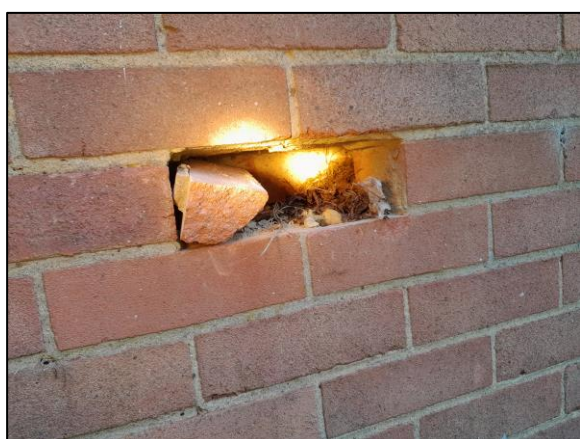
- 3.21. To the rear of the house is a missing brick lower down the wall. No bat evidence was seen – however, this hole does give direct access into the wall cavity and is large enough for bats to access. An old bird nest was also identified in this hole (see Photo 17)

**Photo 17** Missing brick with bird nest and potential bat access to wall cavity

- 5.1. The work at 99 Hartland Road will not adversely affect bats or bat roosts and therefore there are no specific recommendations to be made at this time regarding bats.
- 5.2. The visual survey identified a disused bird nest in the missing brickwork to the rear of the house. If the work is planned to occur between March and August, this area should be checked prior to the work starting to ensure that there are no active nests present.

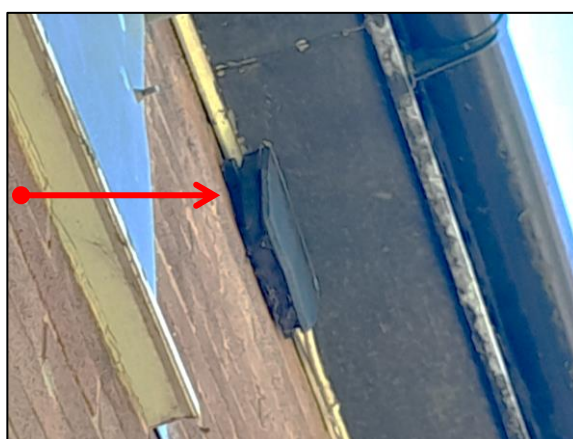
- 3.22. Also to the rear of the house, an external box – possibly for communications / cable TV or similar – was noted just below the eaves. This was fixed so it was sitting slightly proud of the external wall, creating a small secure crevice between the rear of the box and the brickwork, with a gap suitable for bats to access and roost behind (Photo 18).
- 3.23. A slight area of lifted flashing was noted to one corner of the chimney (Photo 19), along with some slight mortar deterioration around the capping.
- 3.24. The fascias around the edges of the flat roof sections of the house were found to be flush to the external walls with no gaps behind (Photo 20). However, a small section of slightly raised flashing was noted to one former of the rear extension (see Photo 21).

**Photo 18** Gap behind wall box

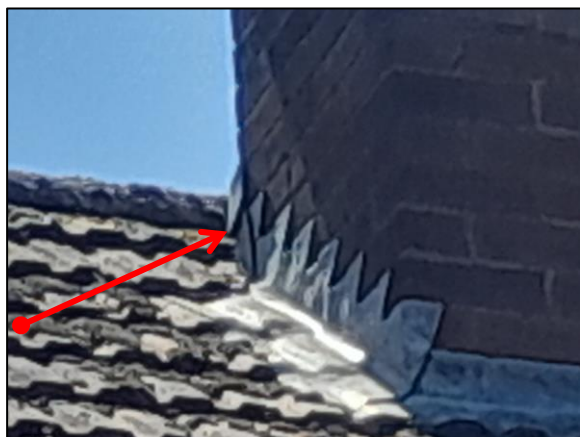
**Photo 19** *Lifted flashing behind chimney*

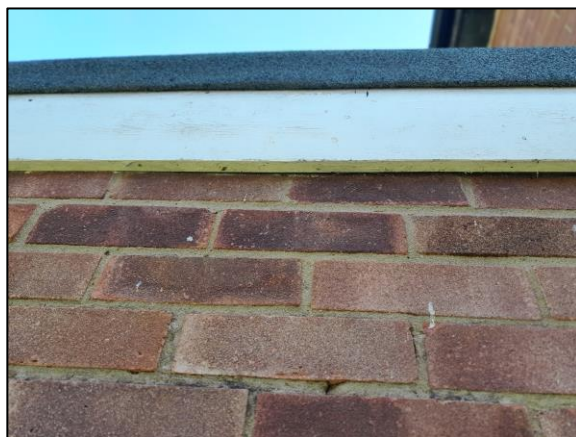
**Photo 20** *Flat roof fascia tight to wall*

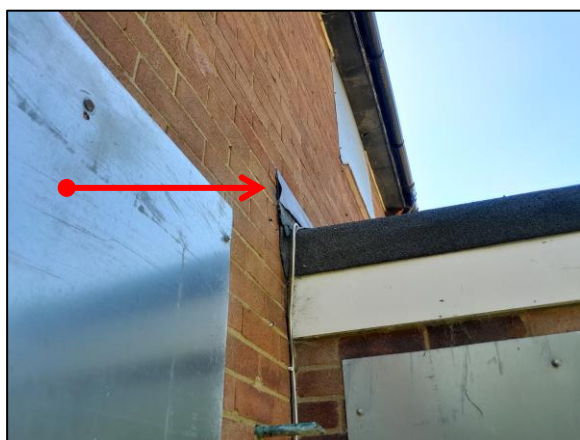
**Photo 21** *Gap to flashing to rear flat roof extension*

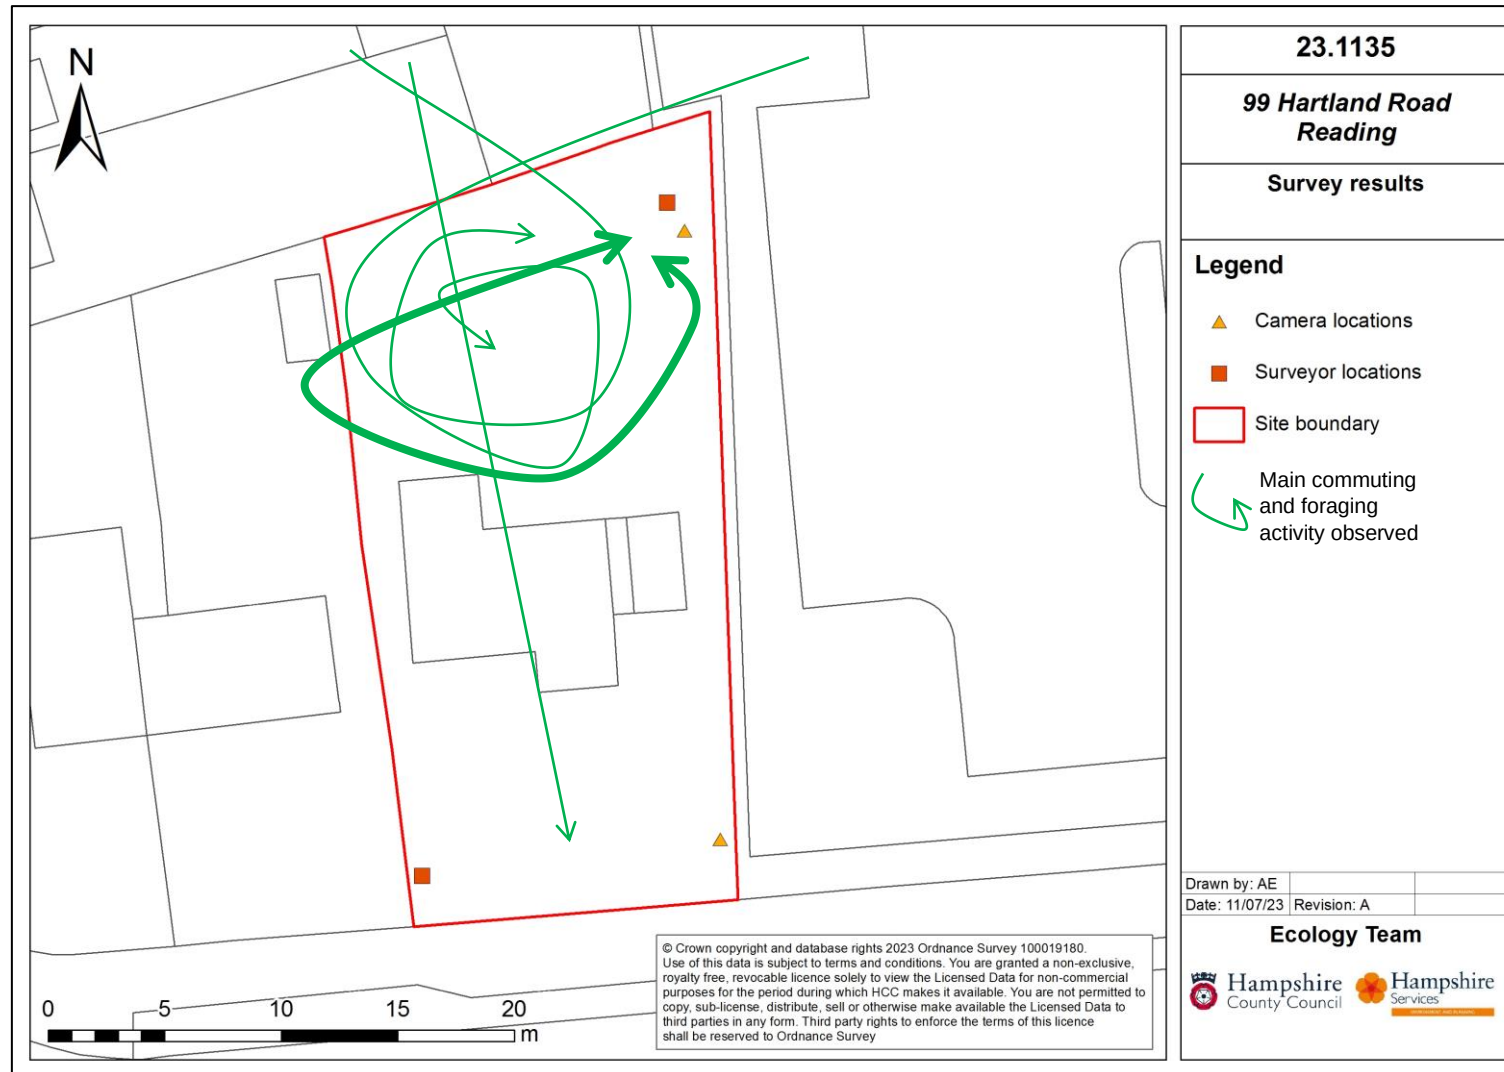
## Appendix 3 – Survey results

- 3.32. The following section describes the survey findings. Appendix 3 shows the key results and surveyor positions.

- 3.33. The first bat heard was a Common Pipistrelle at 21:36, approximately 18 minutes past sunset. This flew into the rear garden from a point north-east of the site then commenced foraging activity over the rear garden. A further Common Pipistrelle entered the garden from the north at 21:37 and also began foraging.
- 3.34. Between 21:37 and 21:54, further bats arrived on site and continued foraging over the rear garden and adjacent properties. A peak of four bats foraging was seen at any one time.

- 3.35. The activity slackened off and became only occasional and intermittent after 21:55.
- 3.36. At 21:58 a Noctule *Nyctalus noctula* was seen and heard commuting high over the site.
- 3.37. A brief Common Pipistrelle pass was recorded at 22:00.
- 3.38. At 22:10, light rain began to fall. This became heavier and the survey was called off at 22:15. As the rain advanced, the house was kept under observation, but no bats entered any of the potential roost locations to shelter.
- 3.39. No bats were seen to emerge from the house.
