# **GAS HOLDER SITE, READING**

Supplementary Site Investigation & Monitoring  
Report

**PROJECT NO. 70031882**

**DATE: MARCH 2020**

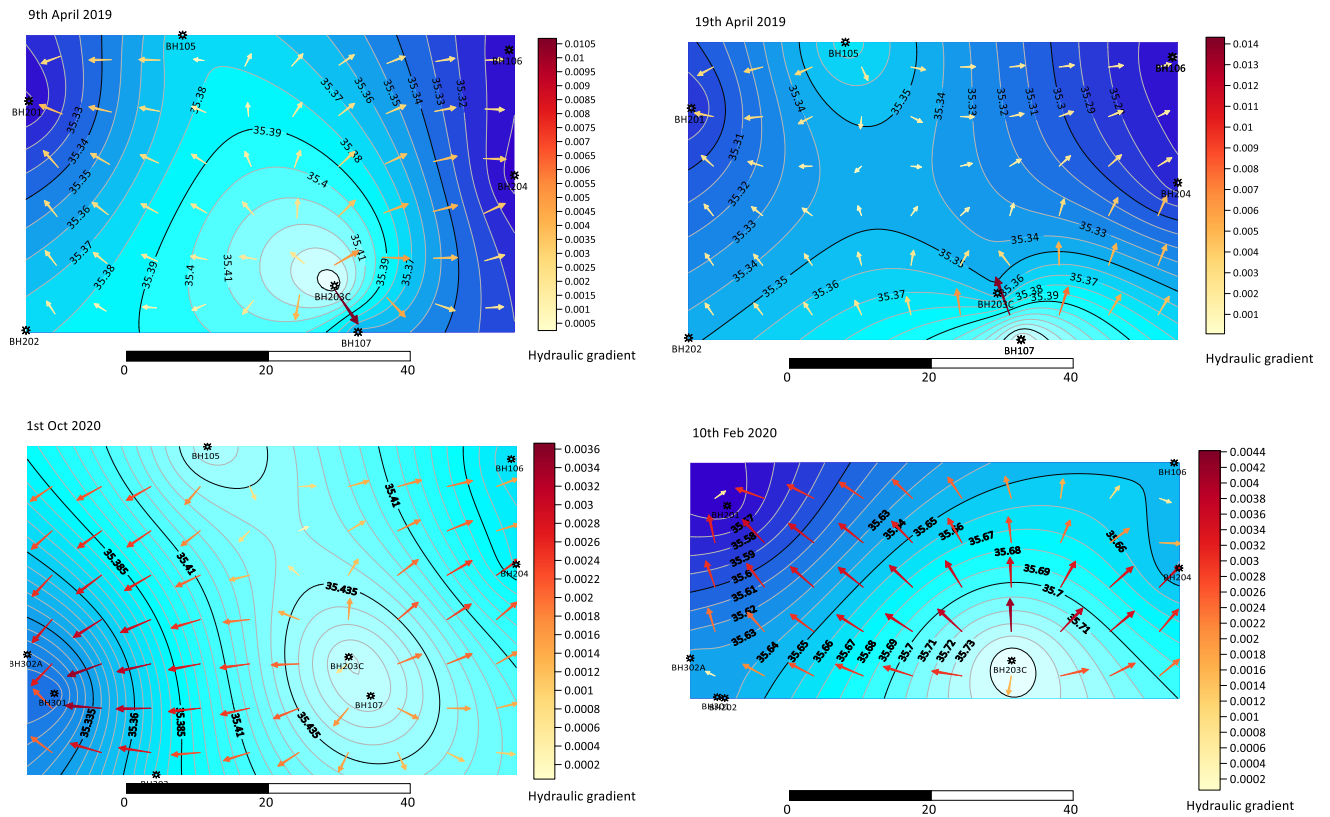
## Inset 2-1 - Groundwater Configuration within the RTG and Chalk Aquifer (9 and 19 April 2019, 1 October 2019 and 10 February 2020)

### Groundwater Flow Regime (interpolated)

Includes those results from the River Terrace Gravels (RTG) and Chalk only

Based on the findings of the recent investigation and monitoring works (September-October 2019 & February 2020), the preliminary hydrogeological model that was provided in earlier reports has been refined. The ground conditions encountered in the additional boreholes comprised Made Ground, Alluvium, River Terrace Gravels and Chalk. Numerous obstructions were encountered in the Made Ground associated with former structures, foundations and services.

Given that the River Kennet is lined in proximity of the Site and the prevalence of a northeast groundwater direction noted within the groundwater configuration, it is assumed that the groundwater flow beneath the Site has a general flow direction to the northeast towards the confluence of the River Thames and River Kennet.

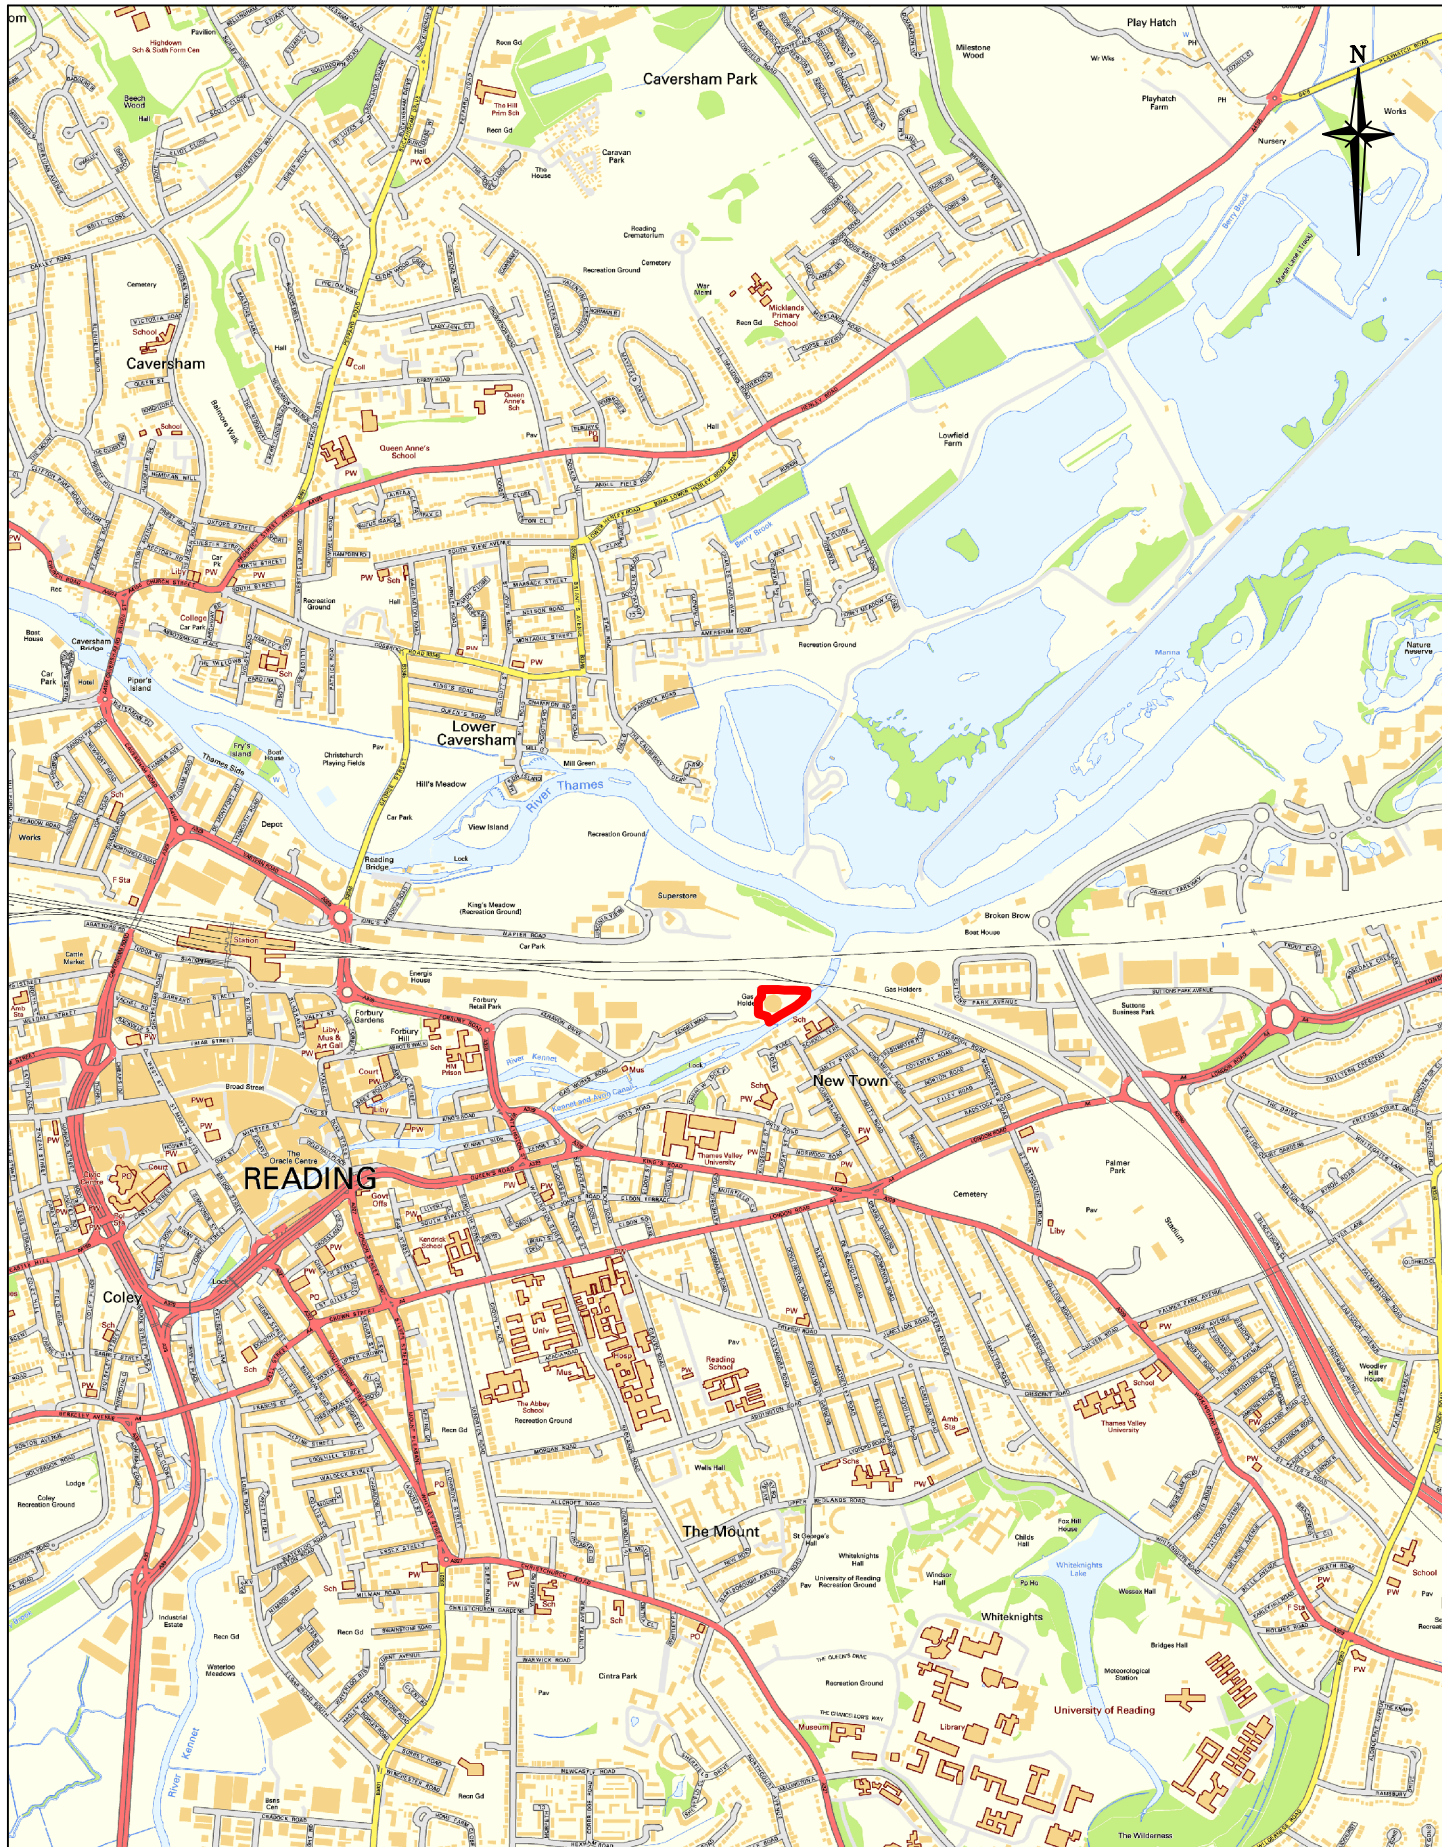
The Site location and current layout are presented in on Figure 70031882-001 and Figure 70031882-002 respectively in **Appendix A**.

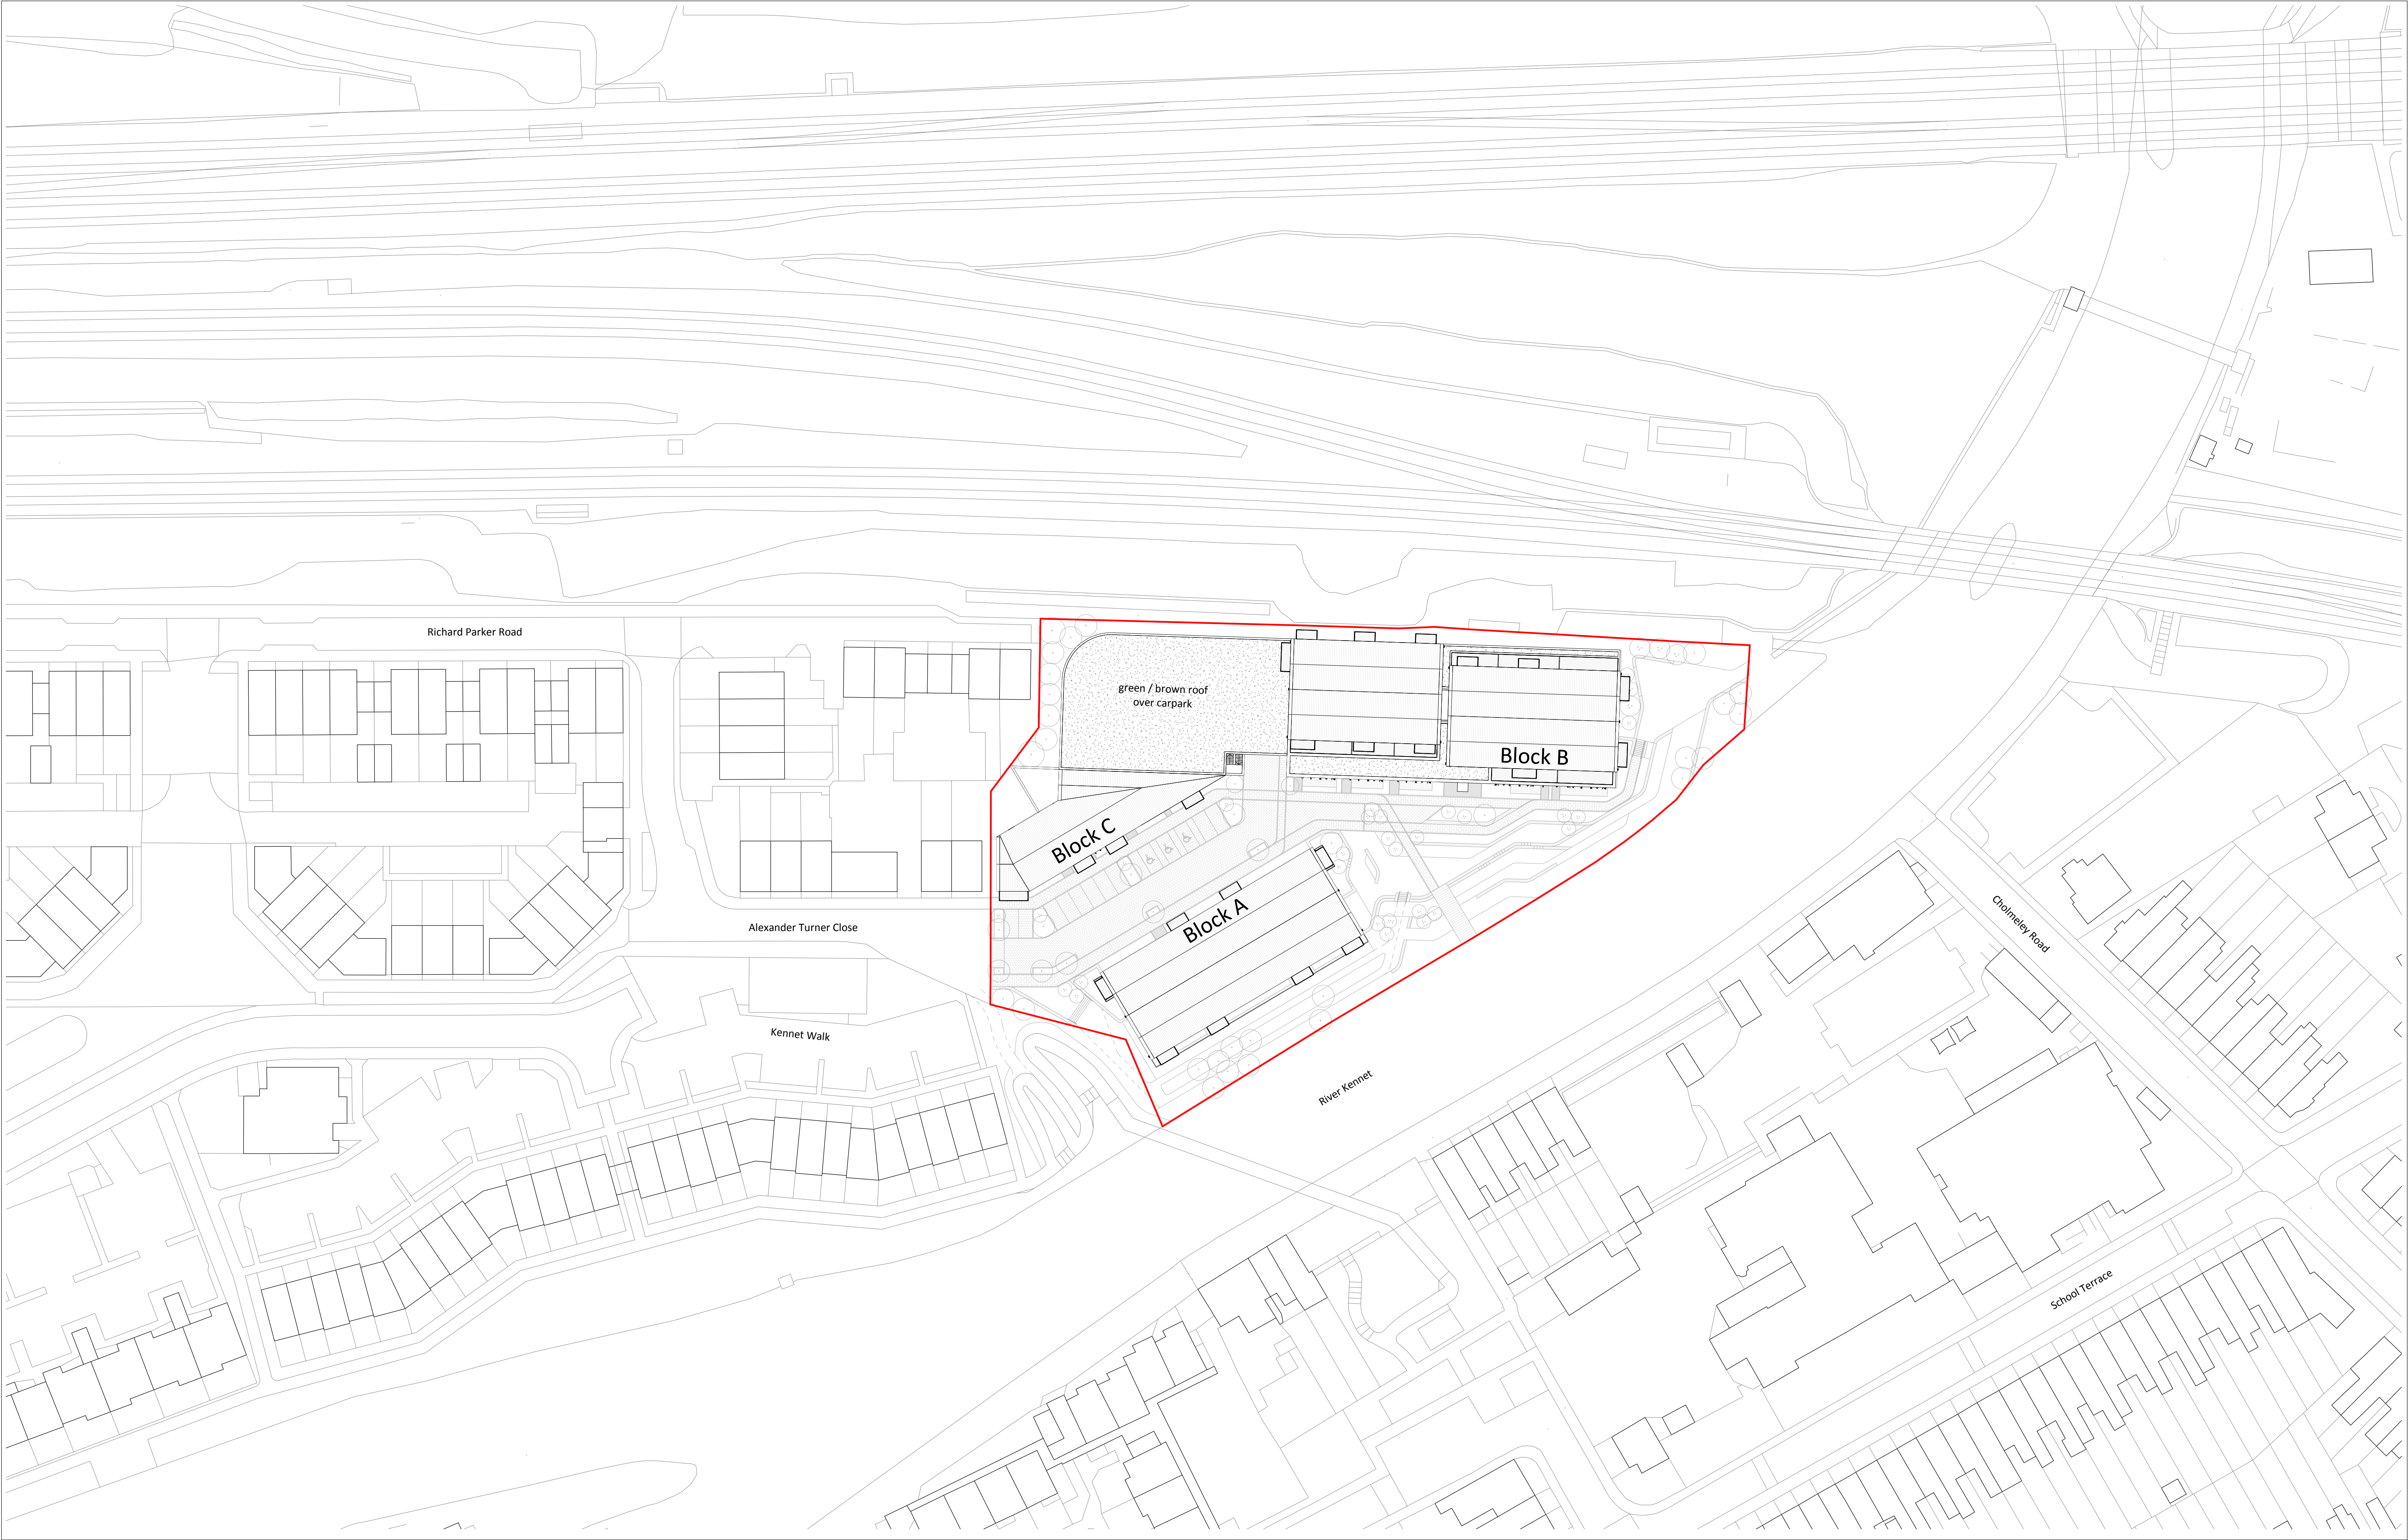
The proposed development comprises demolition of existing buildings and Gas Holder, and the erection of new buildings ranging between 2 and 9 storeys in height, providing 130 residential units (Class C3) with associated access, car parking, landscaping and open space. The proposed development plans (Proposed Site Plan<sup>1</sup> and Proposed Ground Floor Plan<sup>2</sup>) are included in **Appendix A**.

<sup>1</sup> Gas Holder Reading, Proposed Site Plan, ColladoCollins Architects, 16035 P0-010 Dated 28/03/19 – Planning
